## WHY DO KRAFT RECOVERY BOILER COMPOSITE FLOOR TUBES CRACK?

**James R. Keiser, Gorti B. Sarma, Xun-Li Wang, Camden R. Hubbard, Robert W. Swindeman, Philip J. Maziasz**

Oak Ridge National Laboratory  
Oak Ridge, TN 37831-6156 United States

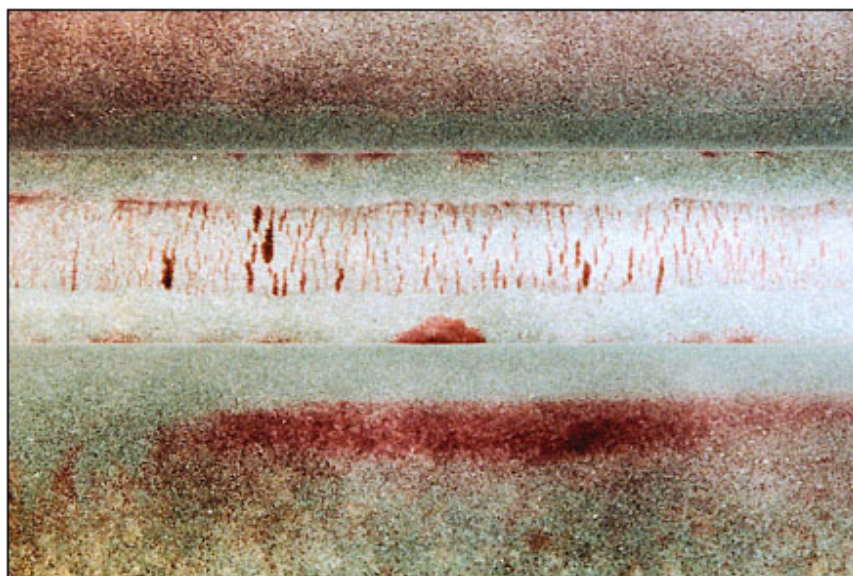
On floors constructed with three inch tubes on four inch centers, transverse cracking in the 304L clad membrane, like that shown in **Figure 1**, is sometimes seen before cracking is found on the tubes. However, cracking is seen on both 2-1/2 and 3 inch composite tubes, and it is found in both slope-floored and decanting-type recovery boilers. Particularly on floors with the wider membrane, cracking can occur at the toe of the membrane to tube weld. Cracking is also found on both sizes of tubes away from the weld. This cracking sometimes is primarily circumferential in orientation (see **Figure 2**) while in other cases it will consist of a series of randomly-appearing interconnected cracks sometimes referred to as craze cracking like that shown in **Figure 3**. The different crack orientations most likely reflect the stress state (tensile or compressive for the axial and tangential directions) at the surface of the tubes at the time that cracking is occurs.

*Figure 1. Transverse cracks like those shown are sometimes seen in the membrane of floor panels constructed with 76 mm (3 in.) diameter tubes on 102 mm (4 in.) centers.*

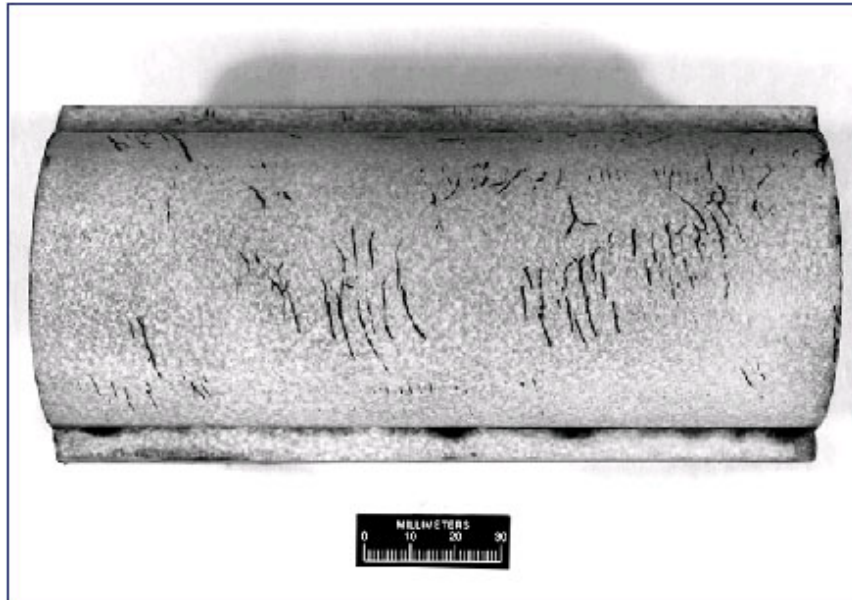
*Figure 2. Circumferential cracks are found on some tubes indicating the tensile stresses on the tube are primarily axial.*

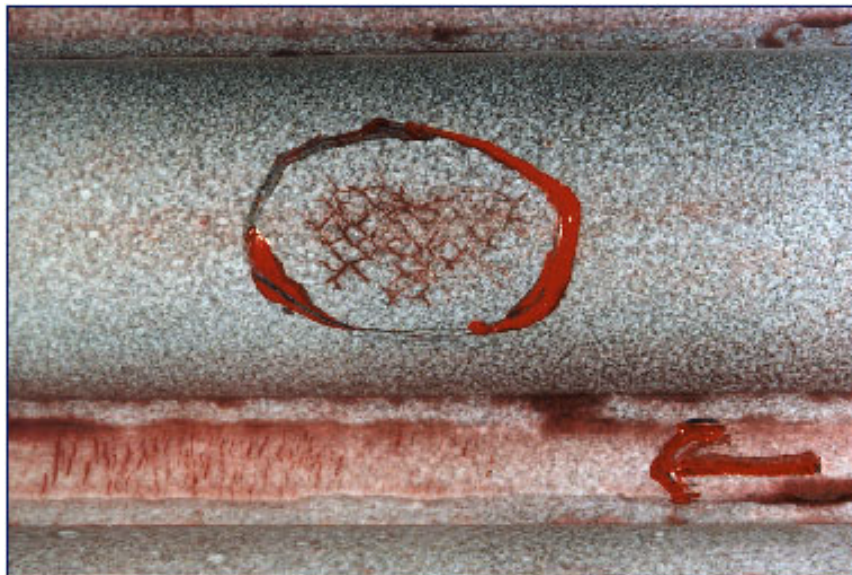
*Figure 3. The craze or interconnected cracking found on some tubes suggests that both axial and tangential stresses are tensile.*

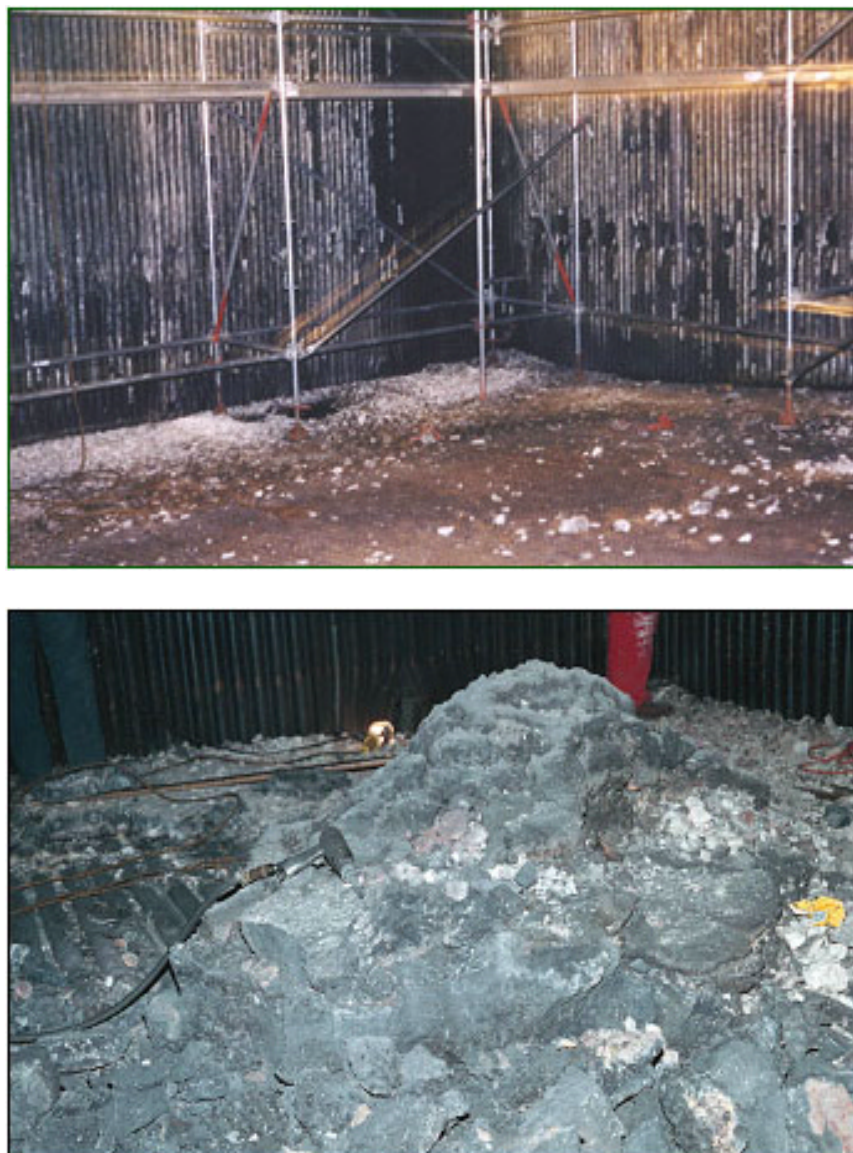
***Figure 4. Examples of a recovery boiler where the smelt bed has been nearly completely burned-out and a boiler where little effort was made to remove the bed before shut-down.***

Before any inspection is performed, debris and adherent deposits must be removed from the surface of the tubes. For floor tubes, this is facilitated by taking the time to completely burn out the smelt bed as the boiler is being shut down for inspection (**Figure 4**). There is an additional benefit to burning out the bed, since such action helps eliminate some of the conditions that can contribute to floor tube cracking. Some mills have used high pressure water lances inserted through the spout openings in the latter stages of a water wash to help remove the residual smelt bed from the floor.

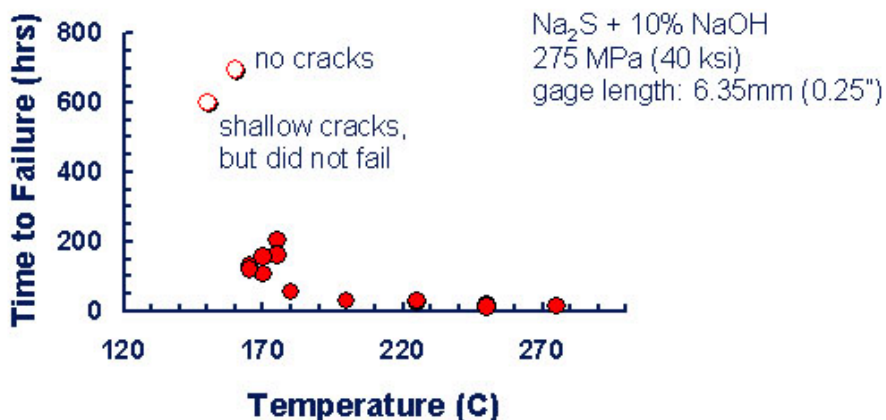
Water washing a recovery boiler subjects the hot floor tubes to a chemical environment rich in sulfide, carbonate, hydroxide, sulfate and other oxidized sulfur compounds. Laboratory experiments have demonstrated that SCC will occur over a temperature range of about 160°C to more than 220°C in hydrated mixtures of these salts (**Figure 5**) [9]. The presence of sulfide was found to be essential for SCC, and cracking was more severe as the content of hydroxide in the salt was increased [8,9]. Significantly, SCC has been induced in test samples exposed only to a moist salt mixture of sulfide and carbonate with no added hydroxide, at temperatures between about 160 and 200°C (320 and 390°F) – conditions which closely match those expected in the early stages of a water wash [9]. SCC will not occur at temperatures lower than about 160°C (320°F) within the concentration range of chemicals that might be expected during water washing, but has been demonstrated at temperatures as low as 60°C (140°F) in a highly concentrated or saturated solution of sulfide and hydroxide [8].

**Figure 5. Effect of temperature on cracking of 304L stainless steel in a sodium sulfide 10% sodium hydroxide solution. Note that cracking occurs at temperatures above about 160°C.**

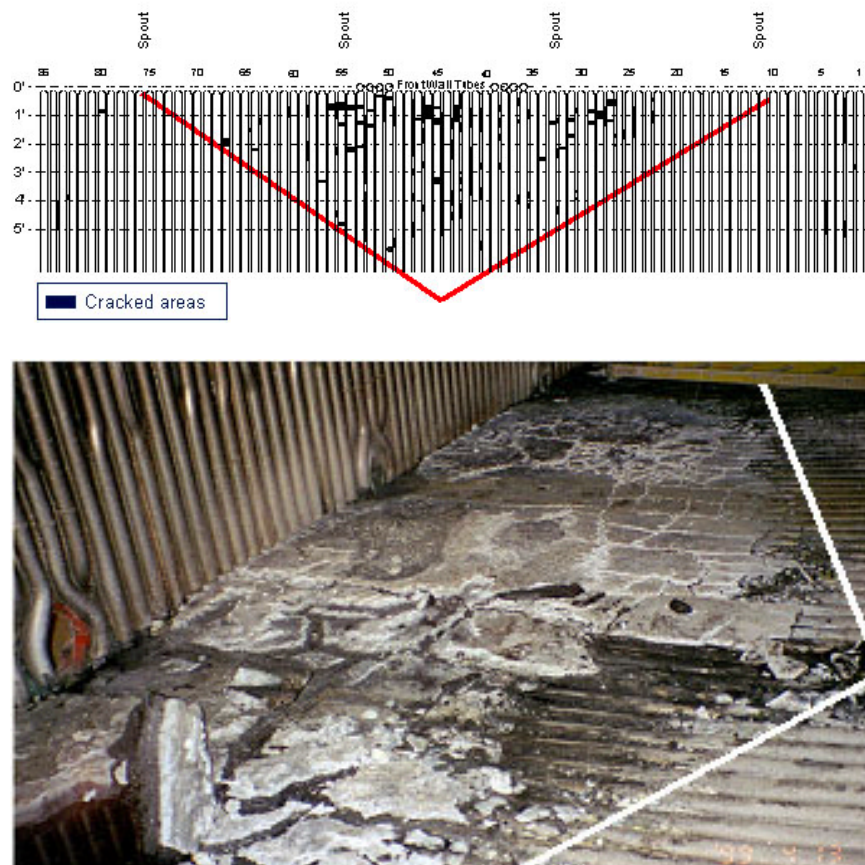
These data suggest that a narrow window of susceptibility to cracking exists when the boiler floor tubes are still hot, and covered by a relatively thick insulating layer of smelt. In the early stages of a water wash, saturated wash water will pass over the tubes, or moisten the smelt in contact with the tubes. Circumstantial evidence suggesting that the presence of residual smelt on the floor during washing plays a part in the development of floor tube cracks is shown in **Figure 6**. The pattern of cracking found on the floor of this boiler closely matches the location of the

smelt left after the bed was burned down and the boiler water washed. A particularly dangerous situation for cracking exists when a residual bed of wet smelt is left on the boiler floor during a dry-out fire (**Figure 6b**). Floor tube temperatures can remain within the range of maximum susceptibility to SCC for several hours during a dry-out fire [10].

**Figure 6. a) Schematic of recovery boiler floor showing location of cracking found in the tubes and membranes and b) photograph of recovery boiler floor showing the residual smelt bed that was present during a shut down. Note that both the cracking pattern and the residual bed have a "V" shape.**

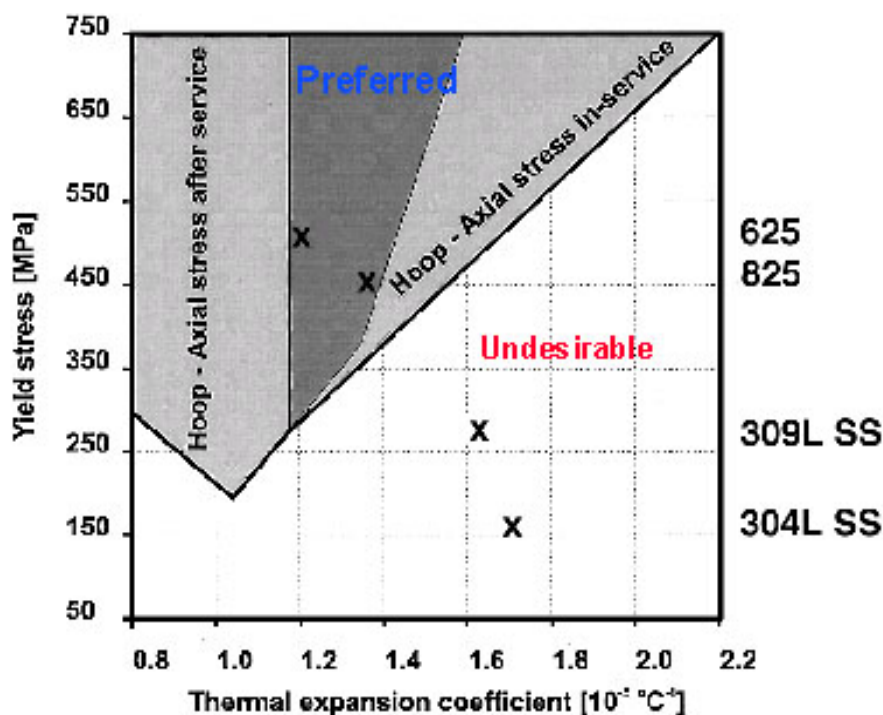
Finite element modeling to predict the stress state that would be developed in a series of alloys with a wide range of yield strengths and thermal expansion coefficients indicates that, as shown in **Figure 7**, alloys with the properties of alloy 825 and alloy 625 in combination with carbon steel require more severe conditions for the stresses to become tensile in the floor tube panels.

**Figure 7.** Plot of the stresses generated in co-extruded tube material when the outer, clad layer has the thermal expansion coefficient and yield stress shown on the axes of this plot. This plot indicates that alloys 625 and 825 have properties that result in less severe stresses being developed than would be seen with 304L and 309L stainless steels.

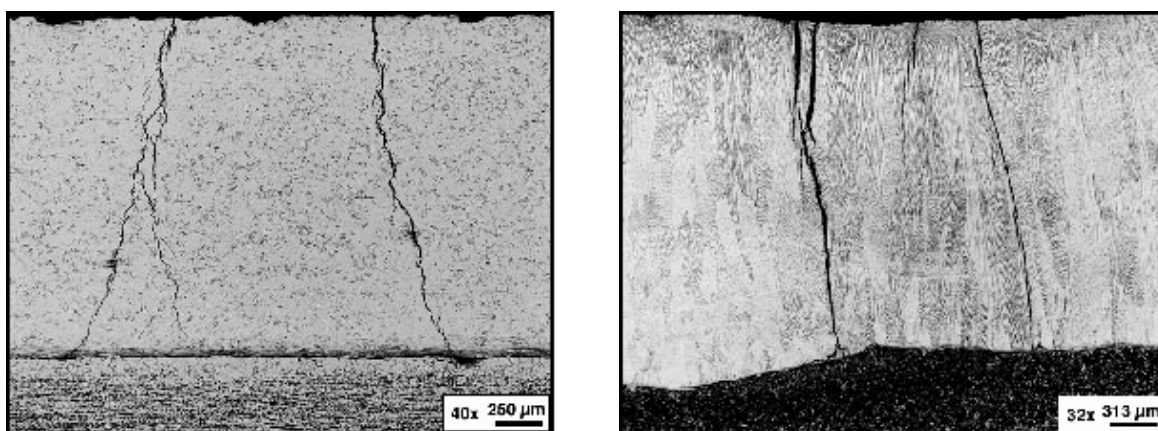
A direct comparison of three compositions of co-extruded tubes and two compositions of weld overlaid carbon steel tubes is being made in a North American recovery boiler. Operating experience from this particular recovery boiler has shown that co-extruded 304L/CS and weld overlaid 309L on carbon steel cracked during the second year of exposure (see **Figure 8**) while co-extruded 825/CS, co-extruded 625/CS and weld overlaid 625 have not cracked after five years of exposure. Reports of operating experience in Scandinavian boilers also indicates that an alloy equivalent to alloy 825 has operated in a recovery boiler floor for at least eight years without cracking.

**Figure 8.** *Cross section of cracking in co-extruded 304L/carbon steel and 309L weld overlay tubing. Note that most cracks penetrate entirely through the stainless steel layer but do not continue into the carbon steel.*

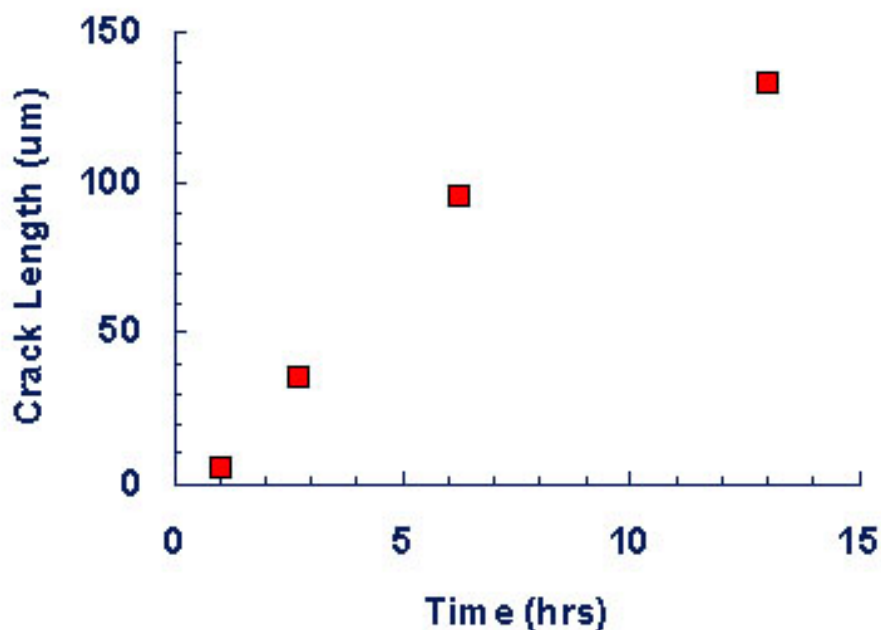
In the event that exposure of the floor tubes to wash water under a still-hot bed is unavoidable, a key question becomes how long at temperatures over 150°C (300°F) can be tolerated before damage to the floor occurs. As shown in **Figure 9**, in laboratory tests cracks have been produced in 304L in about one hour's exposure at temperature to a mixture of sulfide and hydroxide.

**Figure 9.** *Effect of exposure time on crack development in 304L stainless steel in a sodium sulfide 20% sodium hydroxide solution at 160°C. Note that short cracks are present after the first hour of exposure.*
