# *Modifying boiler operation to reduce primary air port cracking in a recovery boiler*

HONGHI TRAN, SHERY VAFA, CINDY MILBURY, BOBBIE BLANEY, FARSHAD PIROOZMAND, ARNIE ROHERTY, DAN MOTT, BLAINE ANDERSON, AND KEITH RIVERS

**ABSTRACT:** This systematic study examined the cause of severe cracking of SS304L/SA210 composite waterwall tubes at primary air ports in the recovery boiler at Irving Pulp & Paper's Saint John mill. The results show that the severity of the cracking problem was strongly related to the frequency and the magnitude of tube temperature excursions at the air ports. The cracking problem has been significantly reduced by operating the boiler at a lower black liquor solids content and at a higher primary air flow. These operating conditions appear to keep the char bed away from the air ports and help reduce tube temperature excursions.

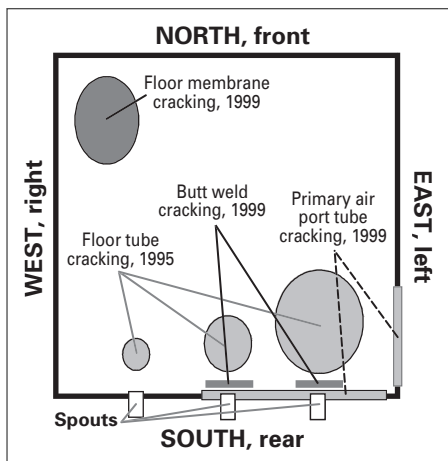
In May 1998, cracking of primary air port tubes was found in the southeast (SE) or rear-left corner of the boiler (Fig. 1). Initially, only a small area was affected, but the extent of cracking problem increased drastically with each subsequent outage. In May 1999, extensive primary air port cracking was found in the east (left) sidewall and along the south (rear) wall. In addition to the primary air port cracking, extensive butt weld cracking was found over two smelt spouts (between the smelt spout openings and

1. Locations of cracking in the lower furnace.

more severe on the south and east walls than on the north and west walls (Fig. 1).

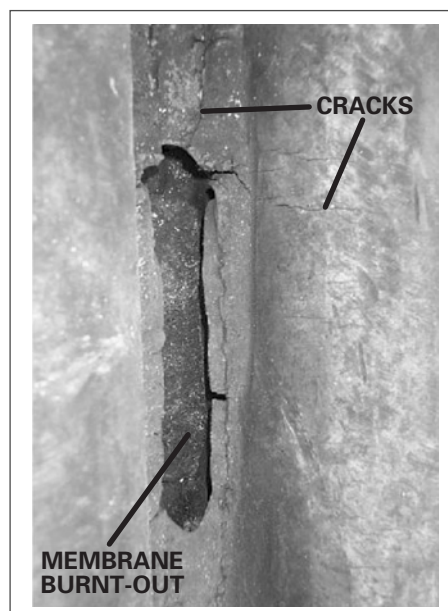
A planned boiler inspection in November 1999 revealed extensive primary air port cracking, butt weld cracking, and membrane bar wastage that required replacement of 20 m (60 ft) of membrane bar in the rear left corner (Fig. 2). Due to the continuing deterioration of these wall panels, the mill decided to replace the south (rear/spout) wall and east (left) wall with WOL 625 tubing during the April 2000 outage. During this outage, eight crown thermocouples were installed just below the primary air ports to monitor tube temperatures and thermal conditions near the air ports (Fig. 3). Tubes East 67 and South 22 were selected as these tubes were in the center of the major problem areas. The remaining six thermocouples were installed using the same tube spacing from their respective corners. Compilation of tube temperature data was important because frequent, high tube temperature excursions are believed to be the main cause of cracking.

2. Burned-out SS304L membrane bar on the east (left) sidewall, just below the primary air port, November 1999. Note cracks on the SS304L/SA210 composite tube and the membrane bar.

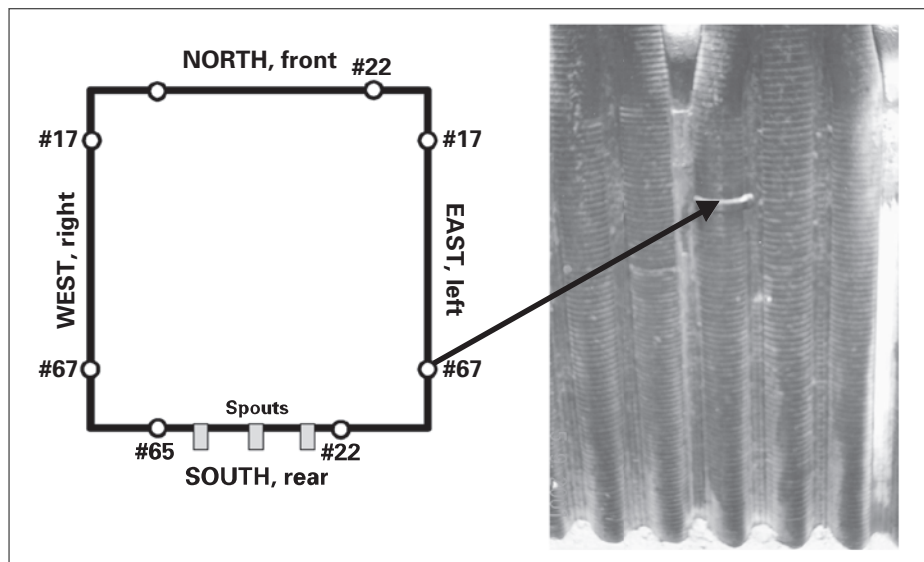
3. Locations of crown thermocouples installed on primary air port tubes during April 2000 boiler shutdown. Photo showing the crown thermocouple installed on WOL 625 tube E67.

appeared to have an effect on temperature spiking. The crown thermocouples in the SE corner burned out at the end of June 2000, after less than two-and-a-half months in operation.

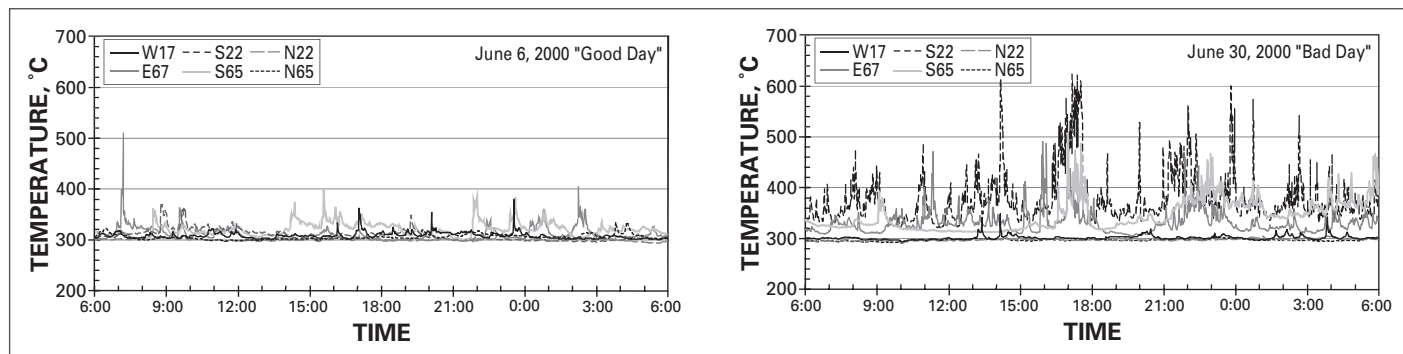
The thermal activity near the air ports varied widely from day to day. Figure 4 shows temperature variations registered by crown thermocouples at various primary air ports for two extreme days. On the "good" day (June 6, 2000), the thermal activity near the primary air ports was relatively calm and little temperature spiking was observed. On the "bad" day (June 30, 2000), the frequency of temperature spikes increased markedly and the magnitude of spiking increased, particularly at air ports on the south and east walls of the boiler. At air ports on the north side (N22 and N65) and at one on the west side (W17), no temperature spikes were observed. The thermal activity was consistent with the cracking pattern in the boiler: the problem was much

4. Tube surface temperatures at various primary air ports on a good day (left) and a bad day (right).

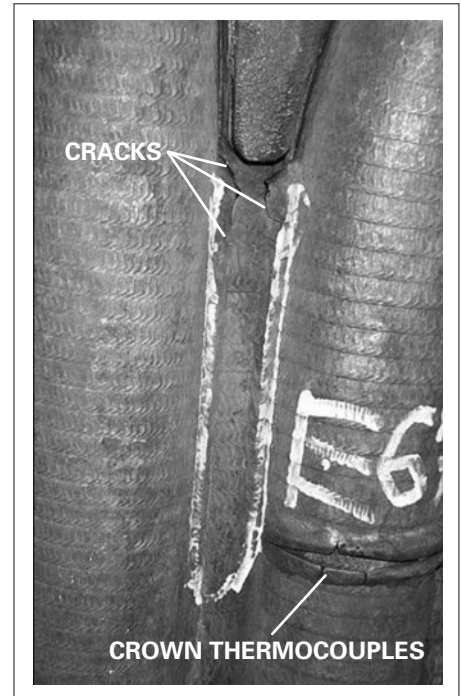
The December 2000 planned shutdown revealed cracking in several membrane bars in the rear left (SE) corner below the primary air ports on the new WOL 625 walls (Fig. 5). The problem was confined to the membrane bars, and none of the cracking was observed on the tubes. Approximately 10 m (30 ft) of membrane bars were replaced during this shutdown, along with the crown thermocouple shields that had burned off.

5. Arrows showing cracking of membrane bar adjacent to Tube E67 during the December 2000 planned shut-down. Note the crown thermocouple burned off on Tube E67.

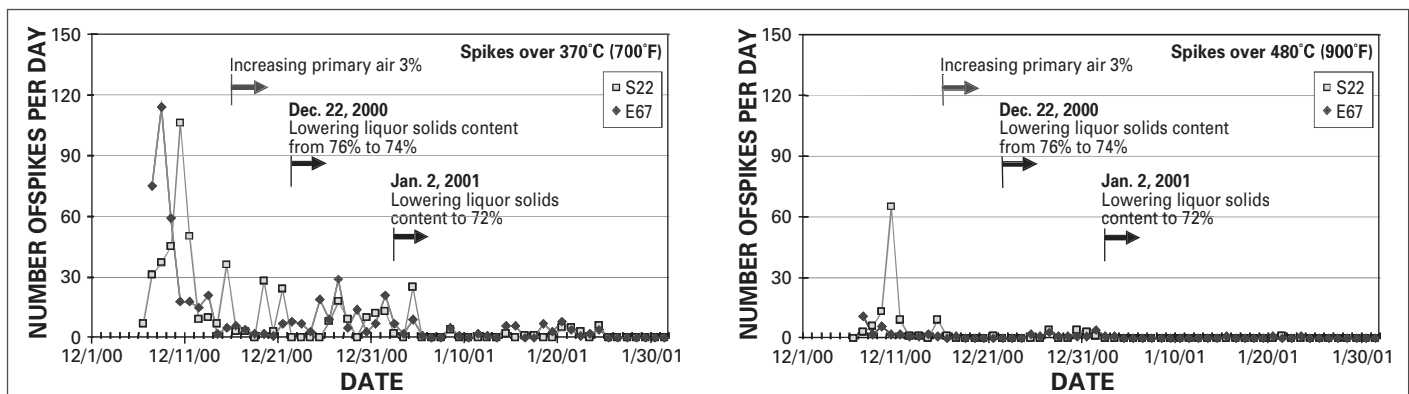
6. Thermal activity at thermocouples below the primary air ports in the rear-left (southeast) corner of the boiler during the months of December 2000 and January 2001. Left: Number of spikes above 370°C (700°F). Right: Number of spikes above 480°C (900°F).

on the number of temperature spikes that occurred above 370°C (700°F), and above 480°C (900°F) in a day. In this study, a “spike above 370°C” is defined as a single thermal event in which the tube temperature increases above 370°C and then drops back below 370°C. Similarly, a “spike above 480°C” occurs when the tube temperature exceeds 480°C and then drops back below 480°C. **Figure 6** shows the results for the thermocouples installed on Tube S22 and Tube E67 in the southeast corner. The number of spikes above 370°C decreased significantly, from more than 50 spikes/day to less than 20 spikes/day, after the primary air flow was increased and the black liquor solids content was lowered on December 22, 2000. The number decreased further, to less than five spikes/day, after the solids content was lowered further to 72% on January 2, 2001. The effect was more dramatic on the number of spikes above 480°C; only a few spikes were observed in December 2000 after the changes were made, and virtually no spikes were observed during the entire month of January 2001.

In mid-December 2000, the primary air flow was increased 3% from a primary/secondary/tertiary air split of about 32/39/29 to 35/35/30, while the

total air flow was kept constant. On December 22, 2000, the liquor solids content was lowered from 76% to about 74% by setting the boiling point rise (BPR) of the liquor in the high solids concentrator (HSC) from 18°C to 17°C (30°F). On January 2, 2001, the solids content was lowered further, from 74% to 72%, by setting the BPR of the HSC liquor to 16°C (28°F) to determine if the temperature spikes could be further reduced.

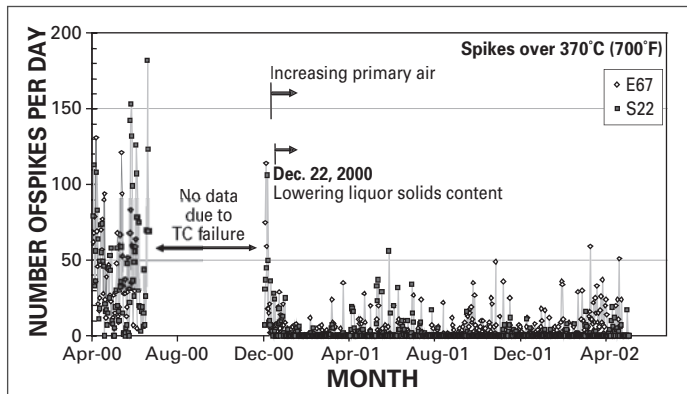
**7. Number of spikes/day above 370°C (700°F) at thermocouples below the primary air ports in the southeast corner of the boiler in the period between April 2000 and May 9, 2002.**

The results were so encouraging that a decision was made to keep the operation of the boiler at 72% to 73% solids and the primary/secondary/tertiary air split of about 35/35/30. The average number of spikes exceeding 370°C (700°F) observed on Tube S22 and Tube E67 has been low (**Fig. 7**), averaging about two and five spikes/day, respectively. What is really important is that *the cracking problem appears to have stopped*. No further cracking was found during planned inspections in May 2001 and in May 2002.

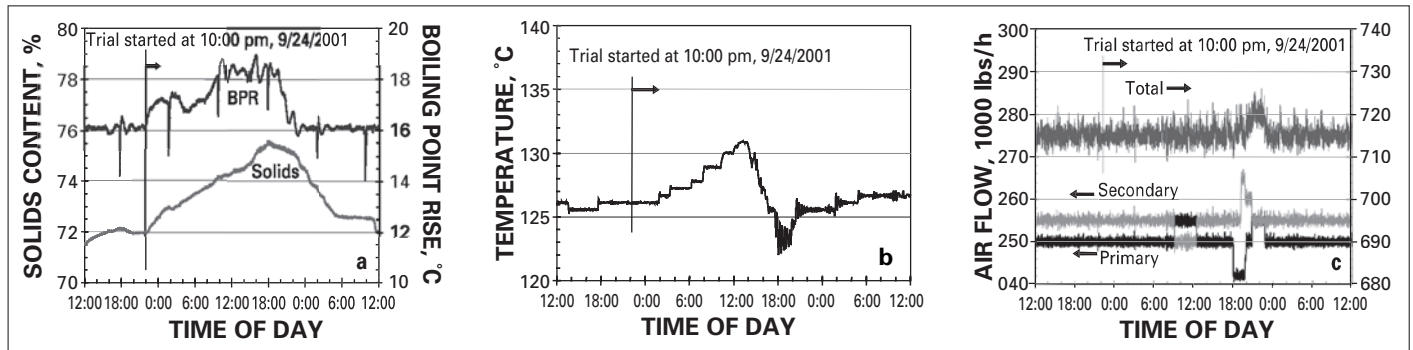
The on-set of high temperature excursions at 6 p.m. coincided with the time when the black liquor solids content reached the highest level, 75.5%, the black liquor temperature was at the lowest value, 123°C (253°F), and when the primary air was lowered from 250,000 lbs/h to 242,000 lbs/h (**Fig. 8**). These drastic operating changes were intentionally induced to allow the char bed to grow so that the effect of char bed on temperature spiking could be examined.

8. Firing conditions during September 24, 2001, trial, (a) as-fired black liquor solids content and boiling point rise; (b) as-fired black liquor temperature; (c) primary air, secondary air, and total air flow rates (tertiary air was not changed).

Even when the boiler was operated at a high liquor solids content, a low liquor temperature, and a reduced primary air flow (Fig. 8 at 6 p.m., September 25, 2002), only the primary air ports in the southeast corner near Tube E67 and Tube S22 suffered from high tube temperature excursions. The primary air ports at other locations had no temperature spiking problem. This suggests that it is not

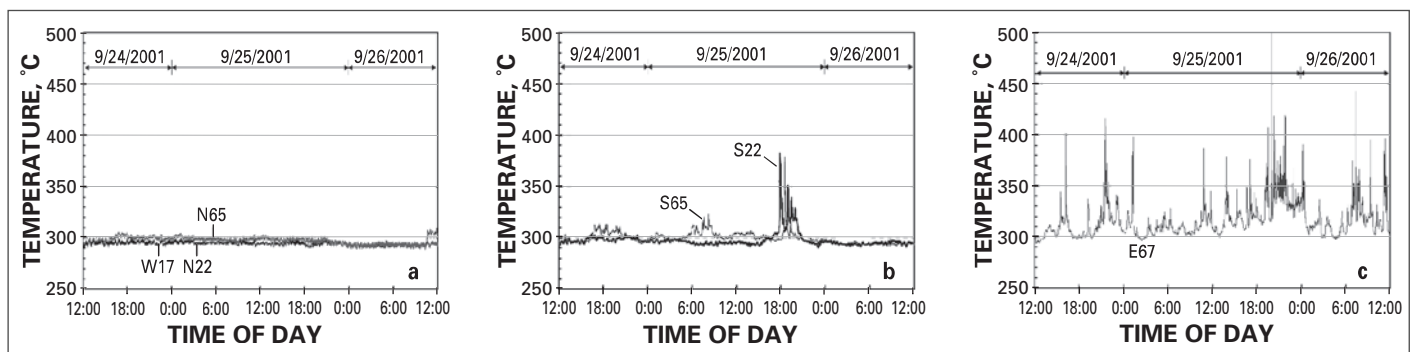
**Figure 9** shows the trial results. No temperature spike was observed on Tubes W17, N22 and N65 (**Fig. 9a**). This was consistent with the fact that no tube cracking has been experienced at primary air ports on the west (right) and north (front) walls of the boiler. On the south (rear) wall where smelt spouts are located, the thermal activity near Tubes S22 and S67 was also relatively low until 6 p.m. on September 25, when temperature excursions started to occur and last for 3 h (**Fig. 9b**). In contrast, Tube E67 on the east (left) wall showed erratic temperature variations with many temperature spikes observed between 6 p.m. on September 25, and 1 a.m. the next day (**Fig. 9c**).

9. Tube temperatures at various primary air ports during the high-solids firing trial.

Visual inspection of the primary air ports in the southeast (rear-left) corner of the boiler at the moment the temperature spike at 6 p.m. occurred showed that the char bed was quite large, and was touching the tube E67. Examination of videotapes of the char bed recorded through the primary air ports near Tubes E67 and S22 also revealed that the conditions at these ports were extremely turbulent when the temperature excursions occurred. The char bed appeared to move toward the air ports, with a large pool of molten smelt present on the bed surface. In contrast, the conditions on the other side of the boiler (right sidewall) near Tube W67 were "calm;" the char bed appeared to be "normal" and was located away from the air port.

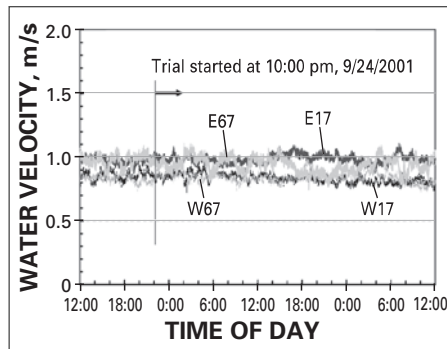
10. Velocities of cooling water in various tubes during the September 24, 2001, trial.

culation was not a cause of the cracking problem at the mill. Figure 10 shows an example of the studies. During the high liquor solids trial, the water velocity in tubes that were monitored was relatively constant, 0.8-1 m/s. Tube E67 is of particular interest. No significant change in water velocity was found in this tube, despite a large number of temperature spikes observed (Fig. 9c).

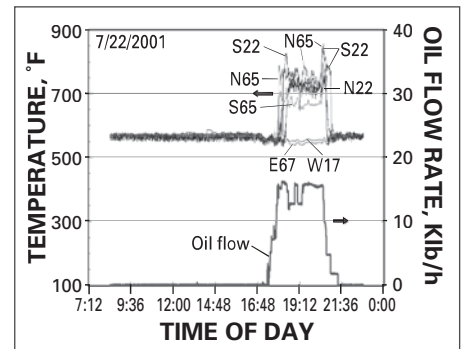
11. Effect of oil firing on tube temperature excursions (July 22, 2001).

excursions. The tube temperatures at several primary air ports were found to consistently increase every time oil burners were operated. **Figure 11** shows an example of that. In this case, four of the six crown thermocouples showed an abrupt increase in tube temperature from 570°F to 750°F as the oil flow rate reached 16,000 lbs/h, and a sudden drop in temperature as the oil flow rate decreased. The magnitude of the temperature increase depended on the location of the oil burners that were in use and the oil flow rate burned at the time.

Mills operate oil burners only during boiler startup and shutdown, and when the black liquor flow is insufficient to maintain a steam production target. Since they are not in use most of the time, oil burners cannot be the cause of temperature spiking, and hence, tube cracking. However, the consistent occurrence of temperature excursions when oil burners were on implies that if a thermal condition similar to that encountered during oil burning occurred, there would be a tube temperature excursion. Although it is not clear what the thermal condition may be, flame impingement, radiation, and/or intense combustion near the tube surface may be a contributing factor.
