# *Materials issues in black liquor steam reforming/gasification*

James R. Keiser, Robert DeCarrera, David G. Newport, Robert S. Rowbottom, and Bruce A. Pint

**ABSTRACT:** Steam reforming/gasification of black liquor produced during wood pulping offers the potential for more efficient energy recovery, reduction of emissions, and improved safety. This technology is currently being implemented in two North American semichemical pulp mills. As might be expected in scaling up any process system, a number of problems have been encountered. Degradation of metallic and refractory components has been observed in several areas. This paper presents the results of the examinations of a number of these damaged metallic components. Carburization was observed in all cases, indicating the process environment was not as expected. Significant oxidation occurred, but the surface oxides formed appeared not to be protective. Studies currently in progress are directed toward identifying materials with resistance to the reformer/gasifier environments.

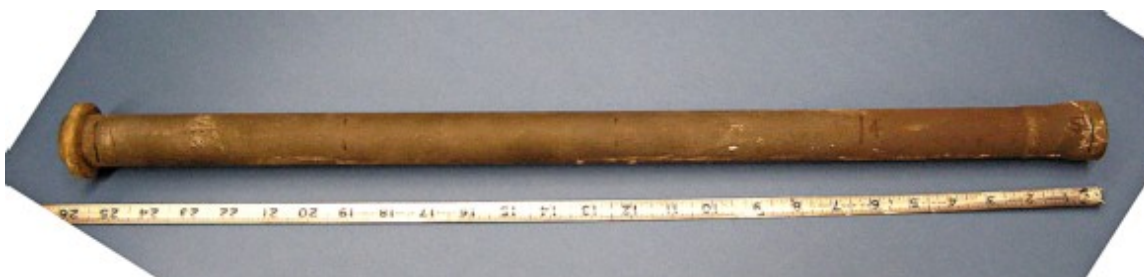
To address the question of whether the high temperature laboratory oxidation studies provided a reliable prediction of shield tube alloy performance, the shield tube (actually 1 in. schedule 40 pipe) shown in **Fig. 5** was provided for examination; this consisted of wall thickness measurements and metallographic analysis. Wall thickness measurements were made at eleven equally spaced locations along the length of the tube and at eight equally spaced points around the circumference of the tube at these eleven locations. The results (**Fig. 6**) indicate significant thinning along one side of the tube. The orientation of this tube was not marked when the tube was removed, so there is no way to determine whether the thinning was primarily on the top, bottom or some other position. Nevertheless, the extent of thinning was greater than the normal variation expected in tube wall thickness indicating significant degradation, almost certainly oxidation, along a portion of the tube.

**Figure 5.** Shield tube from the mill in Trenton, Ontario, Canada. Note the flared exhaust end on the right and the collar on the left end that provides for mounting in the tube sheet.

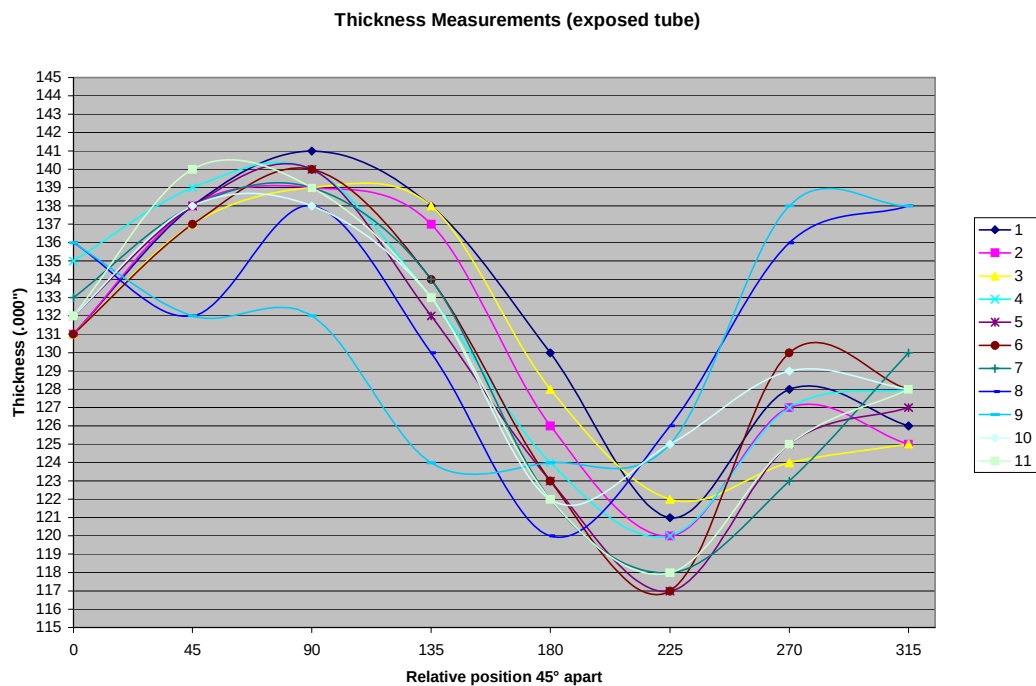
**Figure 6. Wall thickness measurements as a function of position around the shield tube showing severe thinning on one side of the tube.**

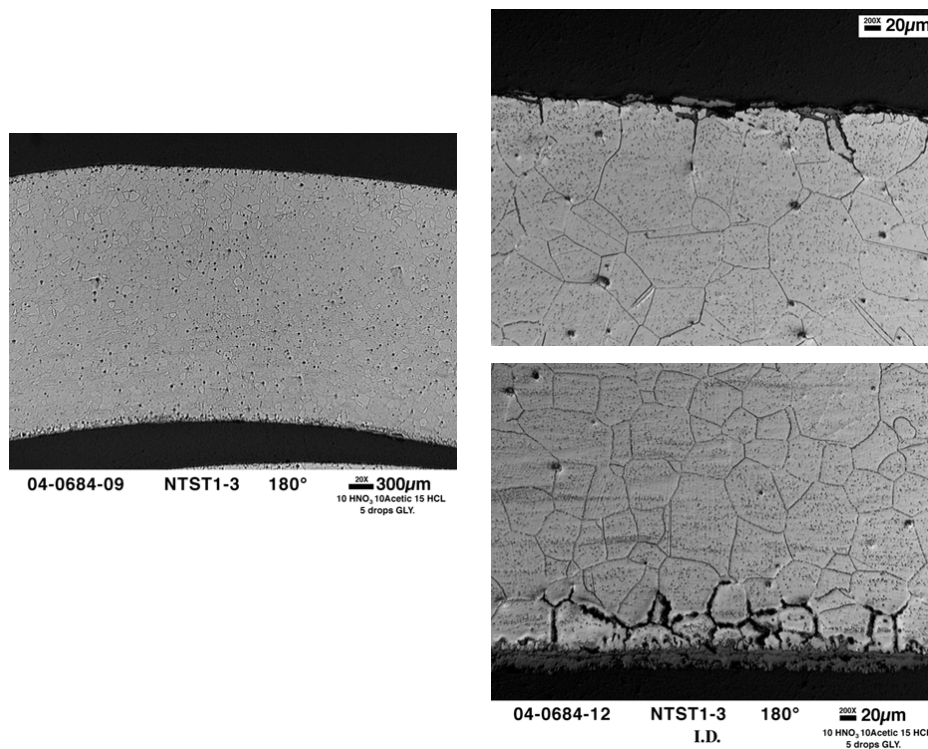
Samples were taken from this shield tube at five approximately equally spaced locations along the tube, and these were prepared for standard metallographic, scanning electron microscope (SEM) and electron microprobe examinations. **Figure 7** shows a micrograph of a typical cross-section of the tube wall along with higher magnification views of the inner and outer surfaces. These micrographs show unexpected and extensive precipitation on grain boundaries and in the matrix. To better characterize these precipitates, a scanning electron

**Figure 7. Micrographs showing the tube wall (left) and the outer (top right) and inner (lower right) surfaces of the shield tube. Note the outlined grain boundaries and the intergranular attack on both surfaces.**

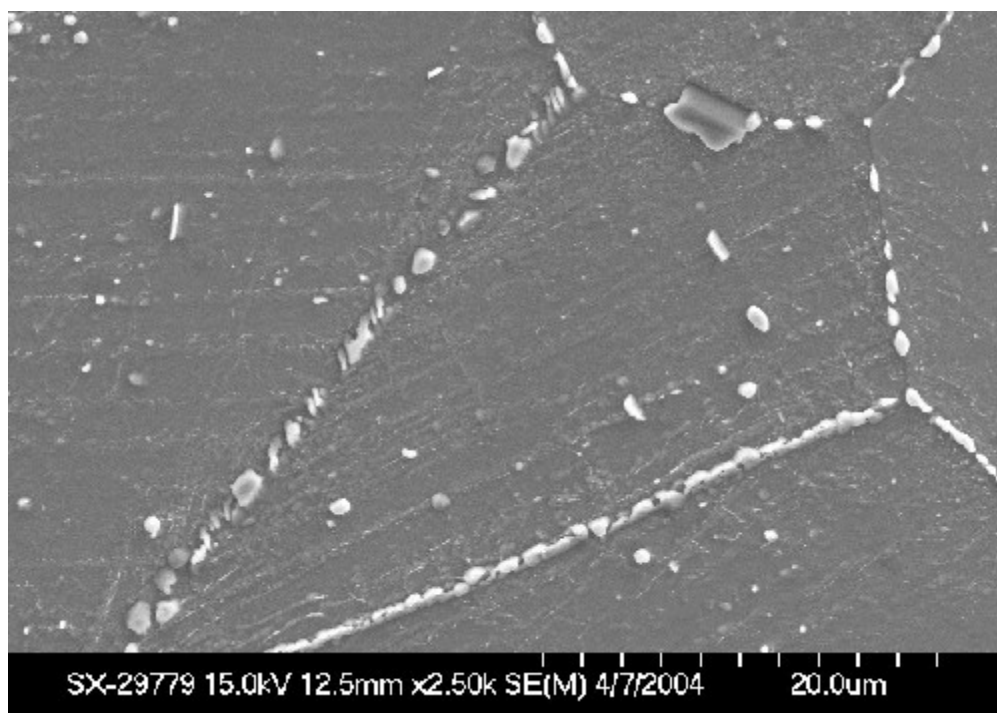
microscope (SEM) was used to produce a micrograph (**Fig. 8**), which shows distinct grain boundary and matrix precipitates. Further refinement in the analysis was accomplished by using the electron microprobe to produce the elemental maps shown in **Fig. 9**. These maps show the distribution of selected elements within an area covering a few grains. From these data and a separate elemental analysis, the precipitates in the grain boundaries appear to be primarily chromium carbides, probably an  $M_{23}C_6$  carbide. The precipitates in the grains show a greater variability in composition than those on the grain boundaries. In all cases, chromium, silicon, and carbon are enriched, but the degree of enrichment varies considerably from one particle to another. Some precipitates are the  $M_{23}C_6$  type chromium carbide, others are a silicon-enriched phase. The presence of these carbides would make the alloy susceptible to intergranular stress corrosion cracking, but a suitable corrosion agent and a tensile stress would have to be present for cracking to actually occur. The precipitates would also have a detrimental effect on the near room temperature ductility of the alloys.

**Figure 8.** Scanning electron micrograph showing the grain boundary and matrix precipitates formed in the shield tube.

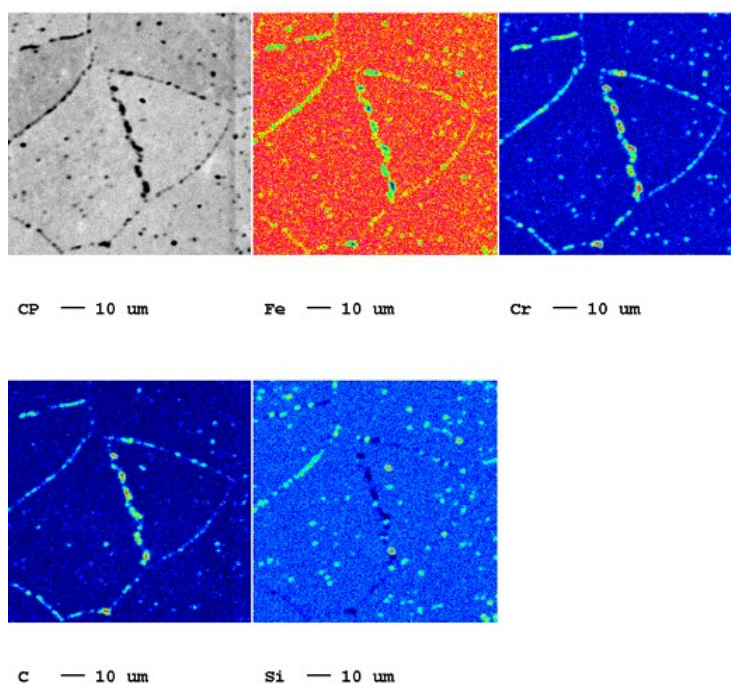
**Figure 9.** Electron microprobe elemental maps showing the concentration of chromium, carbon, and silicon in the grain boundary and matrix precipitates. The darker the color, the lower the concentration.

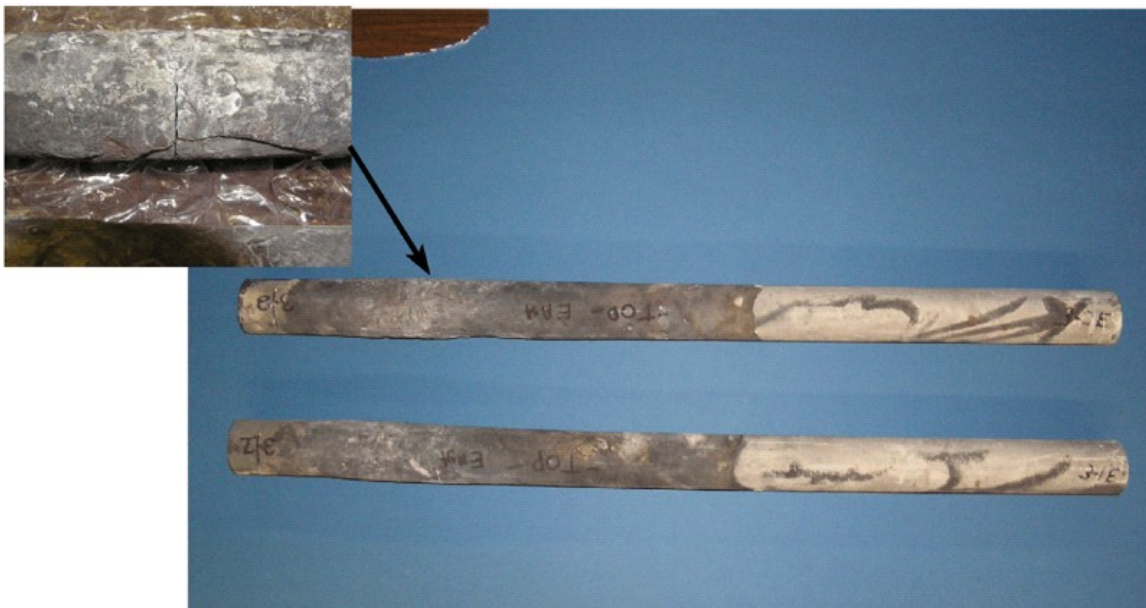
The two type 321 stainless steel pulse heater tubes (actually 1½ in. schedule 40 pipe) shown in **Fig. 10** were removed from the heater tube bundle of a reformer/gasifier (**Fig. 11**) after very short service because of overheating of the tubes caused by bed fluidization problems. As shown in the inset picture in **Fig. 10**, one of these tubes had a through-wall crack, and that tube was selected for examination. Four longitudinal cross sections were cut from the region of the crack. Circumferential sections were cut at 3.8, 7.6, 11.4, and 73.7 cm (1½, 3, 4½, and 29 in.) from the apparent failure site. A short section from the end of the shield tube was included with the heater tube sample and circumferential sections were cut from each end of that shield tube.

**Figure 10.** Pulsed heater tubes removed from the Big Island, Virginia, mill's reformer/gasifier. The inset photo shows a close up of the cracked area on one of the tubes.

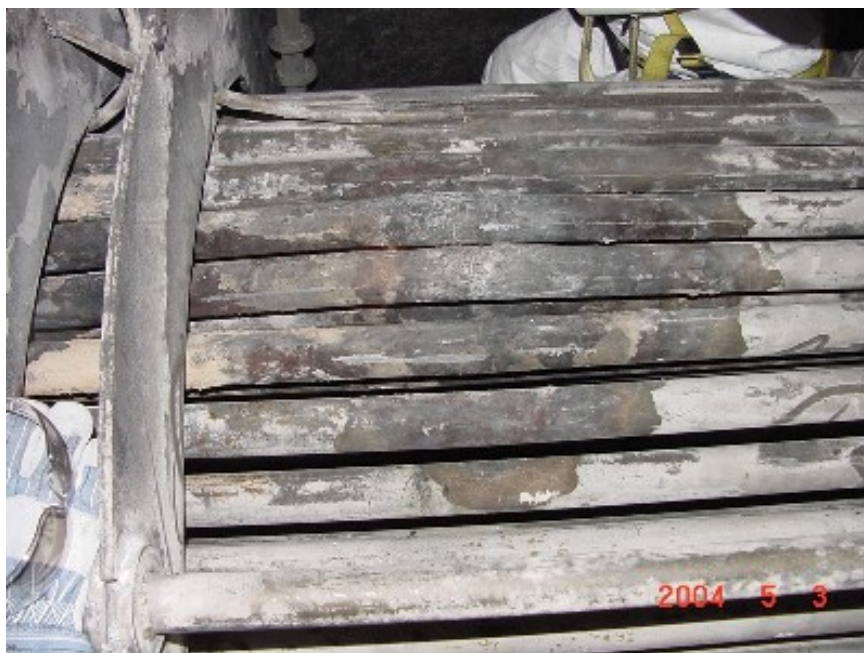
**Figure 11.** Photo of the heater tube bundle from which the tubes in the previous figure were taken. The two damaged areas of the tubes are slightly above center in the picture.

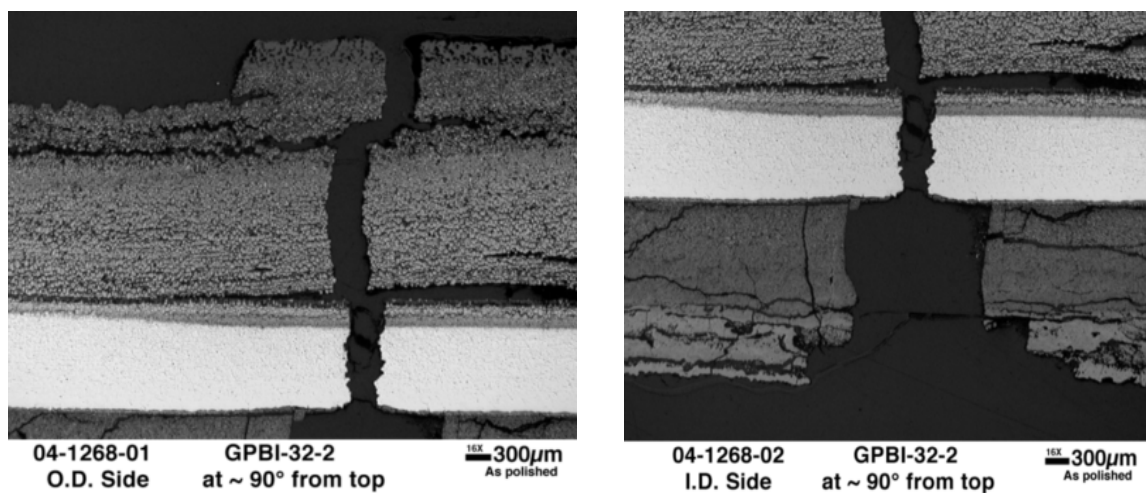
The micrographs in **Fig. 12** show longitudinal cross sections through the crack; the micrograph on the left shows the outside diameter (OD), the micrograph on the right shows the inside diameter (ID). Some of the scale has spalled, but a massive reaction layer is apparent on both surfaces. The remaining metal is about 1 mm (0.040 in.) thick, which is only about 25% of the original thickness. Oxalic acid etching of the sample revealed the presence of grain boundary carbide precipitates on the OD and ID (**Fig. 13**), but the more extensive carburization on the OD strongly indicates the carbon entered from the bed side of this tube.

**Figure 12.** Micrographs showing the inner and outer surfaces of the pulse heater tube in the area where the through-wall crack occurred.

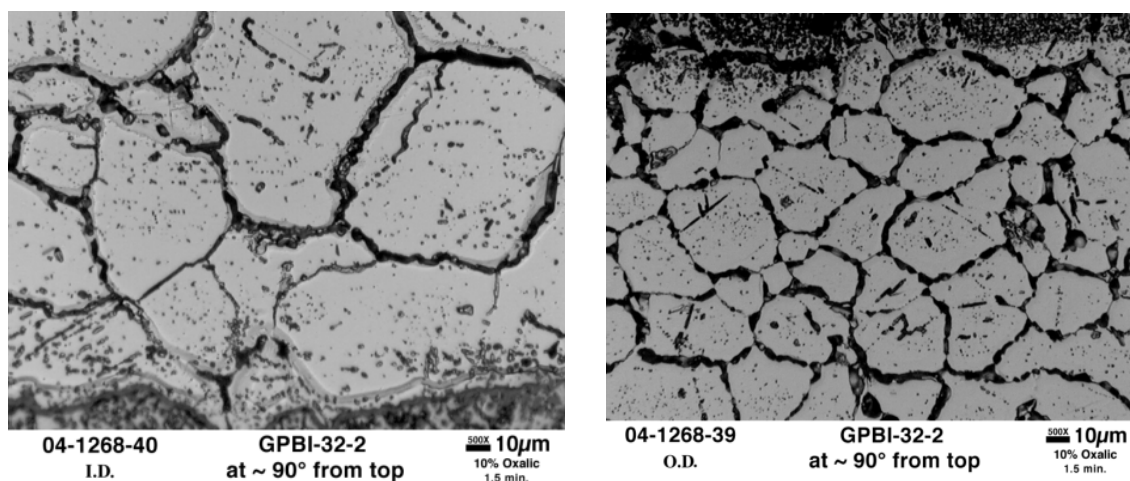
**Figure 13.** Micrographs showing the microstructure just below the inner and outer surfaces of the heater tube pictured in the three previous figures.

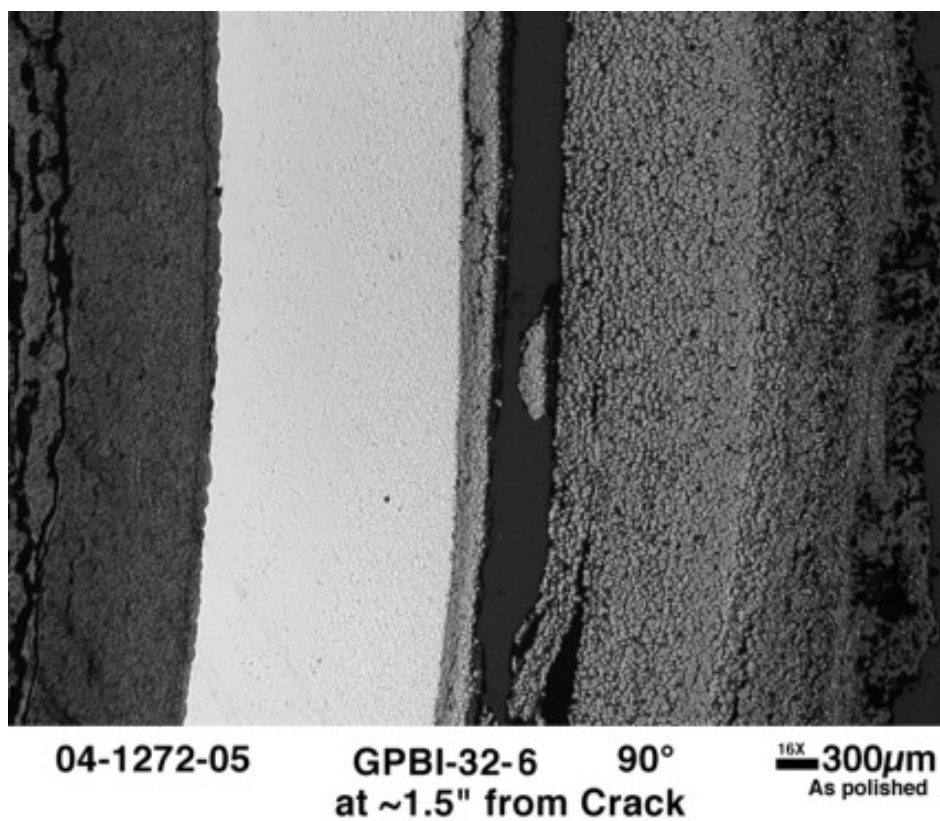
The cross section taken from this heater tube 3.8 cm from the crack suffered significant thinning and scale formation (**Fig. 14**), but the remaining metal was thicker than at the crack. After oxalic acid etching, severe grain boundary precipitation was evident, but, as in the previous sample, the precipitation was more extensive near the OD surface than the ID surface. In fact, examination of the other three cross sections showed the grain boundary precipitation extended through the full length of the tube section that was examined. The extent and distribution of carbide precipitates indicated there was a source of carbon on the fluidized bed side of the tubes. The fact that carbon had penetrated into the tube and formed an extensive carbide structure could be explained if the tube temperature had reached at least 850°C [12], well in excess of the intended bed temperature of 605°C.

*Figure 14. Cross section of the failed heater tube about 3.8 cm from the through-wall crack.*

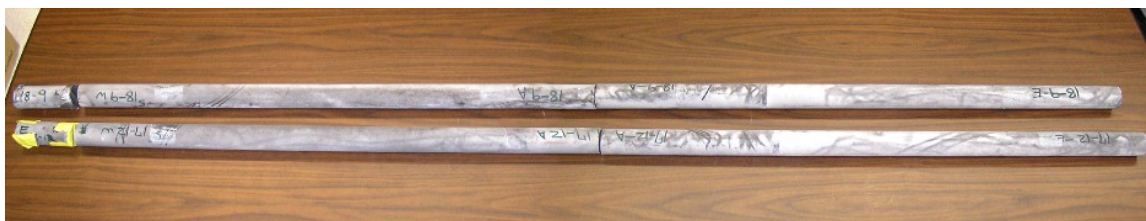
**Big Island tubes 17-12 and 18-9.** To determine the extent of reaction of other heater tubes and to determine if there might be a variation in the extent of reaction with distance along the length of the tubes, six nearly full-length tubes were examined. Two of those tubes, identified as 17-12 and 18-9 by their location in a tube module, were provided in pre-cut sections. **Figure 15** shows these two tubes. Short sections of shield tubes were included with the two tubes. Two metallographic samples were cut from each of the alloy 800H shield tube sections and six samples were cut from each of the two 321 stainless steel heater tubes. After oxalic acid etching, all four shield tube samples showed continuous attack or “ditching” along the grain boundaries. **Figure 16** shows selected micrographs of the OD and ID surfaces from both shield tubes. For the shield tube from tube 17-12, planar defects such as twin boundaries and slip planes, as well as grain boundaries, appear to be preferentially etched, suggesting chromium carbides had formed in all these locations.

*Figure 15. Heater tubes 17-12 and 18-9 that were taken from an area thought to be unaffected by overheating.*

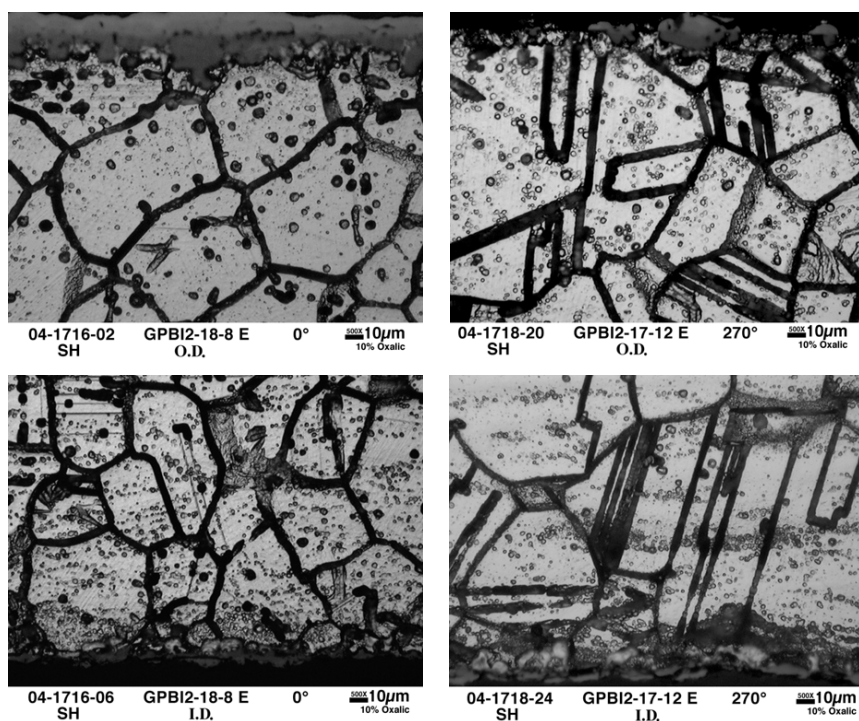
**Figure 16.** Micrographs showing the oxalic acid etched material just below the inner and outer surfaces of the shield tube from heater tubes 18-9 and 17-12.

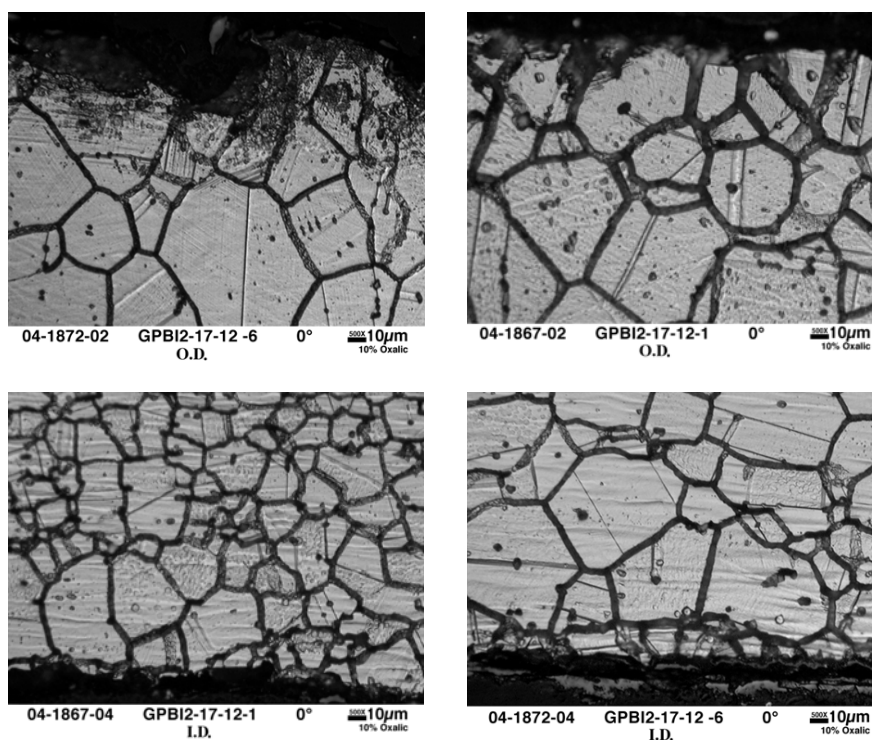
All of the samples from each of the two heater tubes were examined metallographically around the full circumference at each sample location. **Figure 17** shows the etched microstructures from each end of tube 17-12. **Figure 18** shows the equivalent microstructures for tube 18-9. Tube 17-12 shows continuous ditching of grain boundaries on both the OD and ID along the full length of the tube. For tube 18-9, although there might be a small reduction in the extent of the ditching toward the cooler end, essentially 100% of the grain boundaries still contained chromium carbide precipitates along the full length of the tube.

**Figure 17.** Micrographs showing the oxalic acid etched material just below the inner and outer surfaces from each end of heater tube 17-12.

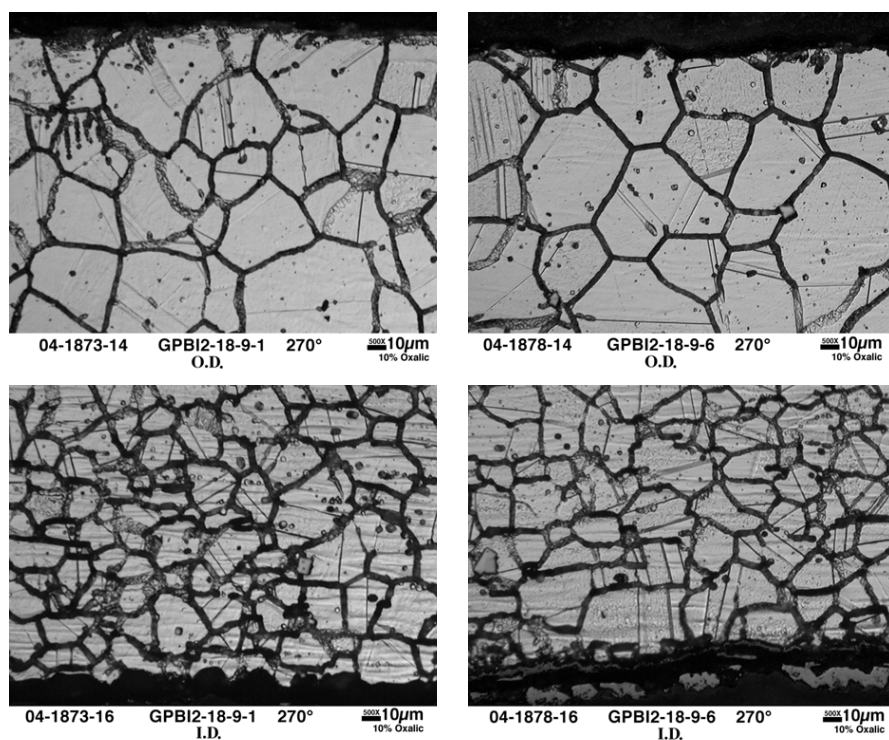
**Figure 18.** Micrographs showing the oxalic acid etched material just below the inner and outer surfaces from each end of heater tube 18-9.

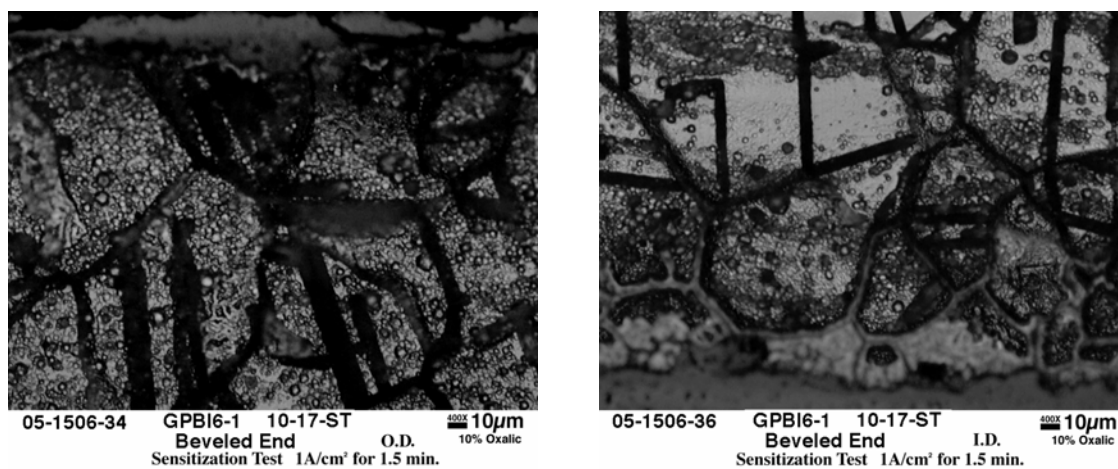
**Big Island tube 10-17.** After 43 days of service, the heater and shield tube (10-17) shown in **Fig. 19** were removed from one side of a heater module where it was thought to be well away from the area where any degradation had occurred. Wall thickness measurements did not indicate any significant loss of material from any area around the circumference of the heater tube or the shield tube. Metallographic samples were taken from each end and the center of the shield tube. Samples also were taken from each end and the  $\frac{1}{4}$ ,  $\frac{1}{2}$ , and  $\frac{3}{4}$  locations along the length of the heater tube. Oxalic acid etching of the shield tube samples showed that a continuous layer of chromium carbide had formed on the grain boundaries of all three samples. **Figure 20** shows a typical example. In addition to the formation of grain boundary carbides, a corrosion product resulting from intergranular attack was found on grain boundaries; this extended a short distance below both the OD and ID surfaces. **Figure 21** shows micrographs of an as-polished sample. The micrographs show the attack was more extensive on the ID than on the OD of this shield tube.

**Figure 20.** Micrographs of the oxalic acid etched surfaces of the flared end of the alloy 800H shield tube from heater tube 10-17.

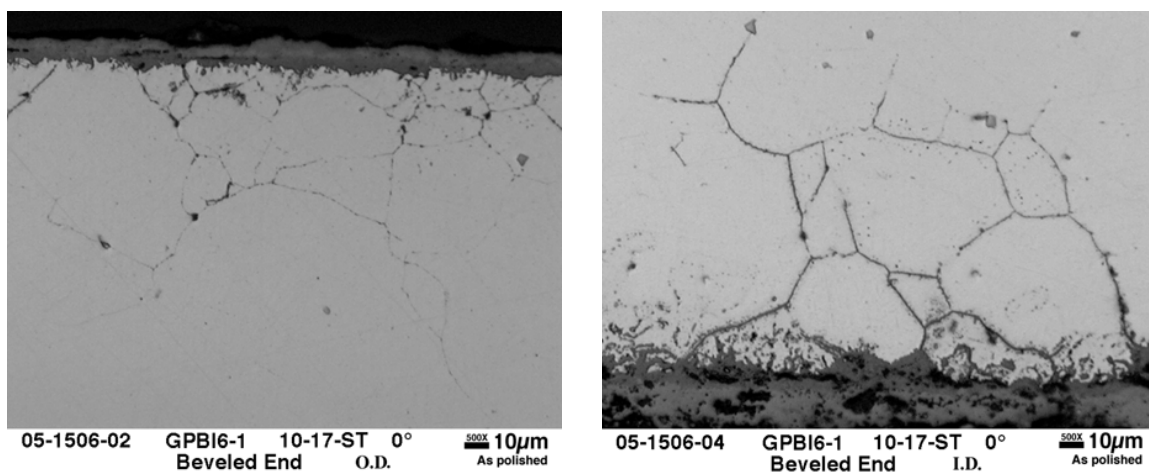
**Figure 21.** Micrographs of the as-polished surfaces of the flared end of the alloy 800H shield tube from heater tube 10-17 showing the presence of a corrosion product (dark color) on the grain boundaries near the surfaces.

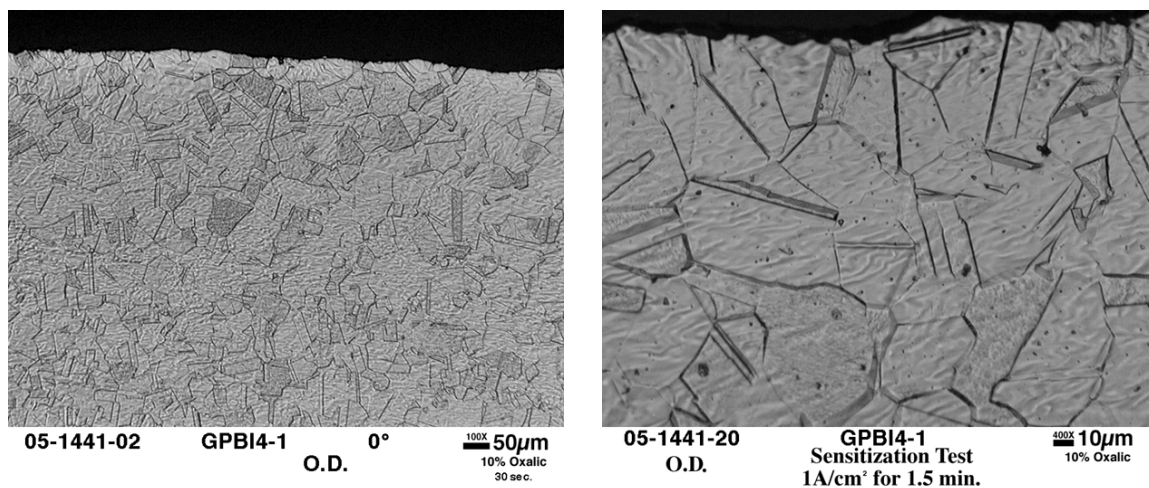
This 321 stainless steel heater tube was outside the region in the module where obvious tube damage had occurred. Consequently, we hoped carbon might not have entered this tube and that it had avoided the formation of chromium carbides on the grain boundaries. The sample taken from the end of the tube nearest the combustion chamber did not show carbide formation. In fact, the tube’s microstructure was that of an as-fabricated tube, with no evidence of sensitization (**Fig. 22**). However, we determined that this end of the heater tube had been inside the water-cooled tube sheet, so this section of the tube was not heated to or above bed temperature. Microstructural examination of the other four sections of this heater tube revealed the usual pattern of carbide formation on the grain boundaries (**Fig. 23**). Both sets of micrographs in this figure show the carbide structure is more continuous on the OD than the ID suggesting the source of the carbon was from the fluidized bed. The other point learned from these micrographs is that the extent of carbide formation does not vary significantly from the  $\frac{1}{4}$  position to the end of the tube.

**Figure 22.** Micrographs of oxalic acid etched 321 stainless steel heater tube section that was inside the water cooled header of the pulsed heater module. The structure is that of an as-received stainless steel tube.

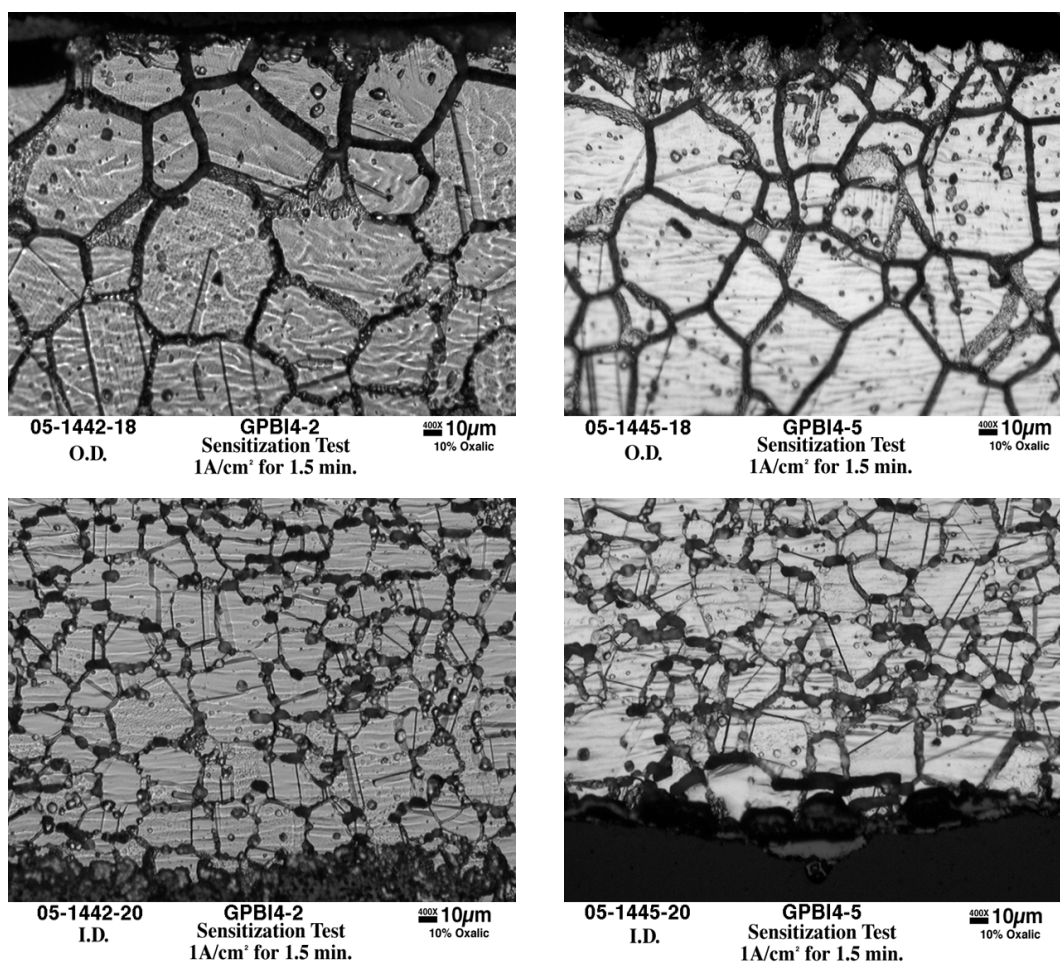
**Figure 23.** Micrographs of the oxalic acid etched material just below the inner and outer surfaces of sections taken from the end and the  $\frac{1}{4}$  position along the length of tube 10-17.

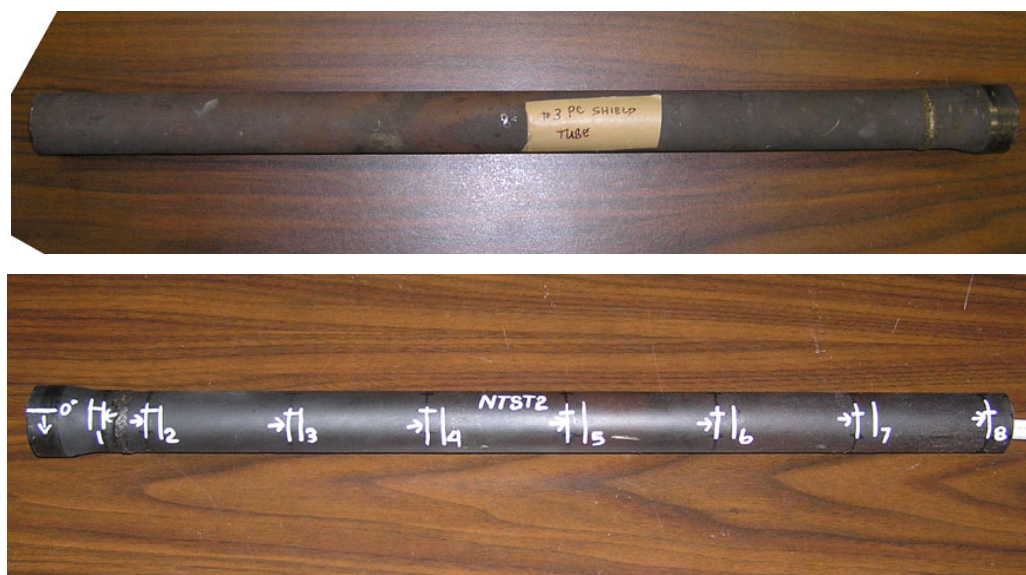
**Trenton shield tube.** The 330 stainless steel shield tube shown in **Fig. 24** is another component that was removed from a reformer/gasifier heater module. Wall thickness measurements did not show any significant pattern of wall thinning around or along the length of the tube. A few isolated measurements did average about 0.33 mm (0.013 in) less than the nominal wall thickness, but the remainder of the tube averaged approximately that amount above the nominal wall thickness.

**Figure 24.** Photos of the as-received 330 stainless steel shield tube from the Trenton, Ontario, mill and the tube as marked for wall thickness measurements and preparation of metallographic samples.

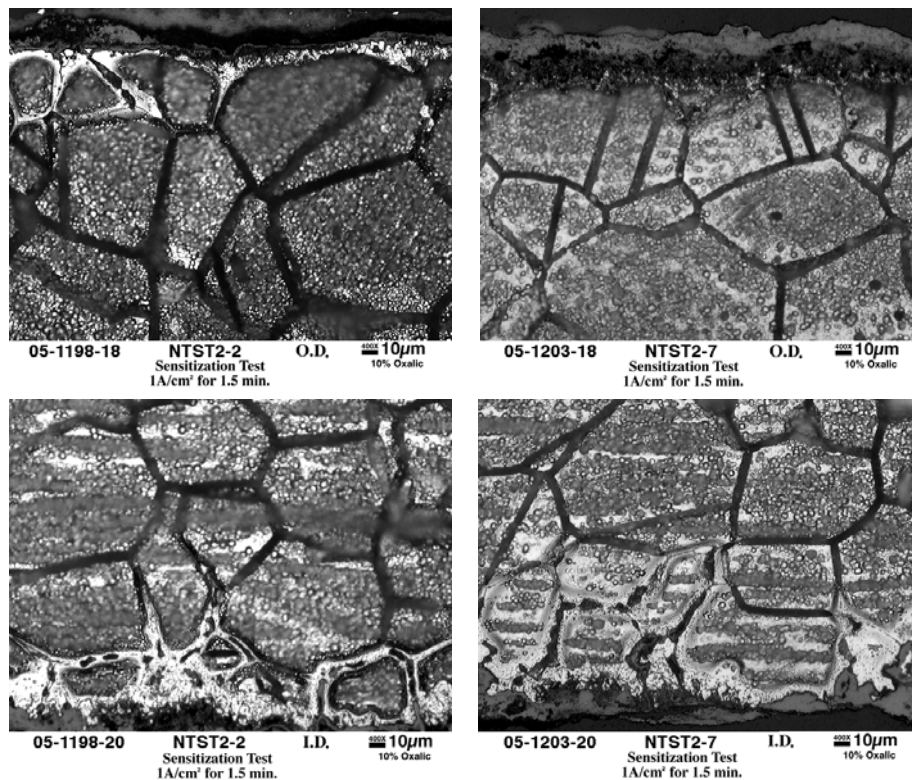
Eight metallographic samples were prepared from this tube. The observations of carbide formation were consistent with what has been seen on previous shield tube examinations. **Figure 25** contains micrographs showing the results of the oxalic acid sensitization test on the second and seventh samples. Although it is fabricated of 330 stainless steel, a different material than the alloy 800H shield tube from Big Island tube 10-17,

**Figure 25.** Micrographs of oxalic acid etched samples from the left and right ends of the Trenton, Ontario, mill's shield tube shown in the previous figure.

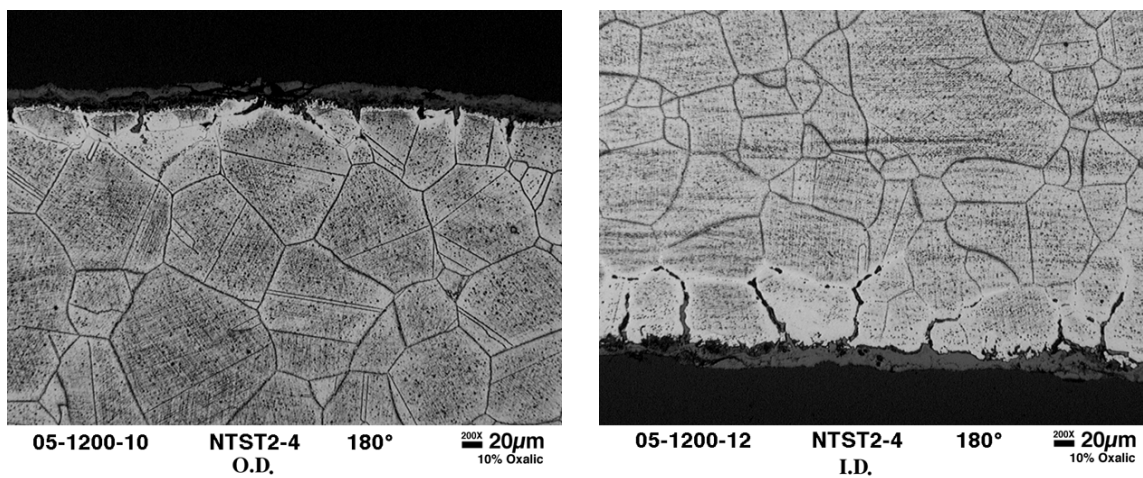
this shield tube also shows some shallow intergranular attack, with accompanying corrosion product, on both the OD and ID of the tube. **Figure 26** shows an example of this attack.

**Figure 26.** Micrographs of acid etched shield tube showing the intergranular attack originating on the inner and outer surfaces.

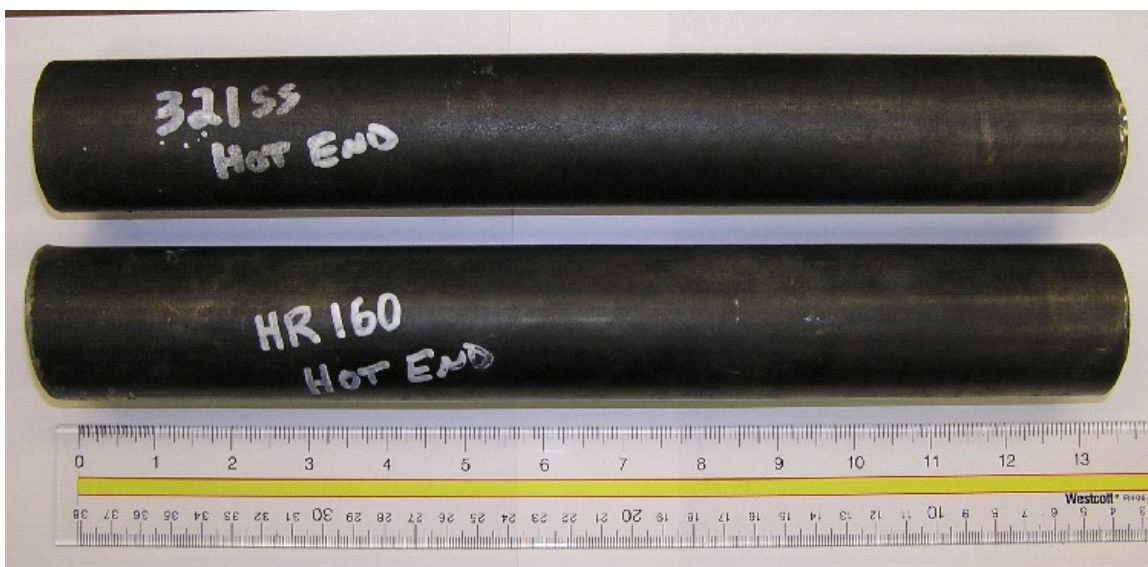
**Big Island heater tube sections.** The two tubes shown in **Fig. 27** were removed from the hotter end of a heater tube after about 6 weeks of service. The type 321 stainless steel is the standard material used for the heater tubes, while alloy UNS N12160 is a nickel-cobalt-chromium (Ni-Co-Cr) alloy that was considered as a replacement for the 321 stainless. Wall thickness measurements did not show significant thinning on either tube. Metallographic samples were cut from the end of each tube, mounted, polished, and photographed after light etching, and then etching to determine whether the samples were sensitized. For the 321 stainless steel sample, **Fig. 28** shows micrographs of the OD and ID surfaces for the two etched states. The results of the sensitization test are consistent with the observations for other heater tubes examined; ditching indicates chromium carbides are present on both the OD and ID of this tube. **Figure 29** shows the microstructures on the OD and ID for the Ni-Co-Cr alloy in the two etched states. As with the stainless steel tube, the oxalic acid sensitization test shows chromium carbides are present on the grain boundaries.

**Figure 27.** Photo of two sections of heater tube removed from the hotter end of the heater bundle.

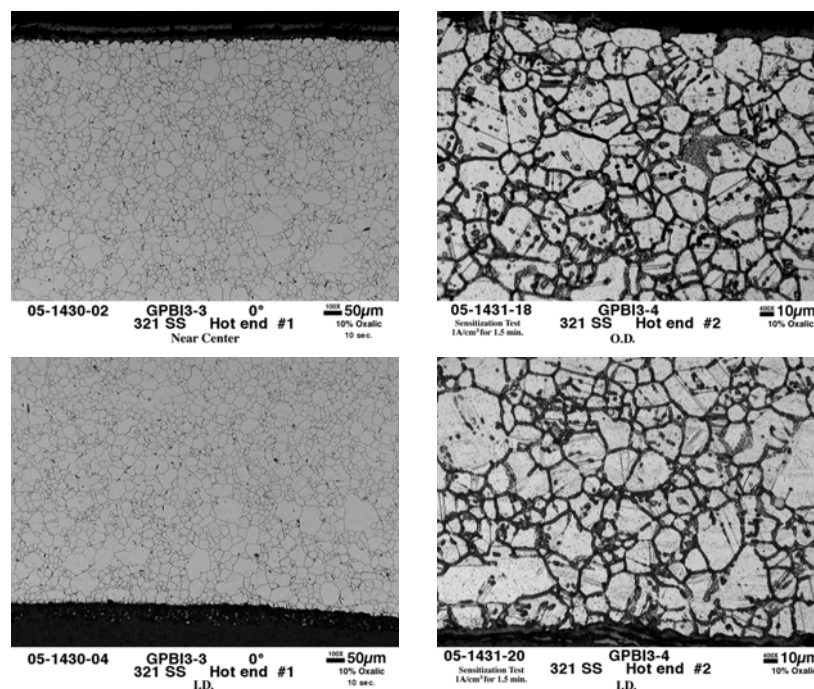
**Figure 28.** Low magnification micrographs (left) of the lightly etched inner and outer surfaces of the 321 stainless steel sample and higher magnification micrographs (right) of the more heavily etched inner and outer surfaces showing the ditching.

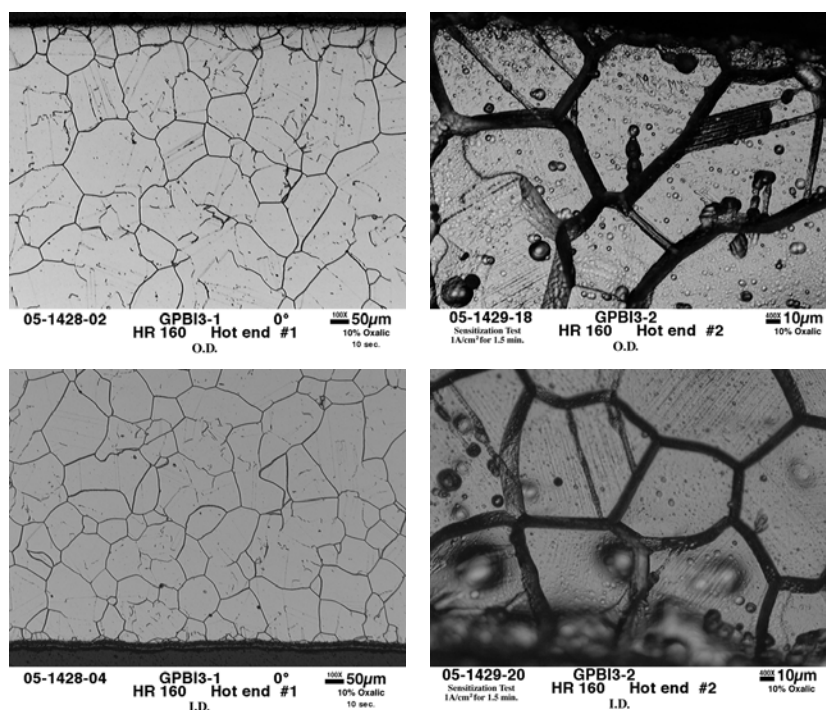
Tubes of alternate shield and heater tube materials have been identified and installed and are being exposed in the reformer/gasifiers in an effort to find an alloy with increased resistance to carburization. However, short sections of two heater tube alloys, 321 stainless steel and a Ni-Co-Cr alternate material, showed roughly equivalent levels of carburization after about six weeks of exposure. **TJ**

**Figure 29.** Low magnification micrographs (left) of the lightly etched inner and outer surfaces of the nickel-cobalt-chromium (Ni-Co-Cr) alloy sample and higher magnification micrographs (right) of the more heavily etched inner and outer surfaces showing the ditching.
