# *Corrosion of carbon steel tubes in the mid-furnace of kraft recovery boilers – environment characterization*

PREET M. SINGH, VIKAS R. BEHRANI, AND JAMSHAD MAHMOOD

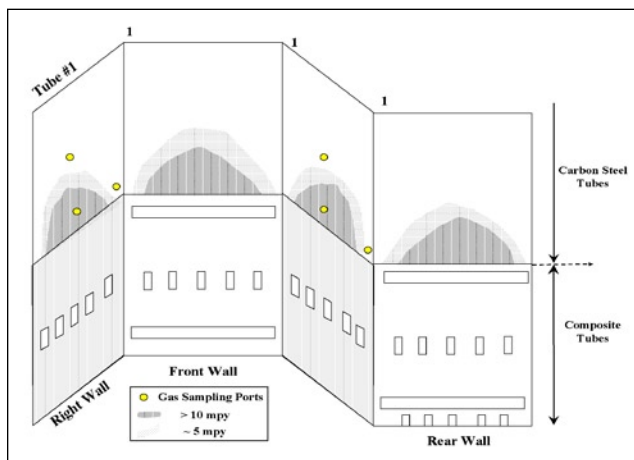
**1. Schematic of boiler 1 showing corrosion patterns and gas sampling port locations on the waterwall surface in mid-furnace area (above the cut line). This boiler had two air levels. High corrosion rates were experienced at higher elevations in the middle of each wall compared with corrosion in the corners.**

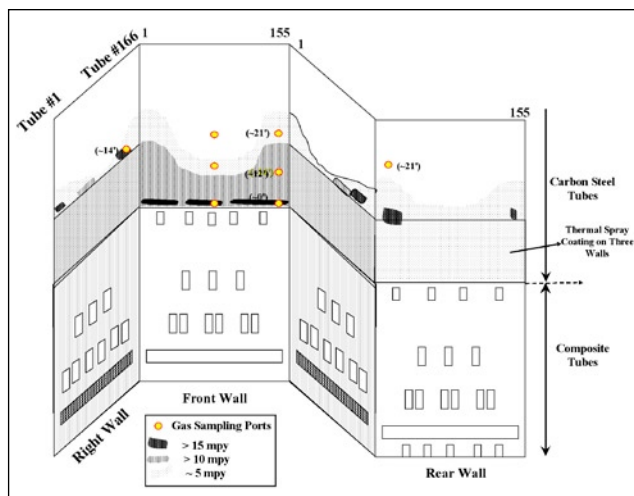
**2. Schematic of boiler 2 showing corrosion patterns and port location on the waterwall surface in mid-furnace area (above the cut line).**

Boiler 2 had three air levels, pressure of 10.3 MPa (1500 psig), and a steam temperature in the mid-furnace of ~320°C. Composite tubes extended up to the tertiary air port elevation. The boiler had significant corrosion of the carbon steel waterwalls in the mid-furnace up to 15–23 ft above the cut-line level. The corrosion pattern differed from that of boiler 1; the corners were more corroded than was the middle of waterwalls (**Fig. 2**).

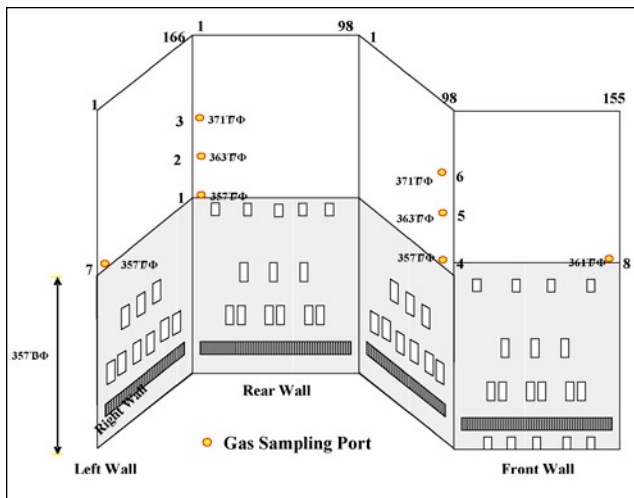
Boiler 3 had three air levels and was operated at 10.3 MPa (1500 psig) pressure with a steam temperature around 320°C. Composite tubes in this boiler extended up to the tertiary air port elevation. The boiler experienced significant corrosion of the carbon steel tubes in three corners. The front wall and the rear wall had accelerated corrosion on the carbon steel tubes extending almost 12 ft above the cut line (**Fig. 3**).

**3. Schematic of boiler 3 showing port location in mid-furnace area (above the cut line).**

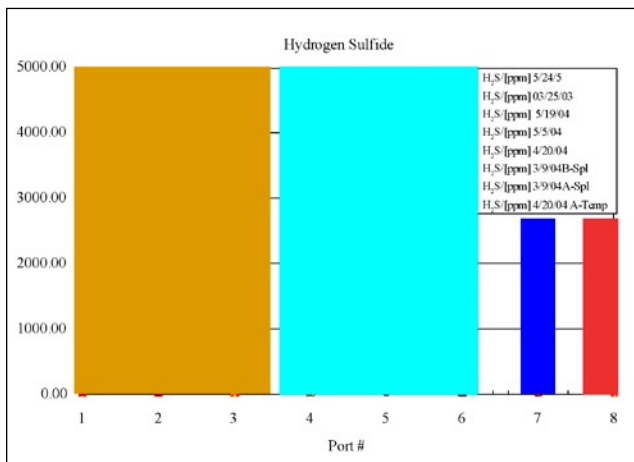
**4. Variation in the concentration of hydrogen sulfide in gas samples, during a 2-year period, taken from different ports in the mid-furnace, shown in Figure 4. Locations at Port #s 1 and 4 had highest corrosion rate (~15mpy) at the waterwall surface whereas Port #s 3 and 4 had the lowest corrosion rates (<5 mpy).**

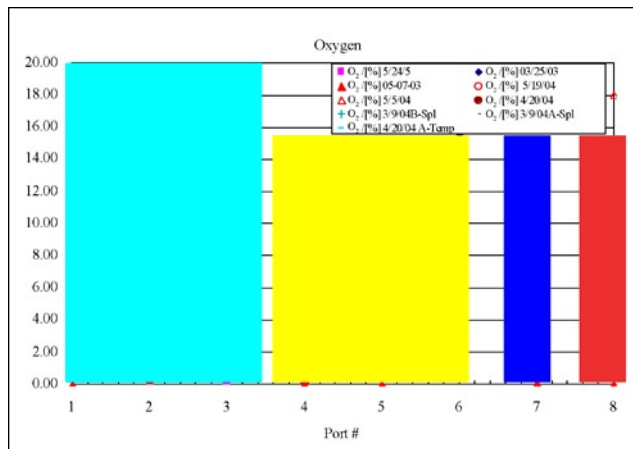
**5. Variation in the concentration of oxygen in gas samples, during a 2-year period, taken from different ports in the mid-furnace, shown in Figure 4. Locations at Port #s 1 and 4 had highest corrosion rate (~15mpy) at the waterwall surface whereas Port #s 3 and 4 had the lowest corrosion rates (<5 mpy).**

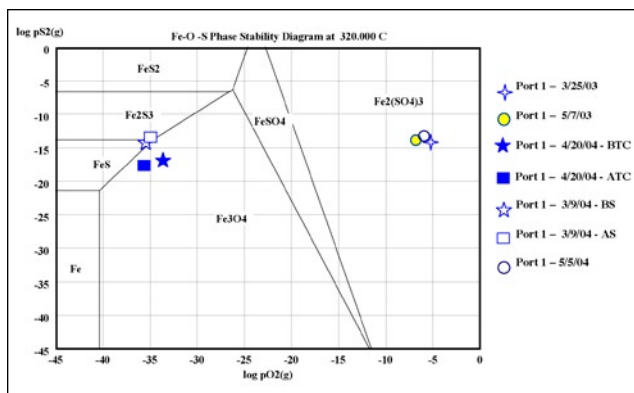
**6. Phase stability diagram for an iron-oxygen-sulfur system at 320°C. Diagram shows partial stability regions for different possible scale compositions as a function of oxygen and sulfur partial pressures.**

partial pressures in an iron-oxygen-sulfur system at 320°C. The average gas composition of samples taken from this port on each day was used to calculate the partial pressures of oxygen and sulfur and was plotted on the phase-stability diagram for the iron-oxygen-sulfur system at 320°C. Gas samples for Fig. 6 were taken from the same port location (i.e. port 1) in the boiler, but on different days. Data indicate that the gaseous environment at this port varied from very oxidizing to sulfidizing under the so-called normal boiler operation conditions during different periods. These results clearly indicate that the gaseous environment fluctuated in the mid-furnace of this boiler. Instability in the boiler gas-flow in the mid-furnace area might explain the difference in the local gas composition at different times under otherwise similar operating conditions (Fig. 6).

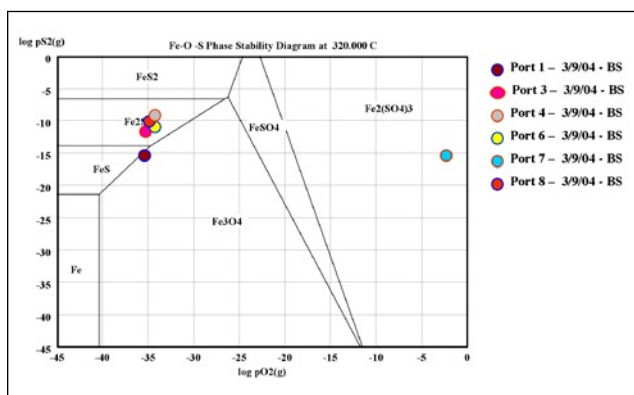
**7. Phase stability diagram for an iron-oxygen-sulfur system at 320°C. Diagram shows partial stability regions for different possible scale compositions as a function of oxygen and sulfur partial pressure in contact with iron.**

Data superposed on the phase stability diagram in **Fig. 7** show the difference in the gas composition at different port locations in the mid-furnace on a particular day. On this day, the average gas composition in all selected areas, except for port 7, was rich in sulfidizing gases, which thermodynamically favors the formation of iron sulfide ( $\text{Fe}_2\text{S}$ ) on the carbon

steel tube surface. On other days, the gas compositions for the ports at the higher elevation were more oxidizing than the lower ports. Figures 6 and 7 show that gaseous environments in local areas can change from completely oxidizing to completely reducing. This was more prominent in the lower areas, near the cut line, and generally associates with areas with higher corrosion rates.
