# *Digester thinning: Erosion-corrosion of internal flow channel headers*

GREG A. BUSBY AND PETER W. HART

**ABSTRACT:** A softwood continuous digester has experienced severe erosion-corrosion of the shell wall inside the internal flow channel headers of the extraction and modified continuous cooking (MCC) zones. Although erosion-corrosion is a common form, it is not typically looked for inside digester flow channels. The worst damage was located where high velocity liquor exits the screen orifices and enters the collection headers. With erosion-corrosion rates as high as 200 m/year, the damage has effectively reduced the wall thickness almost by half in the worst areas. Also affected were the horizontal backing rings that form the bottom of the flow channels. An API-579/ASME FFS-1 Part 5, Level 2 analysis was performed to allow the mill to continue operating the digester until the next scheduled outage. Owner-users are encouraged to inspect these locations in their digesters to ensure that erosion-corrosion has not caused accelerated and/or unexpected shell thinning. The internal flow channels represent locations that are not readily accessible for internal visual inspection with

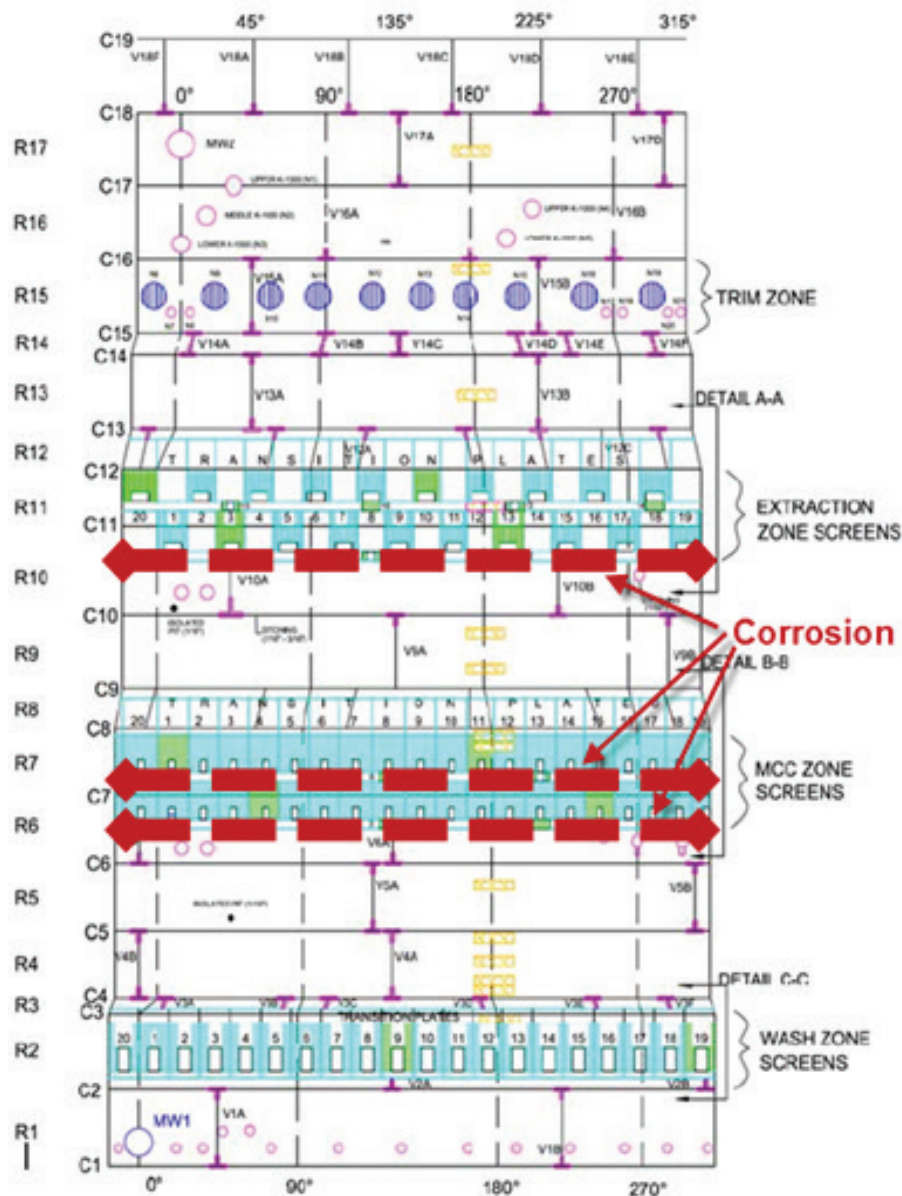
1. Roll-out reference sketch of digester.

age, it was concluded the local flow velocity was a key parameter affecting the rate of thinning damage. Descriptions of how the damage was initially found and how it was monitored with on-stream ultrasonic thickness and electrochemical corrosion probe testing are reviewed. Also discussed are details specifically related to external on-stream thickness testing, which ensure that the corrosion rate data are accurate. A roll-out reference sketch of the digester in question, along with the areas of high corrosion, is shown in **Fig. 1**.

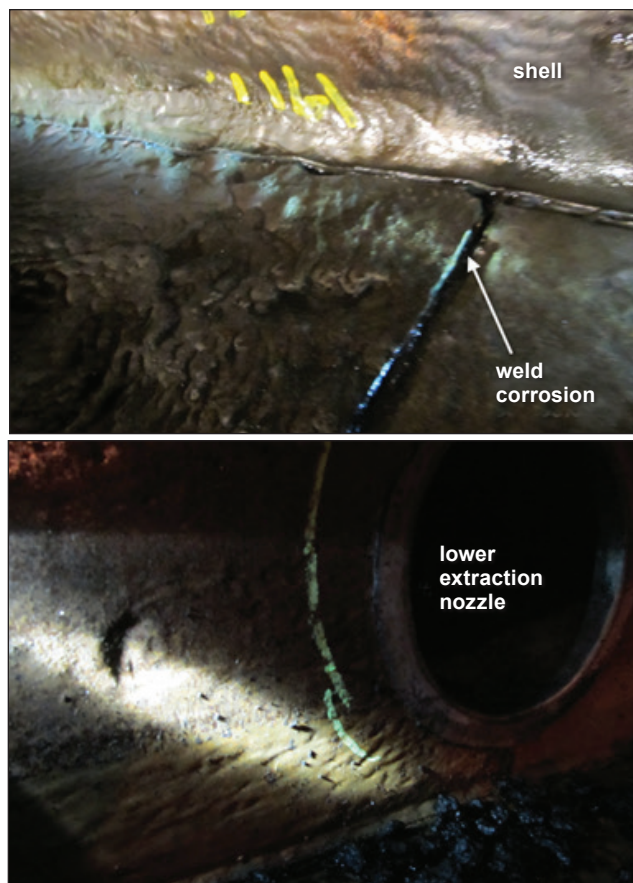
**2. “Wavy” pattern of erosion-corrosion damage to the extraction header plate directly beneath the screen orifice. In the lower picture, notice the erosion-corrosion damage inside the flow channel in the vicinity of the extraction nozzle.**

the screen orifice holes. When plotted, the thinning had an almost sinusoidal pattern around the circumference of the digester.

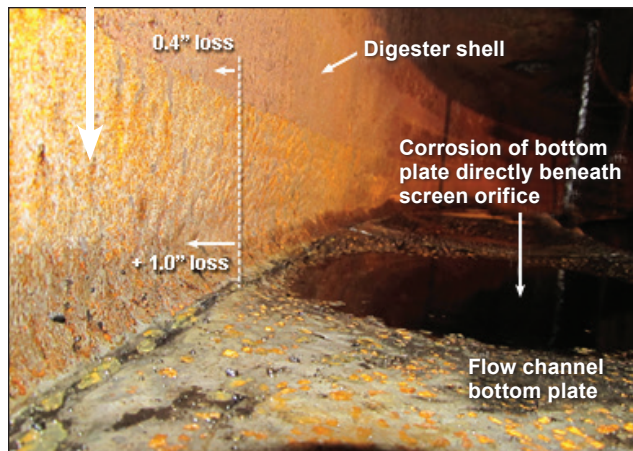
**3.** Inside the lower extraction flow channel with cover removed for access. Note the severe erosion-corrosion of the shell near the bottom plate, as well as wash-out of the bottom plate (holding liquor) that is directly beneath the screen orifice.

All areas of the shell below the corresponding ASME t-min value were repaired by weld overlay. Prior to welding, the area was preheated to 300°F using a rose-bud technique [8]. The welding was performed by shielded metal arc welding (SMAW) using 5/32 dia., E7018 electrodes in consecutive, horizontal weld beads. The weld overlay areas were built-up

to the corresponding t-min value plus an additional 0.050 in. of corrosion allowance. In a few of the worst areas of the lower extraction zone, ER 309L SS electrodes were applied on top of the carbon steel weld build-up.

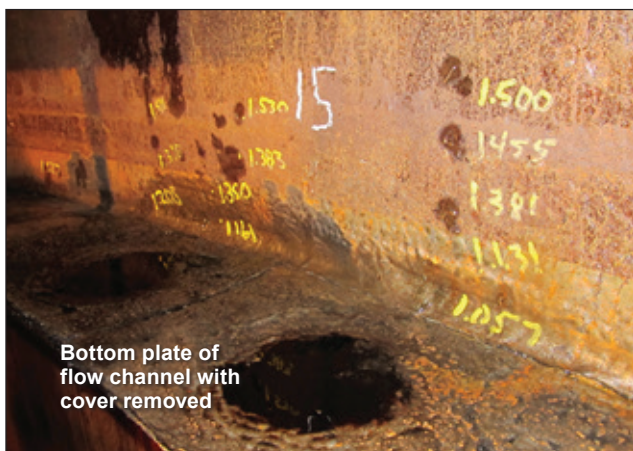
**5.** Erosion-corrosion damage to the digester shell and bottom of the flow channel.

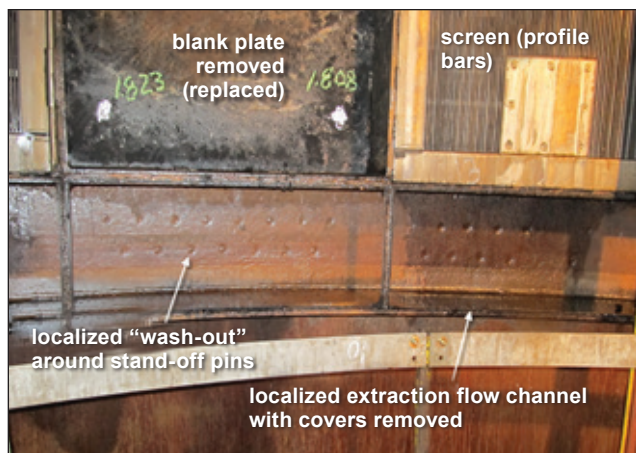
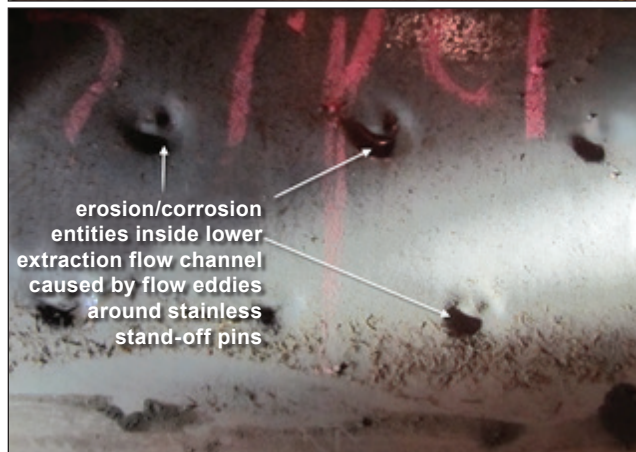
**6. Note the localized damage around standoff pins that are attached to the flow channel covers that were removed. The lower photo is a close up detailing the localized corrosion caused by flow eddies around the standoff pins.**

rosion around the stand-off pins. Flow eddies appear to form around these pins, which causes accelerated erosion-corrosion with the classic “comet tail” and “horse-shoe track” patterns. The corrosion penetration into the shell at these stand-off pins located inside the flow channel were much deeper than that around the pins behind the screens. Even though the process chemistry in these two areas is nearly identical, higher velocities are present inside the flow channel than behind the screens, thus enhancing the erosion-corrosion rate.

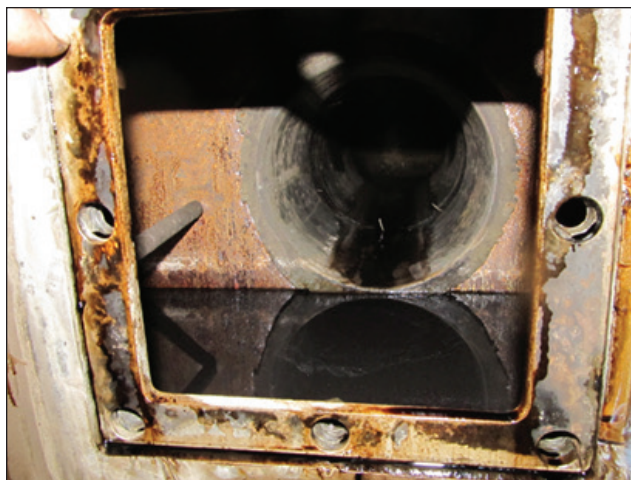
**7. Upper MCC flow channel. (Nozzle height leaves 2.5 in. “heel” of liquor in the bottom).**

There was erosion-corrosion damage to the shell inside both MCC flow channels, similar to that found at the extraction zone. Although this damage required weld buildup repair to restore to ASME t-min thickness, the damage was much less severe than the damage at the extraction level. The bottom plates of the flow channel headers showed minor to moderate damage underneath the open flow orifice. In general, the damage to the shell in the MCC flow channels did not extend more than 2 or 3 in. above the bottom plate of the collection header. **Figure 7** shows the MCC channel along with the “heel” of liquor retained in the bottom of the flow channel that impedes visual inspection of the internal flow channels.
