# *Identifying microbially influenced corrosion on surfaces contacted by mill waters*

W.B.A. (SANDY) SHARP AND LYNDA A. KIEFER

The following case history of corrosion in a mill cooling water system is presented as an example of how multiple pieces of consistent evidence can establish MIC as the cause of corrosion.

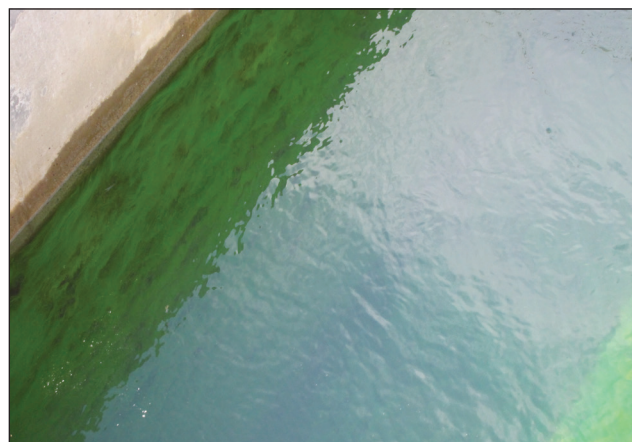
**5. Growth of green algae on the wall of a channel taking recycled water from the cooling towers.**

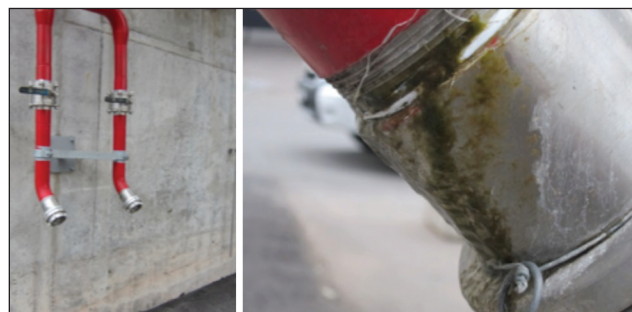
**6. Growth of green algae at a water leak where a fire water outlet nozzle cap was screwed to a fire water pipe.**

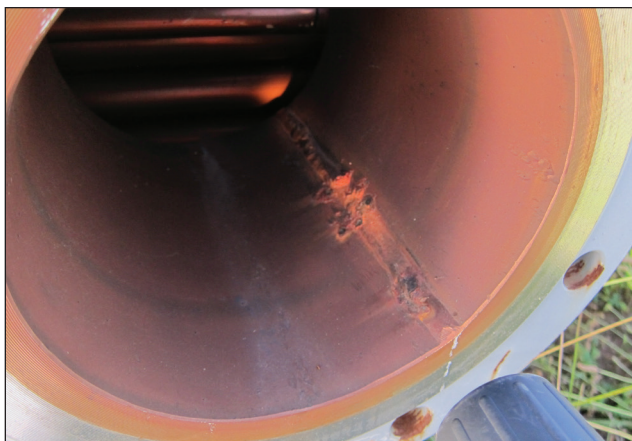
**7. Heat exchanger 1: Deposit mounds along a cooling water discharge nozzle weld.**

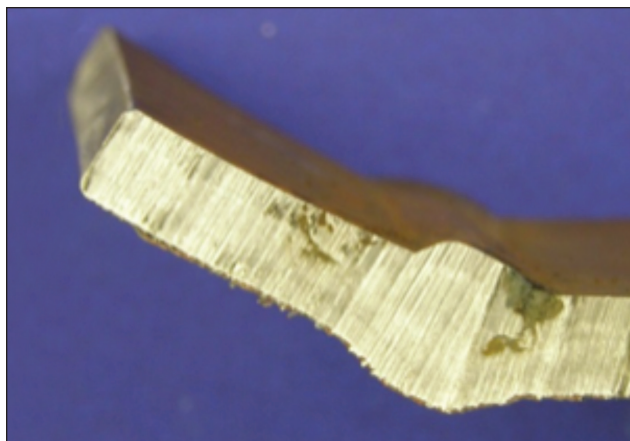
**9. Heat exchanger 1: Cross-section through the longitudinal weld in the cooling water discharge nozzle**

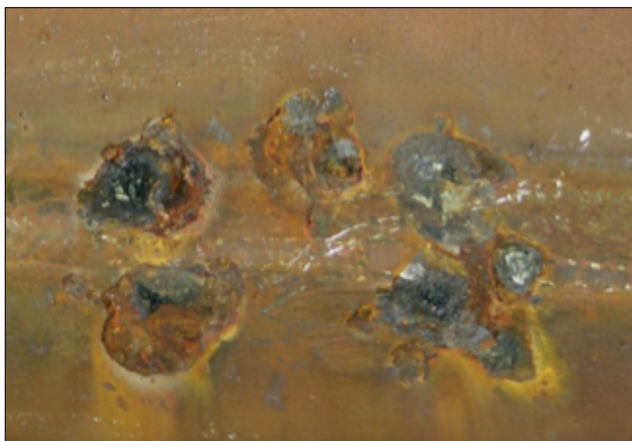
**8. Heat exchanger 1: Pits under deposit mounds on the water-side of the cooling water discharge nozzle.**

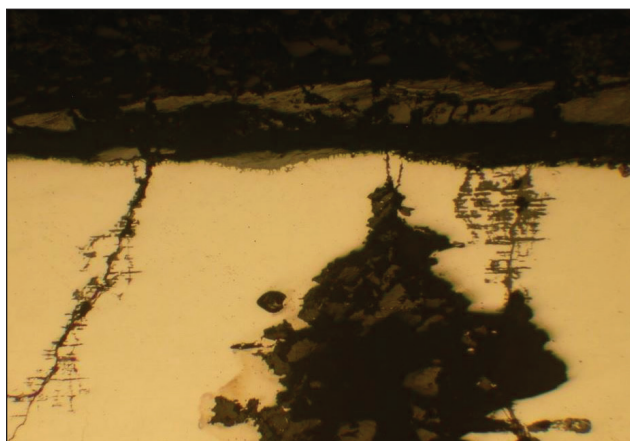
**10. Heat exchanger 1: Narrow surface crack opening to a large subsurface pit, and branched cracking typical of stress-corrosion cracking (75 $\times$ ).**

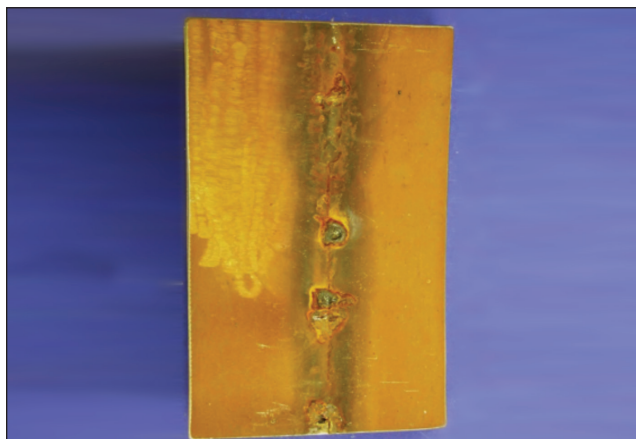
**11. The water-side surface of a sample cut from the shell of heat exchanger 1.**

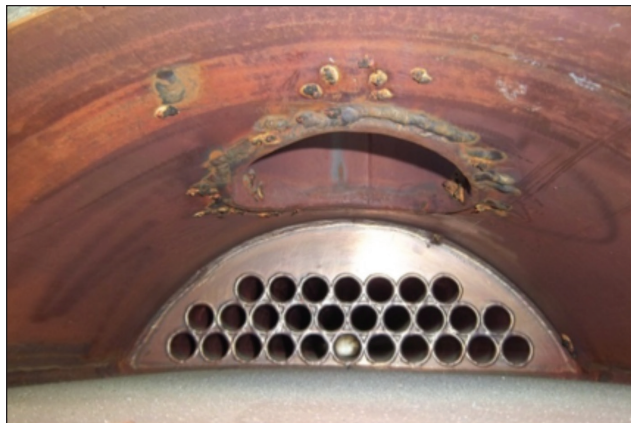
**12. Heat exchanger 2: Pass 4 tube sheet beside the cooling water discharge nozzle.**

these leaks were repaired by welding scab patches to the outside surface of the vessel, but the leaks continued. **Figure 12** shows the water-side of the girth weld joining the hot water discharge nozzle to the heat exchanger shell. Corrosion mounds surrounded by yellow deposits and repair weld penetrations can be seen. Eventually, this heat exchanger was replaced and the cooling water discharge pipe upgraded to type 316L stainless steel. The surfaces of the inlet nozzle that delivered cool water to the scrapped heat exchanger 2 had remained deposit-free and still showed heat tints from the original fabrication welding (**Fig. 13**).

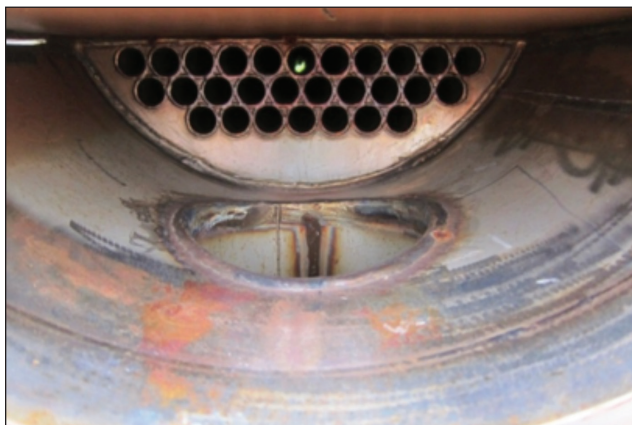
**13. Heat exchanger 2: Clean surfaces of the chamber at the cooling water supply nozzle.**

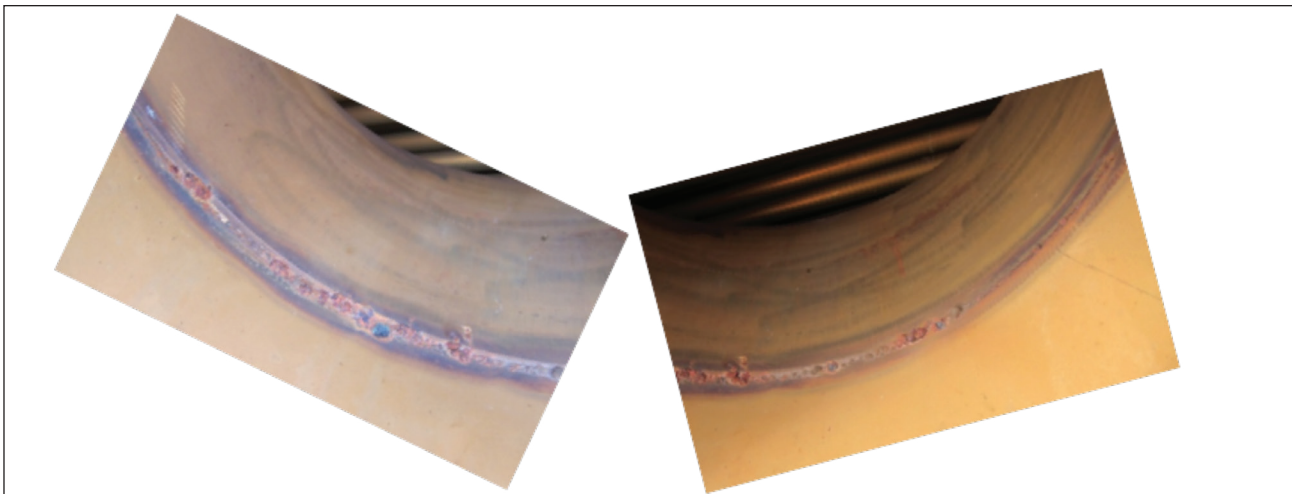
**14. Heat exchanger 3: Localized corrosion in a circumferential weld seam attaching the cooling water discharge nozzle. Photographs taken facing upstream toward the heat exchanger tubes.**

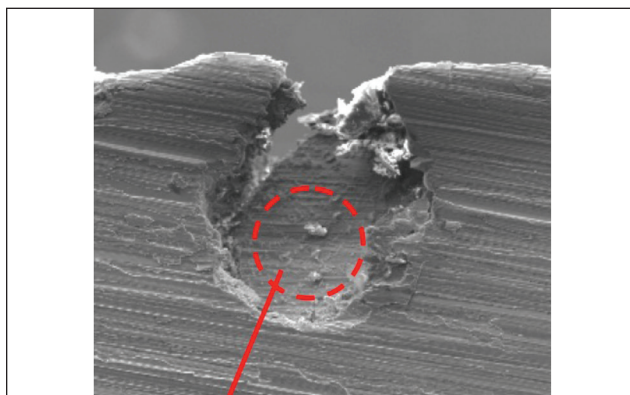
The pits propagated under rust-brown deposits on the lining material. The rounded pit shown in **Fig. 15** had a small entrance at the waterside surface and a large rounded cavity underneath that is characteristic of MIC. Rounded subsurface pits and corrosion tunnels typical of MIC were found at several locations (**Figs. 16** and **17**).

**15. A spherical subsurface pit with a narrow entrance at the metal surface.**

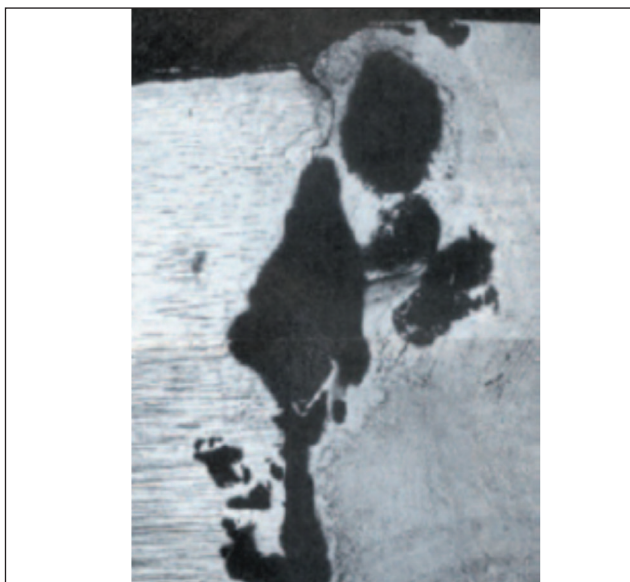
**16. Rounded subsurface pits along a weld joining two adjacent lining sheets.**

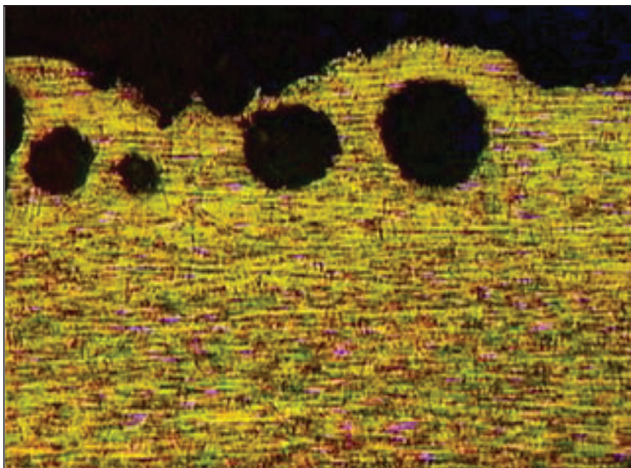
**17. Rounded sub-surface corrosion tunnels in the stainless steel lining.**

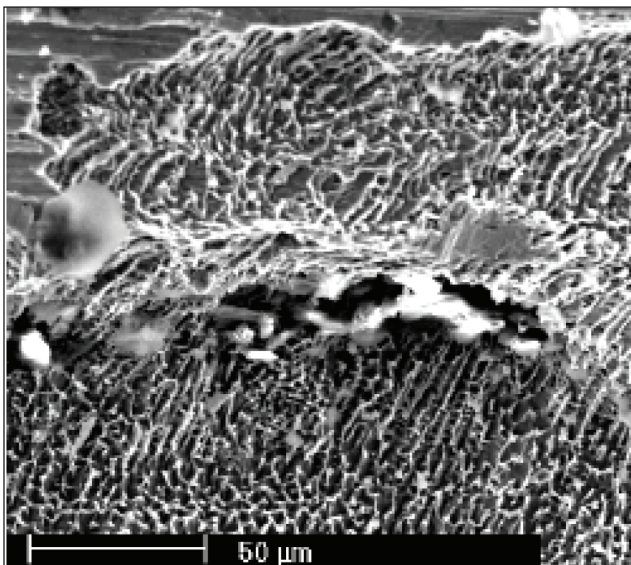
Corrosion had selectively attacked the weld metal, revealing its dendritic structure (**Fig. 18**). The first-to-freeze material would have been most vulnerable to corrosion because it would contain significantly less molybdenum than the last-to-freeze material. Molybdenum additions increase the corrosion resistance of stainless steels. Also, two samples of the sheet lining were found to contain less molybdenum (1.86% and 1.88%) than is specified for type 316L (2.00% to 3.00%). Finally, the heat-affected zone of the stainless lining was slightly sensitized, making it still more vulnerable to corrosion. In the absence of MIC, type 316L stainless steel is adequate to handle white waters that contain only a few tens of parts per million of chloride. The fact that type 316L

**18. White water tank: Selective corrosion revealing the dendritic structure in the weld material.**

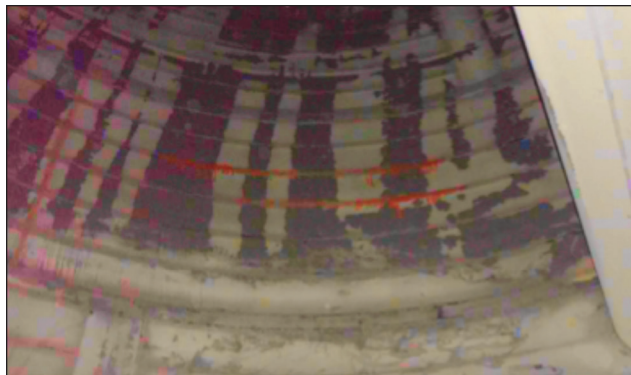
**19. White water tank: Rust-colored fluid leaking from horizontal (circumferential) welds attaching the sheet lining.**

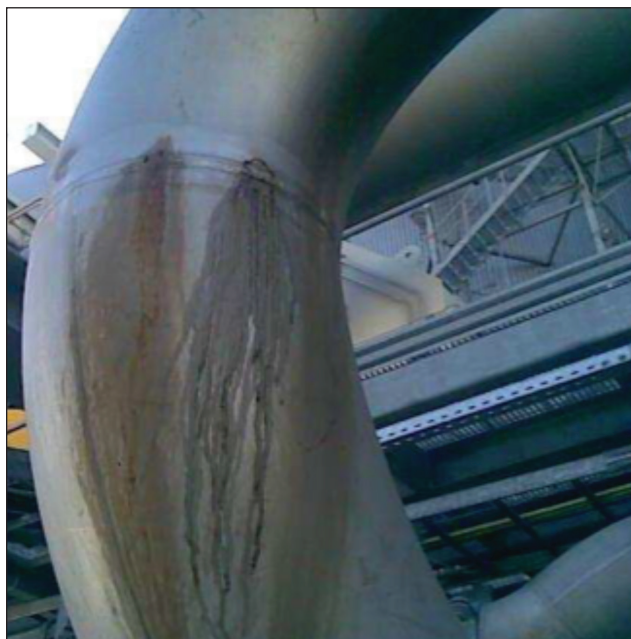
Leaks similar to those at welds in the heat exchangers also appeared in type 316L stainless steel white water piping. **Figure 20** shows typical small leaks at girth welds between sections of

**20. White water piping: External stains produced leaks at a girth weld.**

pipe. Leakage rates were slow enough that the white water evaporated on the surface of the pipe rather than spraying out from it. The deposition of solids from the evaporating white water might have tended to block these leaks.

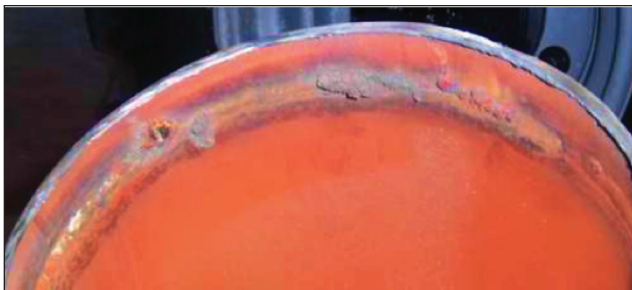
**21. White water piping: Rust mounds at corrosion sites at a circumferential weld in a hot water pipe.**

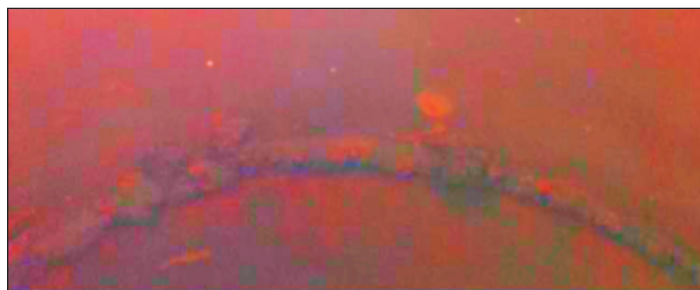
**22. White water piping: Rust mounds on and beside a circumferential weld in another hot water pipe.**
