## Wet-end pressure pulsations: case histories

Warren S. Miller and G. R. Oleson

*Spectrum analysis techniques can reduce the time necessary to diagnose the sources of MD basis-weight variations.*

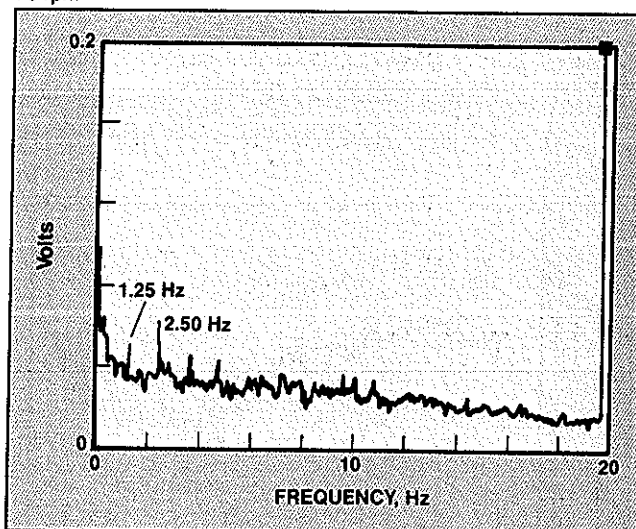
1. Basis weight variation on the rectifier roll at the single-point center, 73 rpm

In one mill, when the slice rectifier roll was rotating at 73 rpm, basis weight variations at one and two times the rotation speed of the rectifier roll were found in the paper (Fig. 1). At 9 rpm, a frequency for hole pass patterning (3.6 Hz) could be detected at the reel (Fig. 2). At 33 rpm, the MD basis weight variations and stock pulsation were at a minimum due to this roll (Fig. 3). Good maintenance, proper design of the hole size and drilling pattern, and correct rotational speed and direction can help minimize MD pulsations.

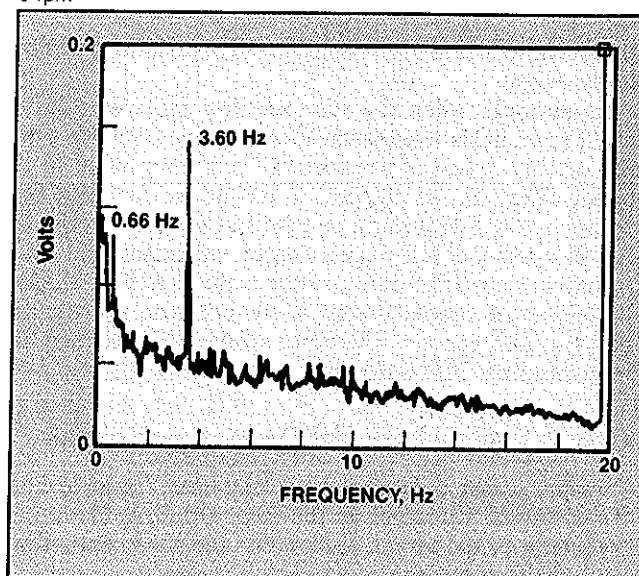
2. Basis weight variation on the rectifier roll at the single-point center, 9 rpm

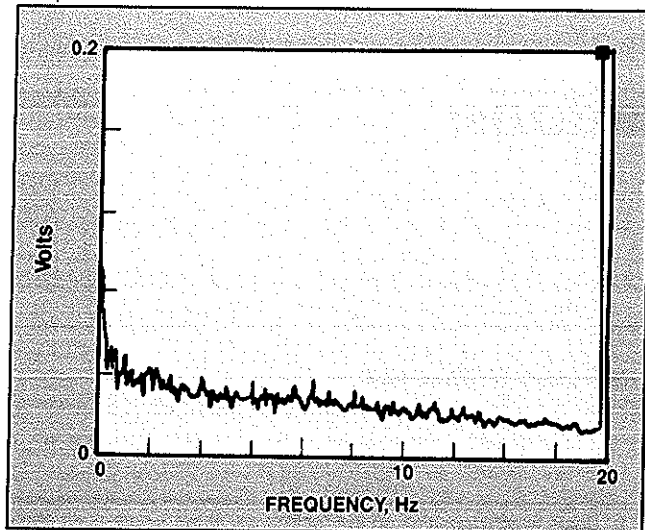
3. Basis weight variation on the rectifier roll at the single-point center, 33 rpm

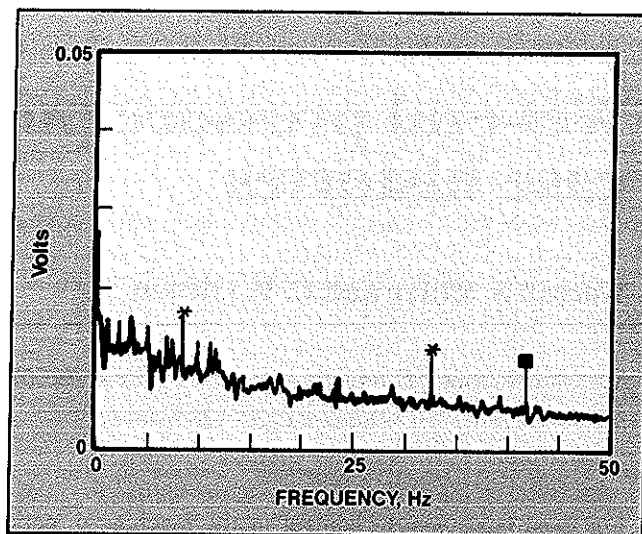
4. Basis weight variation, with a 41.75-Hz periodic pulse

A 41.75-Hz periodic pulse was detected at the headbox and on the sheet (Fig. 4). All attempts at matching this frequency with a rotating element of the machine were unsuccessful. The frequency did not track with machine speed, it was always discrete, and it drifted slightly. The pulsation was largest at the outlet of the primary pressure screens.

Several days after the troubleshooting attempts had been terminated without success, the primary pressure screen's internal bearing rollers fell to the basement floor. After repair was completed, the 41.75-Hz frequency disappeared. A bad bearing that had escaped detection by routine vibration analysis techniques had produced the basis weight variation at the reel. The slight frequency drift observed at constant machine speed can be explained by slippage of the roller bearing elements.

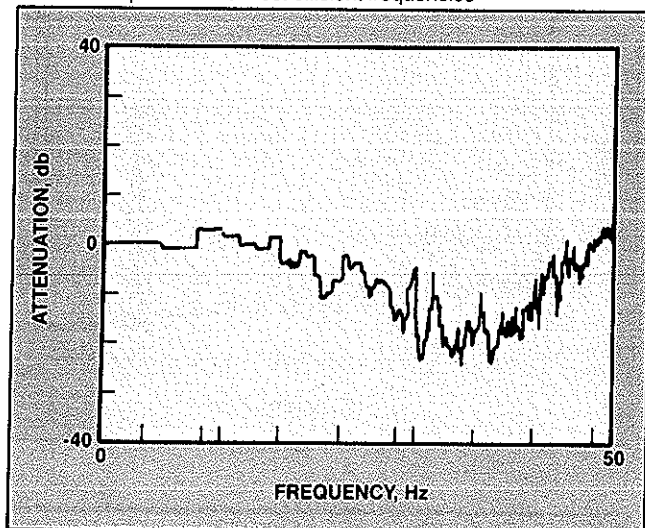
5. Attenuation and reduction for a good attenuator having a three-fold reduction in pulses at its most efficient frequencies

an effective bandwidth of from 1 Hz to 30 Hz, with a three-fold reduction in pulses at its most efficient frequencies (Fig. 5).

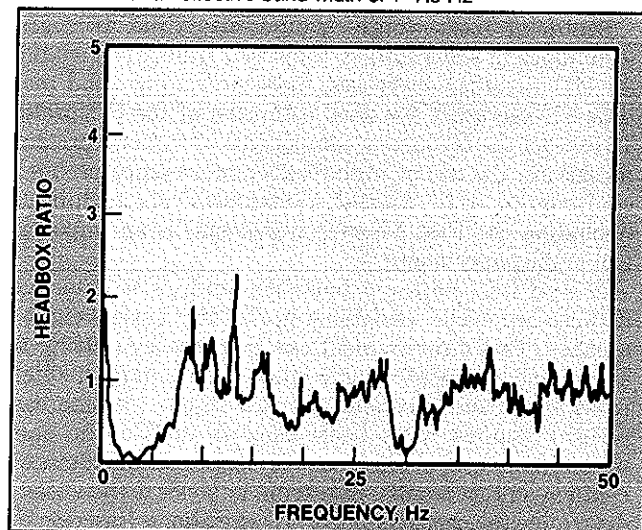
6. Insertion loss, or headbox ratio with the attenuator on vs. off, of an attenuator with an effective band width of 1-7.5 Hz

An attenuator had an effective bandwidth of 1-7.75 Hz (Fig. 6). The attenuator amplified at 13 Hz, which is blade pass frequency of the primary pressure screen. Broad band flow disturbances were creating pulses in the range of 3-5 Hz (Fig. 7). Optimum use of the attenuator was obtained by turning off the air supply to the air pad of the attenuator at times when the screen pulses were high. The installation of a low-pulse rotor assembly to the screen enabled continuous operation of the attenuator.

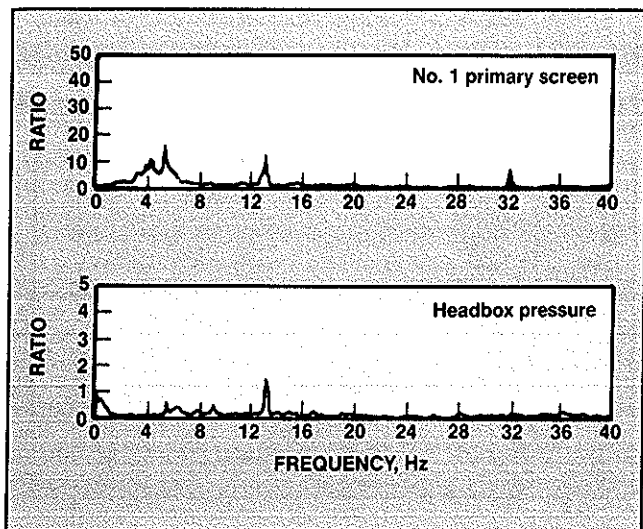
7. Broad band flow disturbances in the range of 3-5 Hz

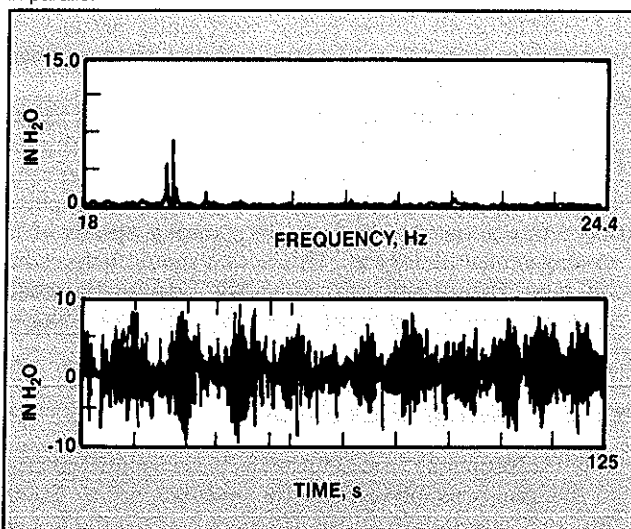
8. A complex beat frequency created by five primary screens running in parallel

Five primary screens running at similar rotational speeds in parallel were exhibiting a complex beat frequency (Fig. 8). The source was the blade pass frequencies (all slightly different) going in and out of phase with each other. At

It was postulated that a large suppression tank located before the headbox was effectively dampening the frequencies of the screens, but the beat remained unattenuated and rectified to the low-frequency pulses. Corrective action to separate the running speeds of the screens is now underway. This action should help reduce the beat frequency and simplify future diagnostic measurements to detect which screens are producing the worst pulses.

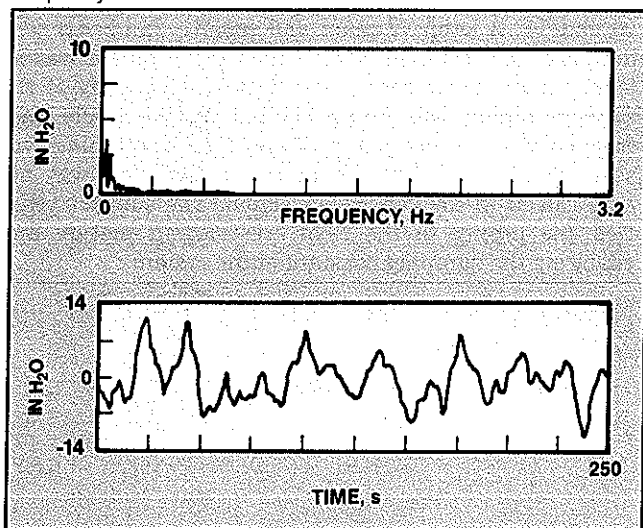
9. Low-frequency pulses producing basis weight variations of the same frequency

the headbox, no sign of the screen frequencies could be detected; only five discrete low-frequency pulses could be detected (Fig. 9). These pulses were quite pronounced, with swings up to 27 in. of water, and they produced basis weight variations of the same frequency.

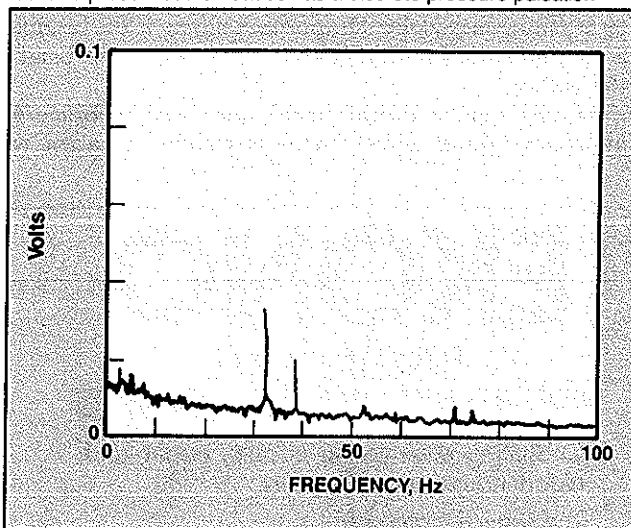
10. A 39-Hz frequency first detected as basis weight variation at the reel and present at the headbox as a discrete pressure pulsation

A 39-Hz frequency first detected as basis weight variation at the reel was present at the headbox as a discrete pressure pulsation (Fig. 10). No machinery in the wet end was rotating at that frequency. Furthermore, the frequency was independent of machine speed, although its amplitude did increase with increasing machine speed. By using a vibration probe and plotting the amplitude of the 39-Hz frequency along the approach piping to the headbox, a maximum value was detected just before a 90° bend in the piping.

monitored. Supporting the pipe from underneath had a negative effect on basis weight variation; support from above significantly reduced variation, as shown in Figs. 10 and 11. A support beam and passive dampener was designed and installed, after which the problem was no longer found. Apparently, the natural frequency of the support piping was being excited by the blade pass frequency of the fan pump (32-36 Hz). The piping was supported by a hanger from the ceiling and was not constrained in the vertical direction. The support beam tied the piping to the floor, restricting motion and changing the damping constant of the system.

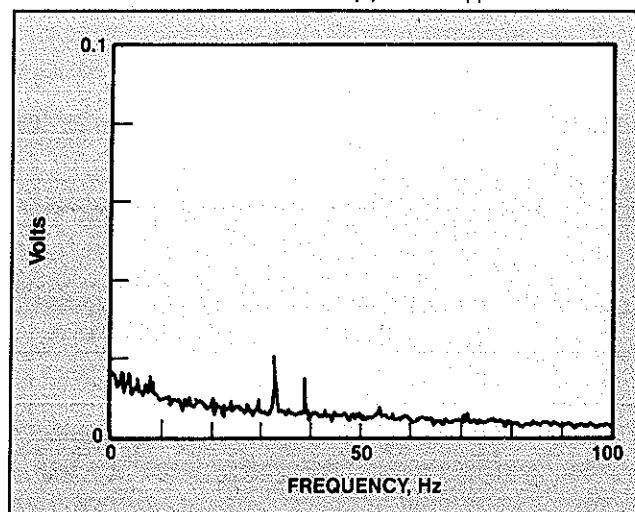
11. Variation was reduced when the pipe was supported.
