# Evaluation of bleach plant piping materials

A. H. Tuthill and A. Garner

*Tests on fabricated pipes in the bleach plant show that further work is needed to establish an inside root pass procedure which avoids the formation of unmixed zones. Possible options include automatic gas tungsten arc welding, a greater root gap, or consumable inserts.*

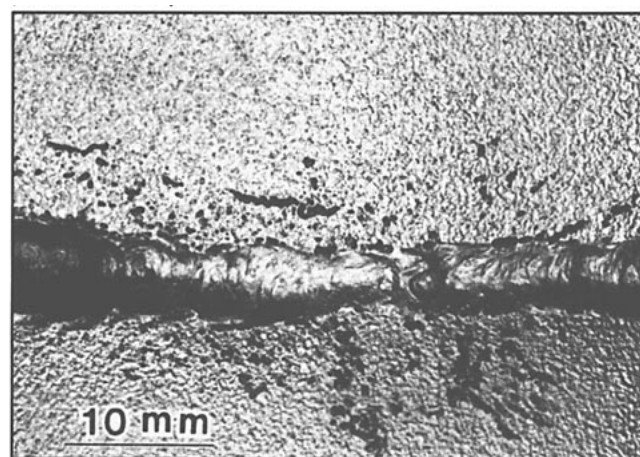
3. A cleaned circumferential weld of AL-6XN showing pitting. Pits initiated in unmixed zones of weld metal and spread under the corrosion products to nearby base metal.

The base metal and longitudinal (solution annealed) welds were unattacked. However, the circumferential butt-weld was pitted over about 60% of its length to depths up to 0.197 in. (5 mm) (Figs. 3 and 4). Metallography revealed that the manual TIG welding procedure had produced weld metal with substantial unmixed zones, i.e., zones in which remelted base metal was not mixed with the alloy 625 filler metal (Fig. 5).

In planning this work, we assumed that the procedures used to weld 304L and 316L pipe could be used, with minor alterations, to weld 6%-molybdenum stainless steels. However, we found that, even with fully qualified and experienced stainless steel pipe welders, these procedures can result in unsatisfactory welds for 6%-molybdenum stainless steels. Although unmixed zone corrosion had been noted in previous coupon test programs (10), its importance had been difficult to gauge without more careful replication of pipe weld procedures. This program was carried out to address this kind of shortcoming. It has shown that further work is needed to establish an inside root pass procedure which avoids the formation of unmixed zones. Possible options include automatic TIG, a greater root gap, or consumable inserts.

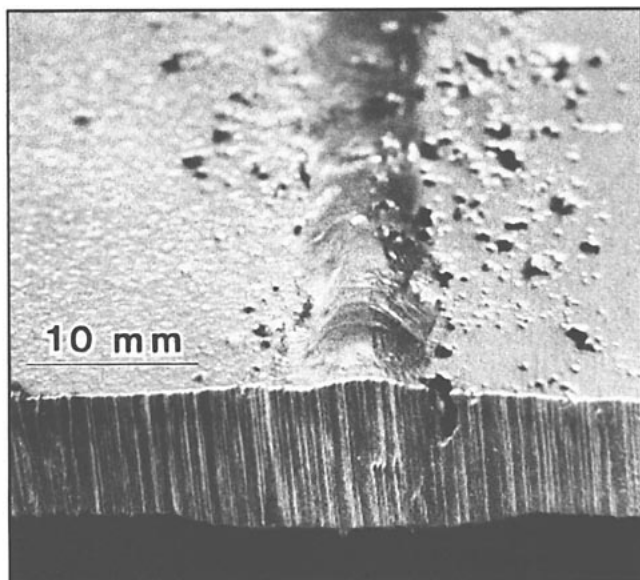
4. Cleaned and sectioned circumferential weld in AL-6XN. Deep pitting followed weld metal unmixed zone.

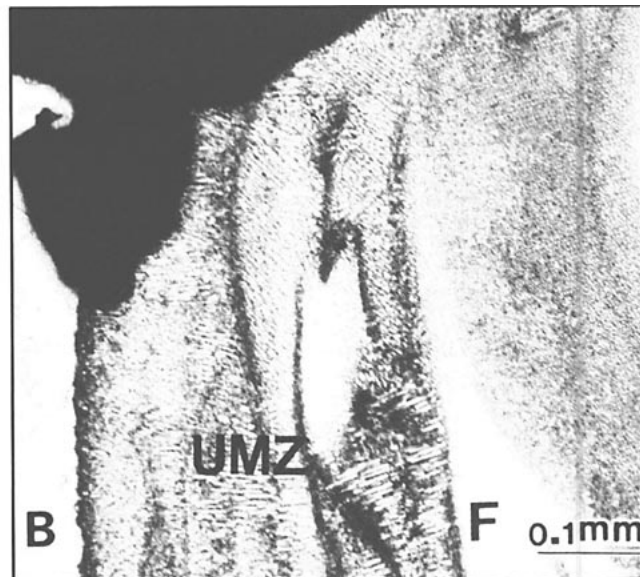
These observations were confirmed using energy dispersive X-ray analysis on a scanning electron microscope. Weld metal unmixed zones contained about 50% iron, as did the base metal; light-etching weld metal contained about 5% iron, i.e., as alloy 625 filler. In 6%-molybdenum austenitic stainless steels, such autogenous areas are well known to have pitting resistance much inferior to parent base-metal (9, 10). Dendrite coring or microsegregation leaves areas of microstructure depleted in molybdenum and chromium, areas through which pits can more easily propagate (Fig. 5).

5. Metallographic section of pit in the circumferential weld in AL-6XN. Dark etching unmixed zones (UMZ) are susceptible to pitting. Base metal (B) and light-etching undiluted Alloy 625 filler metal (F) resisted pitting in this aggressive bleach plant environment (Etch = 40 mL HCl + 10 mL H<sub>2</sub>O + 10 mL HNO<sub>3</sub>).

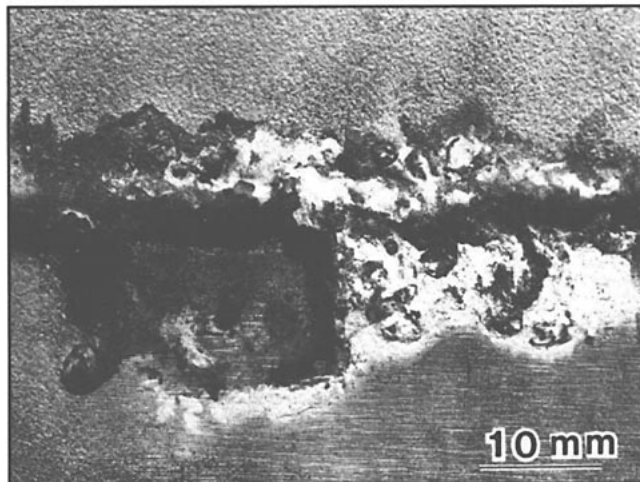
As was found in previous field tests, the corrosion deposits themselves led to additional under-deposit pitting

adjacent to the welds (Figs. 3, 4, 6, and 7). As will be discussed later, these ferric deposits create crevices under which active corrosion can occur readily at these temperatures.

6. Secondary pitting and crevice corrosion occurs under ferric deposits formed near welds.

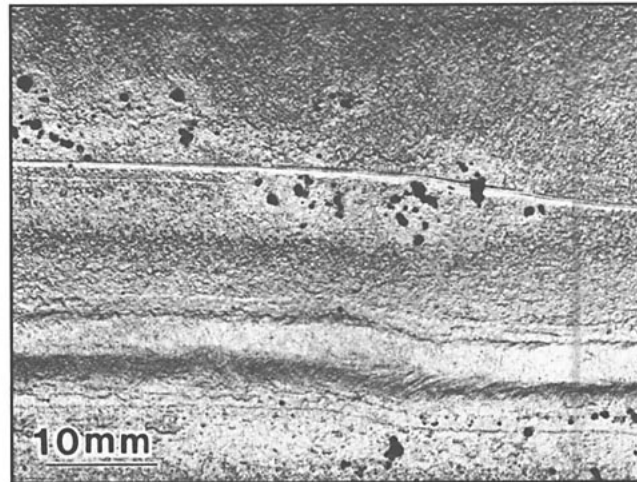
After superficial brown deposit was removed, substantial pitting was evident to a depth of 0.075 in. (1.91 mm) (Fig. 7). About 100 individual pits were visible to the naked eye on cleaned base metal, weld metal, heat-affected zones, and occasionally on a scratch, without any discernible pattern.

7. Pits in G-30 sometimes, but not always, are associated with a scratch or with welding.
