# Resolving wire contamination on a tissue machine

Daniel J. Pekrul and Charles W. Neal

*Analytical troubleshooting techniques can help identify the most probable cause of wire contamination.*

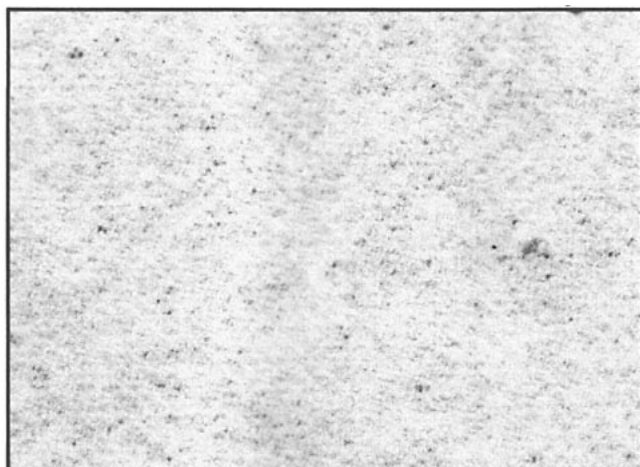
The approach to resolving the wire contamination began with a clear understanding of the problem statement: "Small holes in tissue sheet." If it were not for a limit on small hole count for quality, it would not be necessary to shut down and clean the wires. Figure 1 is a photograph of such small holes.

1. Small holes in tissue sheet

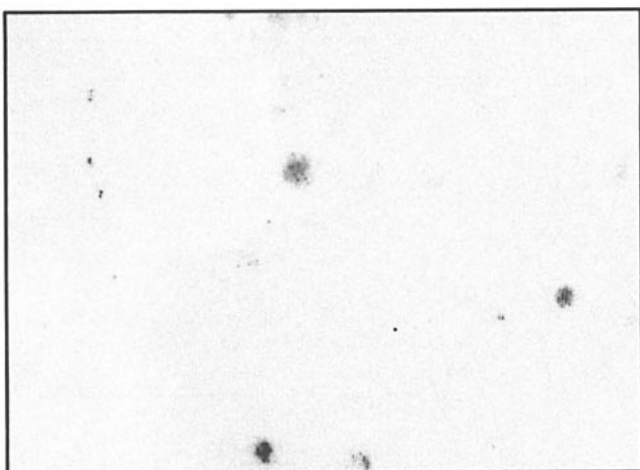
The ATS effort identified the most probable cause to be wire contamination. A photograph of the results of pitch contamination on the wire is shown in Fig. 3. Cleaning the wire eliminated the holes in the sheet, as shown in Fig. 4.

3. Pitch contamination on wire

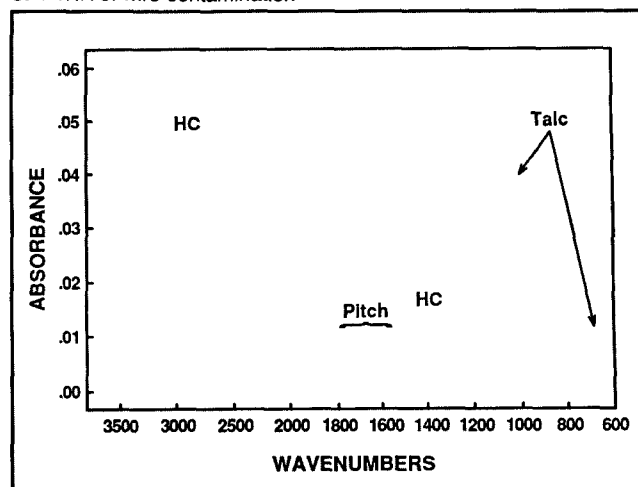
FT/IR micromolecular spectroscopy utilizing a diamond cell identified the wire contamination to be a combination of pitch and talc, as Fig. 5 illustrates.

5. FT/IR of wire contamination

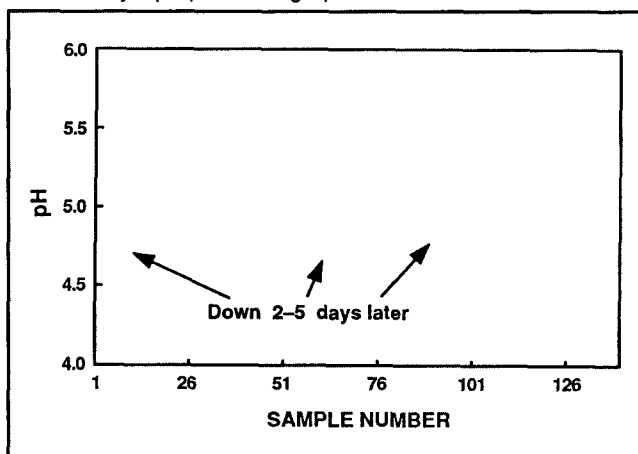
Several of the items mentioned above changed to one degree or another, but pH stood out as the most probable cause. Within three days after pH fell below 5.2 at the headbox, the wire would become contaminated with pitch and require a shutdown for cleaning, as Fig. 6 indicates. This finding was confirmed with each shutdown and matched data acquired from a similar paper machine. Further investigation showed a pH control problem which caused spiked drops in pH and thus wire contamination.

6. Fabric layer pH (shift averages)

Several action steps were immediately put in place to gain control of the wire contamination problem. The first step was to educate the operators on the findings so they would understand the importance of the manual pH control at the pulper. They would also be more likely to identify other signs or changes if they occurred in the future. A clear procedure was issued for maintaining proper pH levels at the pulper. The quantity of soda ash was increased to ensure pulp pH swings from the supplier would not fall below what was observed to be the acceptable lower limit.

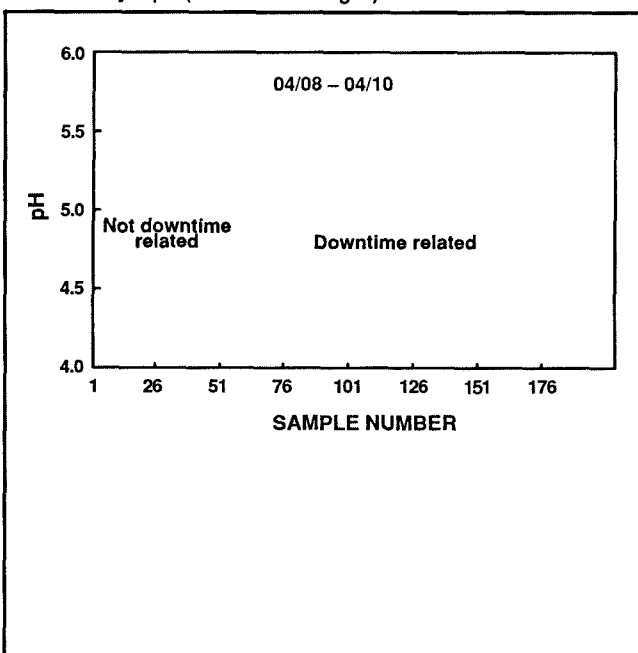
Another observation was unexplained contamination incidents following paper machine downtime with no apparent problem with pH control. Figure 7 illustrates these occurrences. The finding here was acid valve leakage when the paper machine was down. The acid caused system pH to drop, resulting in pitch precipitation and contamination of the wire.

7. Fabric layer pH (12 minute averages)

In addition to improved pulper pH control, headbox acid valves were replaced, and a procedure for maintaining valves and pH probes was initiated. The new valves eliminated acid leakage, and thus low pH excursions, while the paper machine was down.
