# Risks of bacterial hydrogen generation in white water systems

Robert S. Rowbottom

**ABSTRACT:** *Between 1969 and 1988, at least eight explosions occurred in paper mills under conditions of limited ventilation. Bacterial hydrogen generation is known to have been responsible for four of these explosions and is suspected in the others. Current trends to convert to alkaline process conditions and further close up white water systems are increasing the danger of exposure to this risk.*

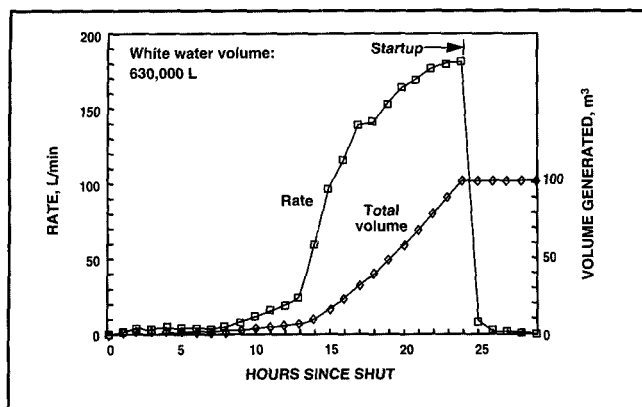
level in the white water is rapidly depleted. Laboratory and mill studies indicated hydrogen generation rates of 0.01–0.02 L per L of the mill's white water per hour. For the white water storage tank during a typical mill shutdown, this corresponds to a hydrogen generation rate approaching 180 L/min with a total production of over 100 m<sup>3</sup>. **Figure 1** illustrates this hydrogen generation.

1. Hydrogen generation in white water tank during a mill shutdown

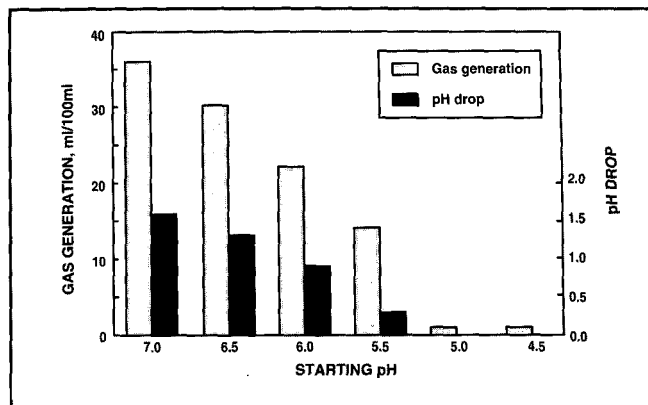
Laboratory experiments further indicated that adjusting the starting pH of the white water from the Ontario corrugating medium mill involved in the 1988 explosion to 5.5 substantially reduced hydrogen generation. A further decrease to pH 5.0 eliminated the activity. **Figure 2** illustrates the effect of changes in pH on anaerobic activity. Continuing trends toward more tightly closed white water systems,

2. Effect of pH on anaerobic activity of a corrugating medium mill white water
