# Suction roll pilot bearing failure due to inadequate lubrication

WOLFGANG S. CAMPBELL AND JERRY IACOPINI

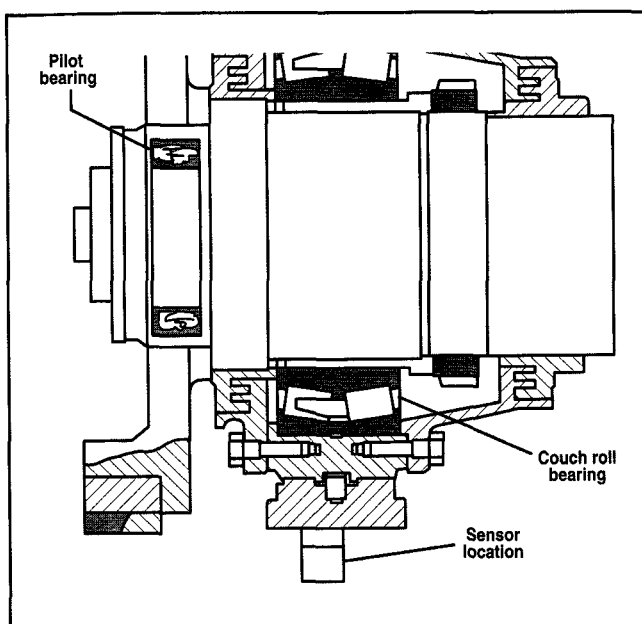
1. Couch roll drive side assembly

The couch roll has a stationary suction box inside the rotating outer roll shell and is supported at each end with 32-in.-diam. outside diameter (OD) spherical roller bearings (SKF 230/560CA). The inner, stationary suction box assembly is rigidly attached at the tending side, while the drive side is supported with a 10-in.-diam. OD spherical roller bearing (SKF 23230CC). The vibration sensor used for this analysis, the IRD 970 accelerometer, was mounted radially in the load zone on the couch roll bearing housing with a magnet. The lump breaker roll, mounted on the couch roll housing, operates loaded against the couch roll. **Figure 1** shows the arrangement of the couch roll back and pilot bearings.

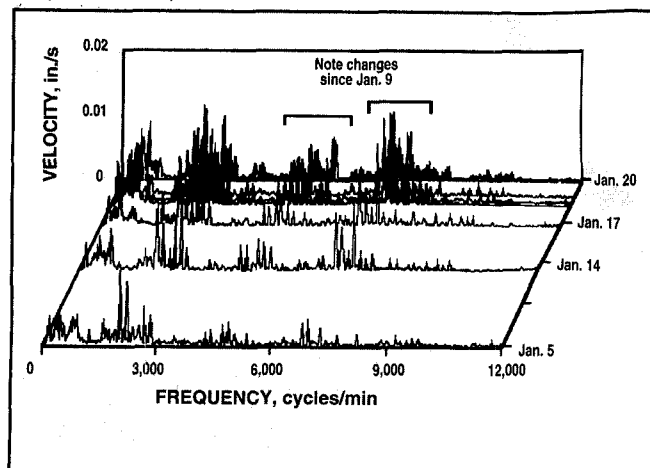
2. Spectral history of couch roll drive side

The velocity spectra collected from Jan. 9–20, 1994, shows how the vibration changed. **Figure 2** shows that, over time, the spectra became "richer," with more frequencies present on Jan.

Note that the third and fourth regions have significantly more frequencies after Jan. 14 than existed on Jan. 9. This shows how quickly a race defect can develop and accelerate the deterioration of a bearing.

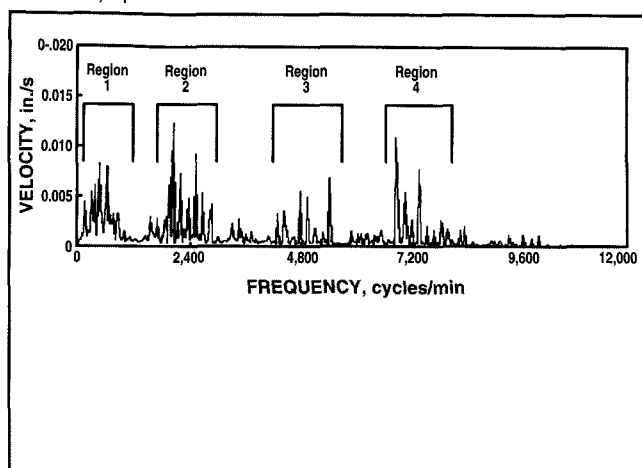
3. Velocity spectrum

20 compared with Jan. 9. The spectra show four general regions, depicted in Fig. 3: 0–1100, 1500–3000, 4000–5800, and 6500–8500 cycles/min.

The first region is mostly composed of the couch roll speed and multiples of this fundamental frequency. The second region has frequencies associated with an inner race defect of the couch roll back bearing. Centered within this region is the fundamental inner race defect frequency of 2455 cycles/min for a couch roll speed of 160 rpm. The other frequencies are side bands of the fundamental frequency, with a differential between any two peaks equal to the couch roll speed. Also noted was the presence of the couch roll pilot bearing defect frequency at 1648 cycles/min.

The third region of frequencies is related to the couch roll back bearing inner race defect. The frequency at 4913 cycles/min is the second multiple of the inner race defect frequency associated with the couch roll back bearing. There are also other frequencies that are modulated by the couch roll speed. The 4590 cycles/min frequency is associated with the second multiple of the inner race defect frequency of the lump breaker back bearing. Located within the fourth region is the third multiple of the couch roll back bearing inner race defect frequency. The differential between the other frequencies is the couch roll speed.

The presence of side bands around the bearing defect frequencies and multiples of defect frequencies indicates advancing deterioration into Stage 3 failure mode. Bearings in this failure mode generally have 2–5% of their  $L_{10}$  life remaining.<sup>1</sup> Stage 3 also has an elevated spike energy level associated with it. This analysis indicates that this bearing is nearing the end of its life.

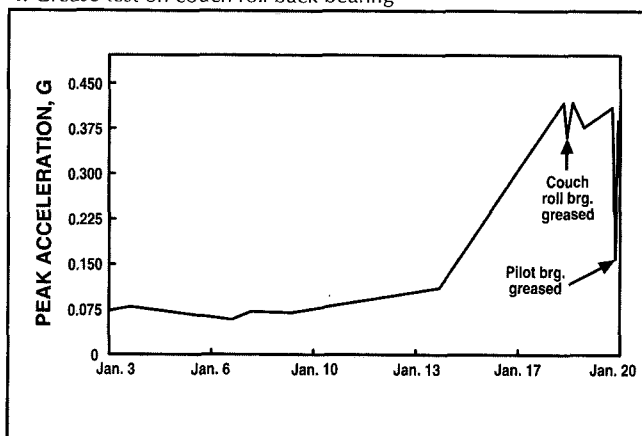
4. Grease test on couch roll back bearing

Adding a small amount of grease to the couch roll back bearing reduced the overall vibration for 1–2 hours, as shown in Fig. 4. During this period, the couch roll bearing temperatures increased, as expected. Collected spectra showed the continued presence of couch roll and lump breaker roll bearing defect frequencies identified earlier. Little change was noted as a result of this test, indicating that the effect of the grease was not within the spectral range being monitored.

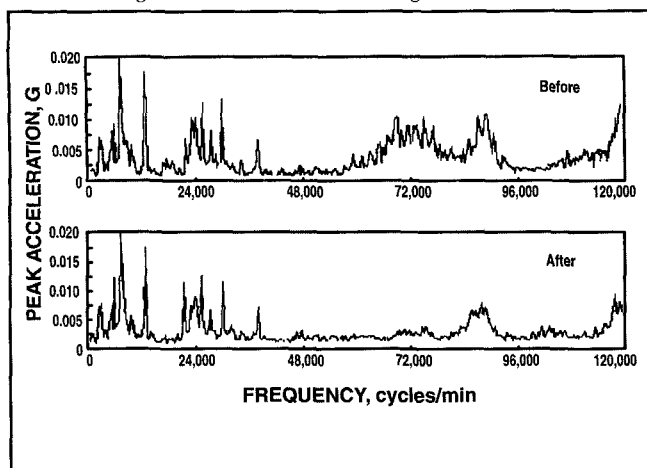
5. Pilot bearing evaluation before and after grease insertion

duction of 2 oz. of grease, at 0830 hours, into the pilot bearing on Jan. 20 is reflected by the data shown in Table I. A noticeable decline of the overall acceleration values along with slight decreases in the velocity and spike energy readings confirmed that the pilot bearing was responsible for much of the measured vibration levels.

Figure 5 shows the acceleration spectra collected before and after the grease insertion. The spectra reveal that a smaller "haystack" of frequencies, centered around 72,000 cycles/min, virtually disappeared after greasing and reappeared after a few hours of operation. This analysis also revealed a change at the upper limit of the acceleration frequency display (120,000 cycles/min), confirming that the frequency range required an increase. A very slight decrease in the velocity spectra was noted, with no additional frequencies developing as a result of this test. Spike energy levels decreased when the grease was injected and returned to original levels after several hours of operation.

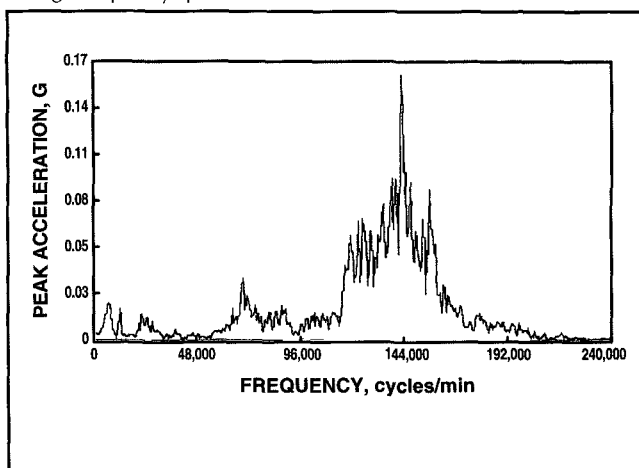
6. High-frequency spectrum

Increasing the acceleration spectra maximum frequency range revealed a large frequency "haystack" that was significantly reduced when the bearing was greased. Figure 6 shows the acceleration spectra collected before the couch roll pilot bearing was greased. After greasing the large haystack centered at 144,000 cycles/min was reduced to two small humps, with a maximum amplitude of 0.03 G, as the grease damped the high frequency vibration signals emanating from the pilot bearing.

Based on this information, the paper machine was stopped, and the couch roll pilot bearing was replaced. Visual inspection of the bearing revealed advanced spalling of the inner race in the load zone (see Fig. 7). The spall area, located in the first quarter of the load zone, was 1.5 in. long. Grease samples from the couch roll pilot bearing were sent for analysis, which revealed an iron content of 845 ppm, a copper content of 370 ppm, and a water content of 28%. This confirmed that major damage was present in the pilot bearing and that the grease quality was inadequate, permitting the bearing deterioration.

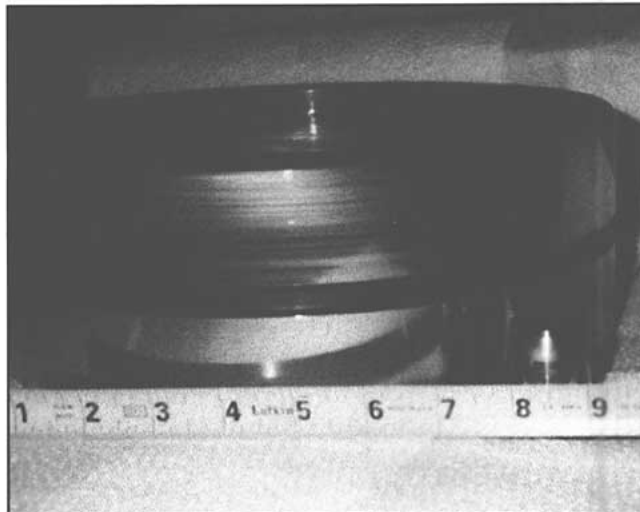
8. Polished outside diameter

The OD of the bearing was polished, indicating that the outer race had been spinning in its fit (see Fig. 8). The OD fit to the housing was -0.005 in. (loose) instead of +0.002 in. (tight) as specified by the bearing manufacturer. This fact probably accounts for the lack of bearing defect frequencies. Once a bearing spins within its fit, the defect calculations are no longer valid. Excessive roller-to-race clearance was found, and the outer race was rough due to fragment denting.<sup>2</sup> Additionally, significant wear was found at the outer edges of the inner race (see Fig. 9). This wear, along with the other wear identified, accounts for the high level of iron found in the grease. This was the result of the bearing cage rubbing the inner race.
