## Video surveillance troubleshooting at LSPI

**ABSTRACT:** *One of the first steps in improving paper machine runnability is to pinpoint where breaks are occurring.*

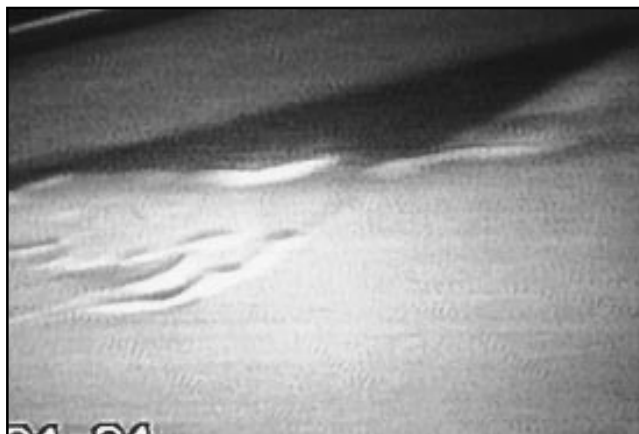
Figure 7 is a view of the bottom side of the pickup felt near the back edge. The figure shows the sheet dropping off the felt as it travels into the first press nip. Knowing where the sheet break occurred, the operating team washed the forming section well before attempting to rethread.

7. Bottom side of the pickup felt near the back edge

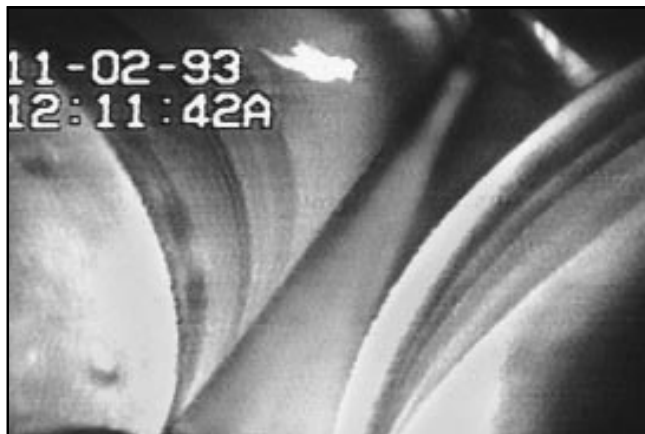
Breaks that are caused by inadequate cleanups are also captured with the video system. Figures 8–11 are from the drive side fourth press camera. In Fig. 8, a piece of broke that was not removed during a prior break's cleanup is seen traveling with the first dryer felt. The piece of broke is thrown off the felt and floats down (Figs. 9 and 10) until it contacts the paper in the transfer between the fourth press and first dryer section, causing a break (Fig. 11).

8. Piece of broke that was not removed during a prior break

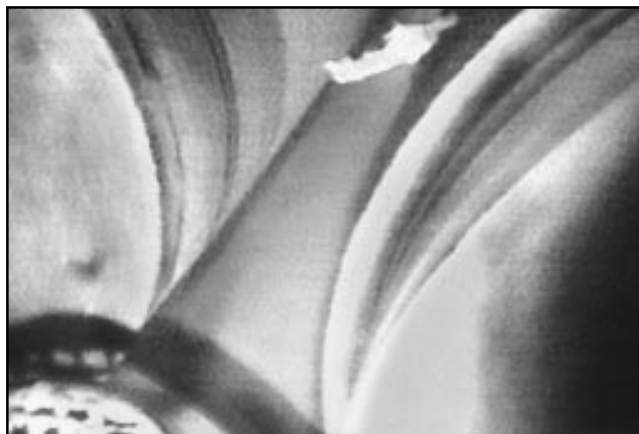
9. Broke is thrown off the felt

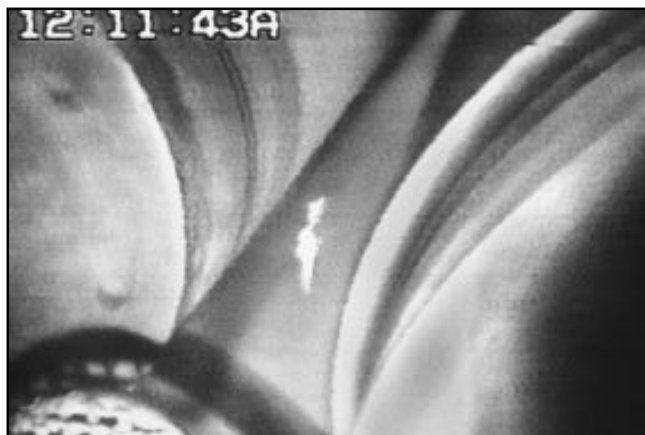
10. Broke contacts the paper between the fourth press and first dryer section

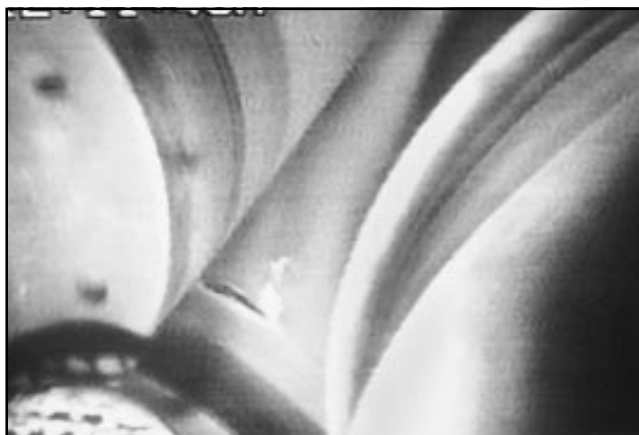
11. Broke causes paper break

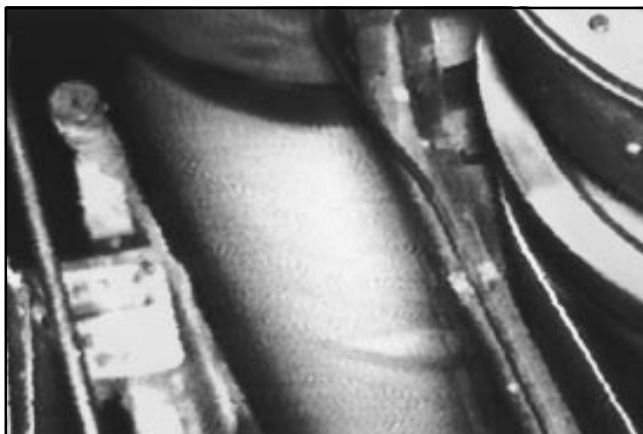
Figure 12 is from a camera in the press section. The paper is seen leaving the center granite roll and passing under the No. 1 paper pass roll. The apparent bubble/hole was observed on several other breaks that occurred over a one-week period. In an attempt to solve this recurring break, a trial was performed, which consisted of throwing small lumps of dewatered stock into the machine at various locations. When thrown into an area at the top wire, this material re-created the break (Fig. 13). A modification of the washup procedure eliminated this type of break. The results of this and similar trials proved beneficial in troubleshooting other breaks as well.

12. Paper leaving the center granite roll and passing under the No. 1 paper pass roll

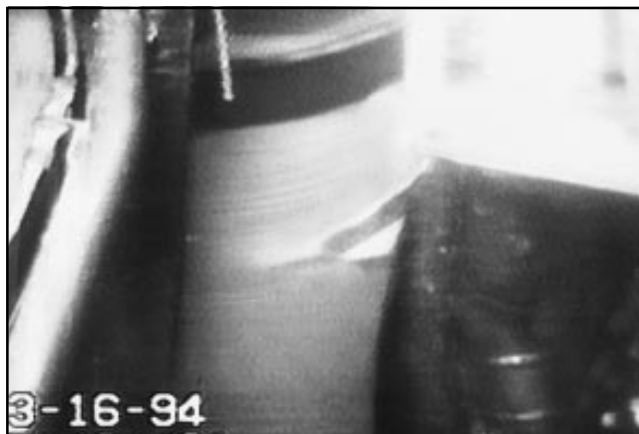
13. Stock thrown in the top wire area re-creates the break

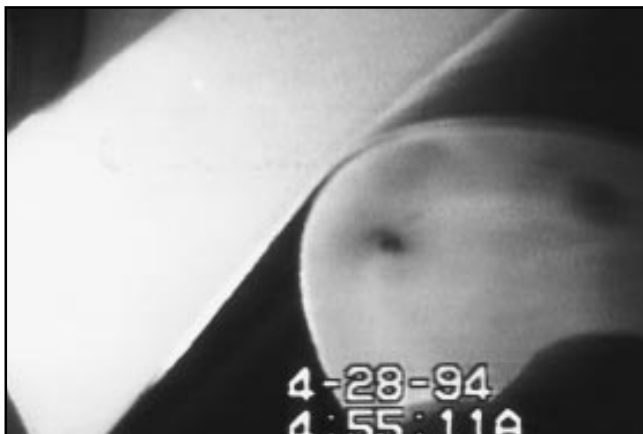
Sheet defects that caused breaks similar to that shown in Fig. 14 were also re-created. This figure shows the paper on the drive side of the center granite roll between the second and third press nips. A small white spot can be seen about 46 cm (18 in.) in from the sheet edge. This spot caused a break in the dryer sec-

14. Paper on the drive side of the center granite roll between the second and third press nips

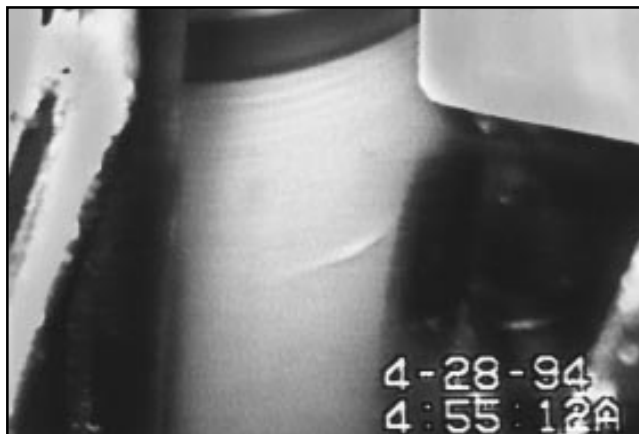
tion. Figure 15 is the re-created break caused by throwing stock onto the center granite roll after the doctor blades. Again a small white spot can be seen approximately 61 cm (24 in.) in from the sheet edge. This spot became the bubble shown in Fig. 16 and the break seen in Fig. 17. Figure 16 shows the lower side of the No. 1 paper pass roll between the center and fourth presses, and Fig. 17 shows the transfer between the second and third dryer sections. This evidence confirmed a suspected

problem that the center press doctor blades were not uniformly contacting the granite roll; they were occasionally allowing stock to leak past them.

15. Re-created break caused by throwing stock onto the center granite roll after the doctor blades

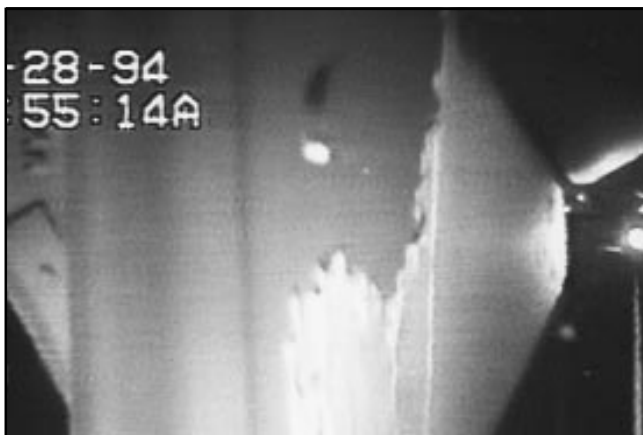
16. Bubble approximately 61 cm (24 in.) from the sheet edge

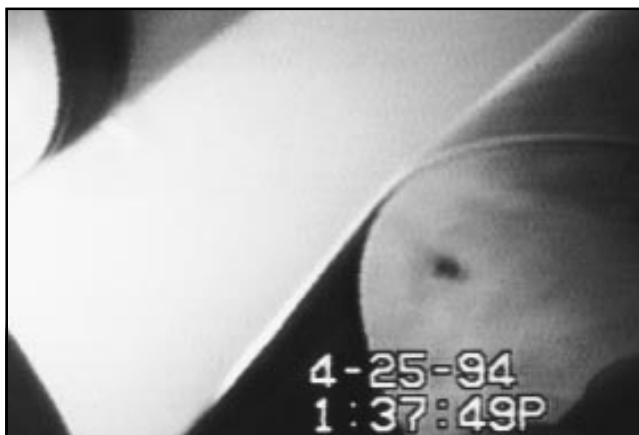
17. Bubble becomes paper break
