## Yankee dryer crevice corrosion evaluation

Ray E. Jostad

**ABSTRACT:** *A Yankee dryer was found to have crevice corrosion at the clamp fit of the head and shell flanges. The severity of this corrosion caused high stresses due to corrosion jacking forces. A replacement dryer was ordered. Nondestructive examinations (NDEs) were performed to track corrosion growth and verify Yankee dryer structural integrity during the last year of operation. These tests included head tilt, shell runout, acoustic emission, and ultrasound. After the dryer was replaced, further nondestructive examinations were conducted to augment the original NDEs. Finally, sections of the dryer head were cut out to validate nondestructive examinations. Investigations of two other Yankee dryers with the same problem are also discussed.*

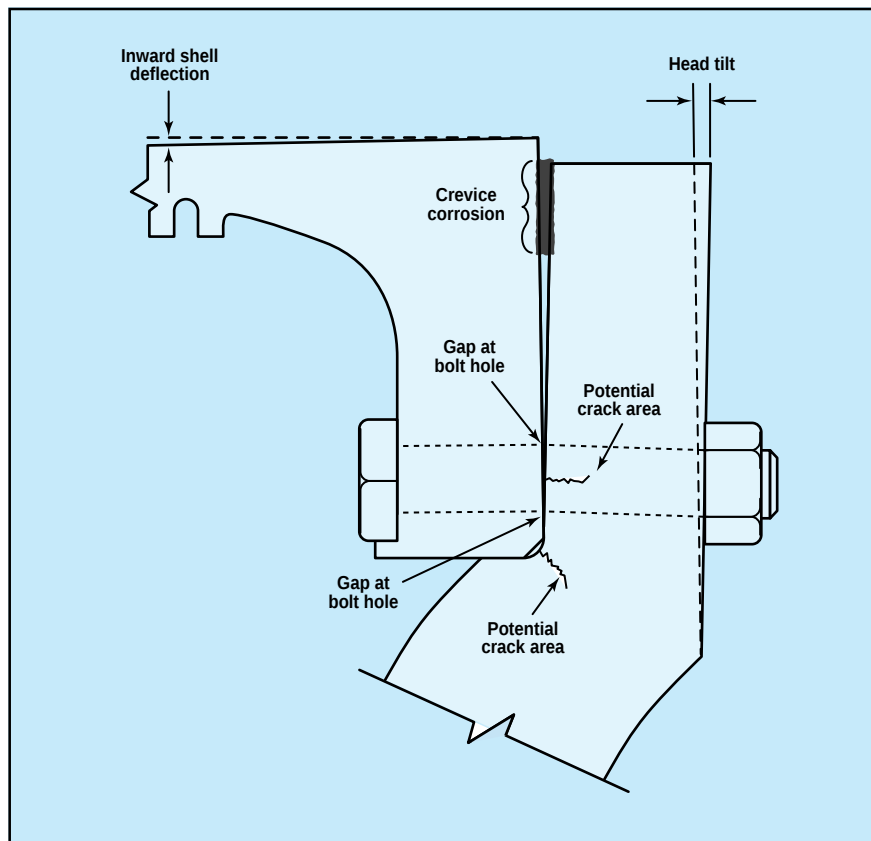
#### 1. Yankee crevice corrosion

Crevice corrosion occurs at the clamp fit of the head/shell flange interface of a Yankee dryer. Thermal stresses during the papermaking operation provide the forces that tend to create a small gap at the outside diameter of the head/shell fit. Corrosion then begins in this gap and grows in size, creating jacking forces which stress the head flange and, to a lesser degree, the shell flange. As the corrosion grows, stress increases and can crack the head flange when stress exceeds the rupture strength limits of the cast-iron flange.

An advanced stage of crevice corrosion was found on Yankee C. This report covers the NDE results during the last year of operation, and the nondestructive and destructive tests done after the dryer was removed from service. The results of this effort are: (a) NDE methods that can verify the structural integrity of a Yankee dryer and (b) methods to determine the severity of crevice corrosion in a Yankee dryer. **Figure 1** shows crevice corrosion and where it can cause head cracking.

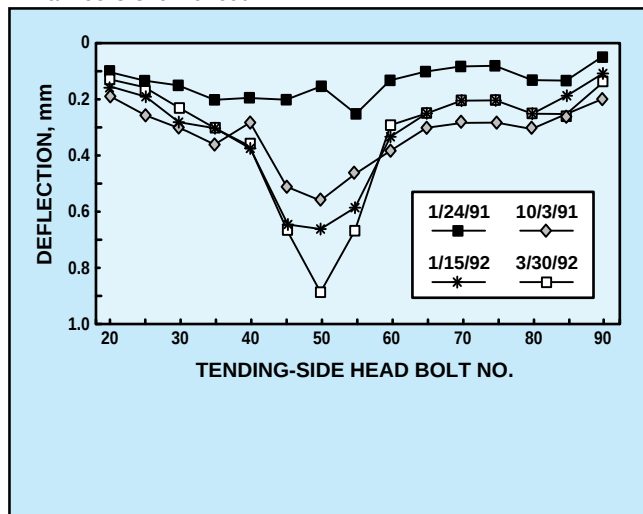
2. Yankee C shell runout

Shell runout measurements were taken at scheduled shutdowns. These tests showed an increasing shell deflection in areas of known, major crevice corrosion (**Fig. 2**). Instructions were given to "lock the steam valve" if the shell deflection changed direction, since this would indicate a weakening of structural integrity of the head.

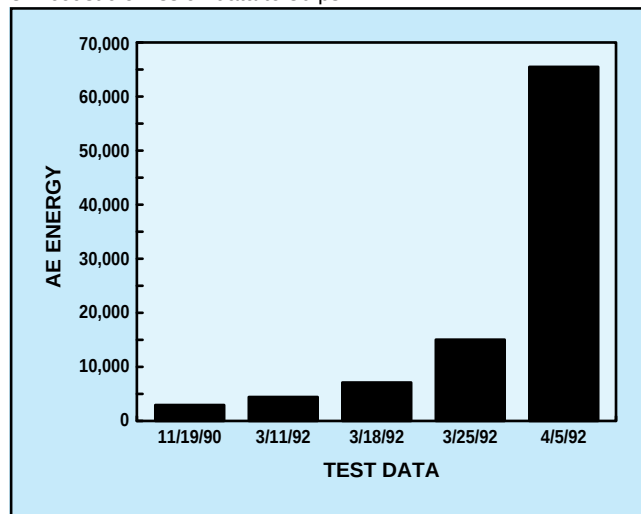
3. Acoustic emission data to 80 psi

Several AE tests were taken during the last few months of operation. These indicated more activity than a new dryer but did not indicate a loss of structural integrity. The last AE test was taken at the final operating shutdown for Yankee C. Results of this investigation showed AE activity had increased to a level of con-

cern. Results of AE tests on Yankee C are shown in **Fig. 3**.
