# Hydrostatic testing of Yankee dryers

Bengt Unneberg

**ABSTRACT:** *The hydrostatic pressure testing of a Yankee dryer is performed as a fitness-for-service test made before delivery of the Yankee. In some countries, there are also statutory requirements for on-site hydrostatic testing after the delivery, as well as periodic testing of the cylinder during its lifetime. Hydrostatic pressure testing is discussed, and the particular case of a Yankee dryer failure during on-site hydrostatic testing is described.*

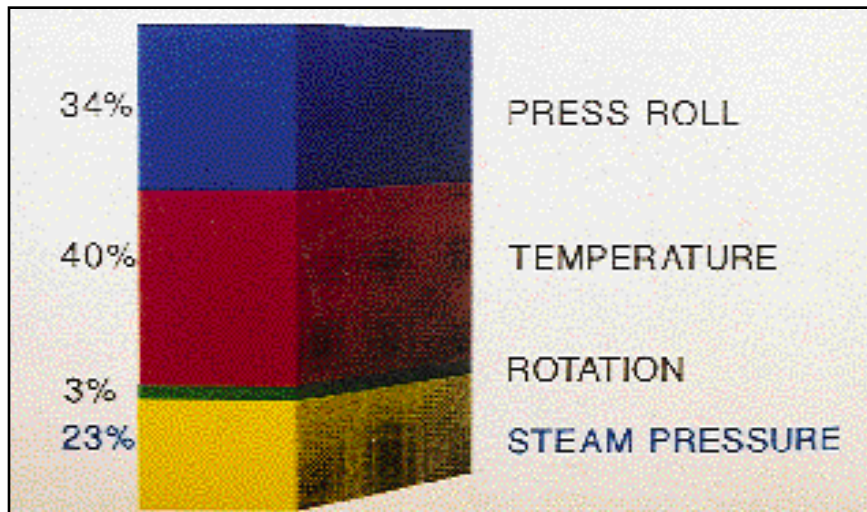
1. Yankee loads

with the linear load from one or two press rolls. In Fig. 1, the relative magnitude of these loads can be seen. In this case, the load from internal pressure is only 23% of the total load.

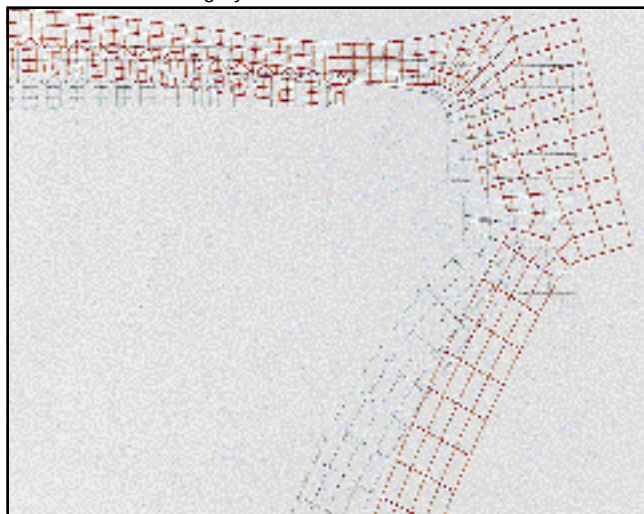
2. Deformation during hydrostatic test

Figure 2 illustrates the deformation of the Yankee dryer during the hydrostatic test, which means deformation from internal pressure only. This load causes a bending moment in the shell and head flange area that attempts to increase the angle between these parts at the flange interface.

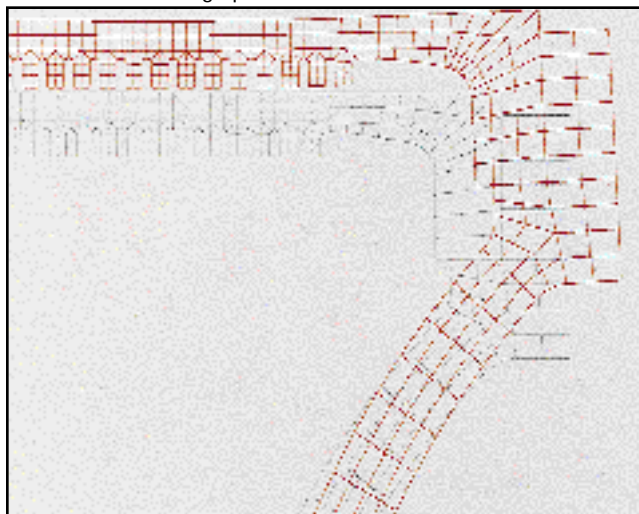
3. Deformation during operation

Figure 3 illustrates the deformation of the Yankee dryer during op-

erating conditions. The significant deformation here is the thermal deformation caused by the wet sheet on the shell surface. This reduces the diameter and length of the shell and causes a bending moment in the flange corner that decreases the angle between the shell and head at the flange interface.

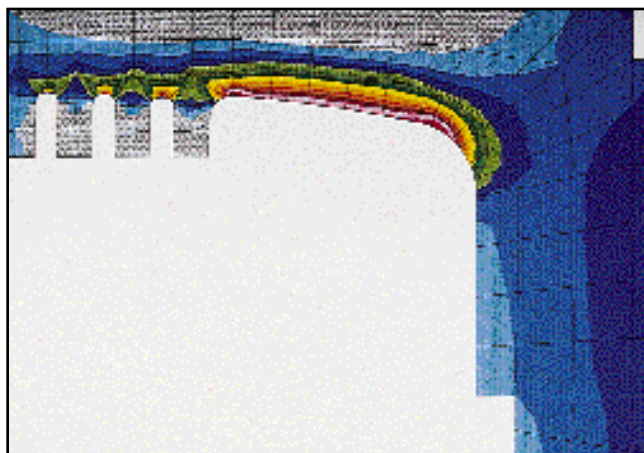
4. Stresses during hydrostatic test

Figures 4 and 5 provide two plots of the maximum principal stress in the flange area, with the hydrostatic test condition shown in Fig. 4 and the running condition in Fig. 5. The dark areas in these plots indicate high stresses.

These plots clearly show that the stress distribution is quite different for these two scenarios. During hydrostatic testing, the high stresses are located on the inside of the shell flange and extend into a region around the first grooves for a ribbed dryer. For the operating condition, the stresses in this area are very low and mostly compressive. The high tensile stresses are, in this case, found on the outside of the shell. This is an effect of the thermal stress, caused by the temperature difference through the shell wall, that creates a bending stress in the shell with compressive stresses on the inside and tensile stresses on the outside.

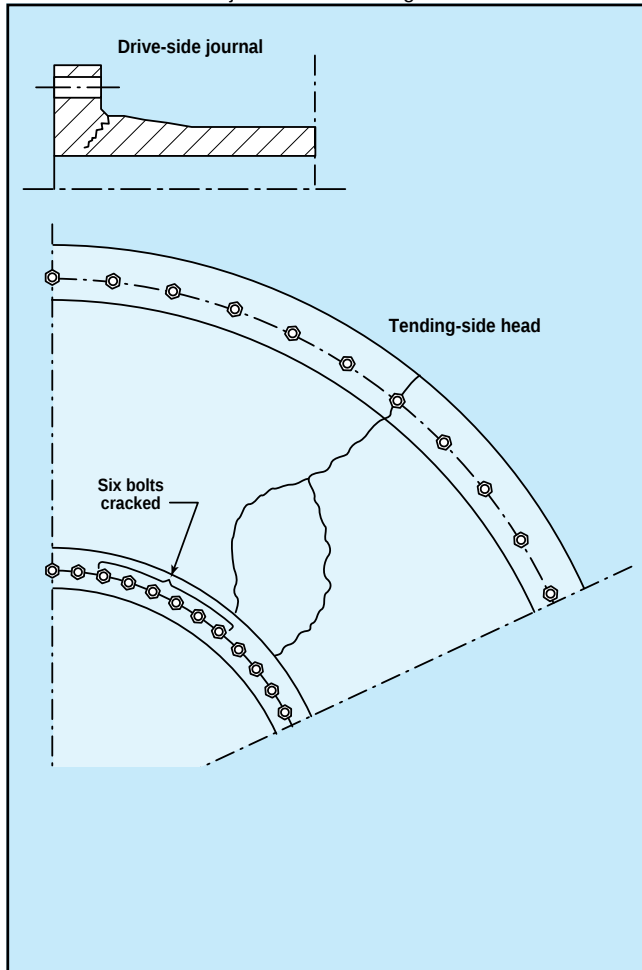
6. Cracks in drive-side journal and tending-side head

- Drive-side journal cracked at inner flange radius
- Six journal-to-head bolts broken on tending side
- Radial cracks at Bolt 135 on tending-side head
- Crack across shell at Bolt 135
- Circumferential crack in tending side at second groove
- Circumferential crack in drive side at first groove.

This list is written in the probable order in which the cracks developed. It suggests that the initial crack probably occurred in the center flange, followed by the heads being pushed

**Figure 6** shows the position of the crack in the center flange, also a very highly stressed area during a hydrostatic test, and the cracks in the tending-side head.

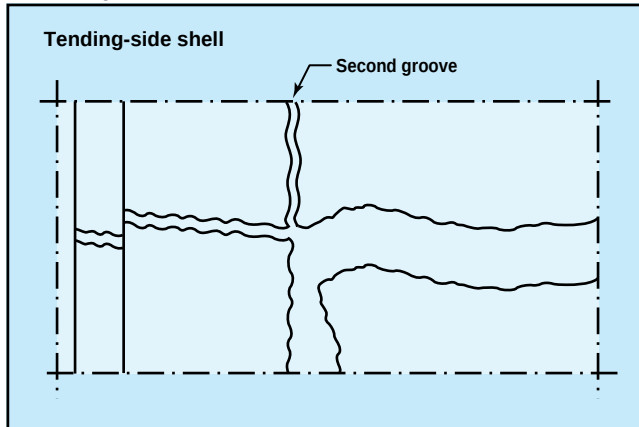
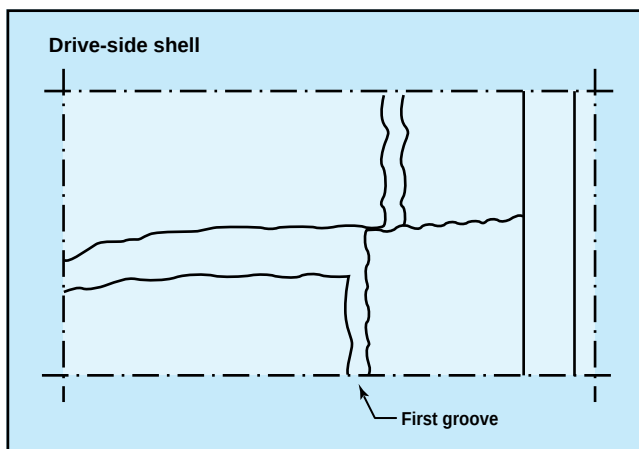
out and the breaking of the journal-to-head bolts. From this point, radial cracks progressed in the head out to the shell flange, where the axial crack started and progressed over the full width of the cylinder. From this axial crack, the two circumferential cracks were initiated. These cracks started close to the outer grooves in the shell that is, as shown earlier, one of the areas of highest stress during a hydrostatic test.

**Figures 7 and 8** show the crack pattern in the tending side and the drive side of the shell.
