# Mechanism and prevention of localized corrosion of recovery boiler tubes at air ports

Lad Falat

**ABSTRACT:** *This work studied the localized thinning of the stainless layer of composite tubes at air port openings in two large 1500-psi recovery boilers. Weld overlay repair patches of nickel applied to corroding areas on air port tubes survived less than six months of operation. This suggests that a previously presented sodium hydroxide mechanism is not sufficient to explain the localized thinning. Corrosion by molten flowing smelt in direct contact with the tube surface is an alternate mechanism that is consistent with experimental observations. Air port redesign to minimize the localized loss of a protective frozen smelt layer is a promising long term preventive measure.*

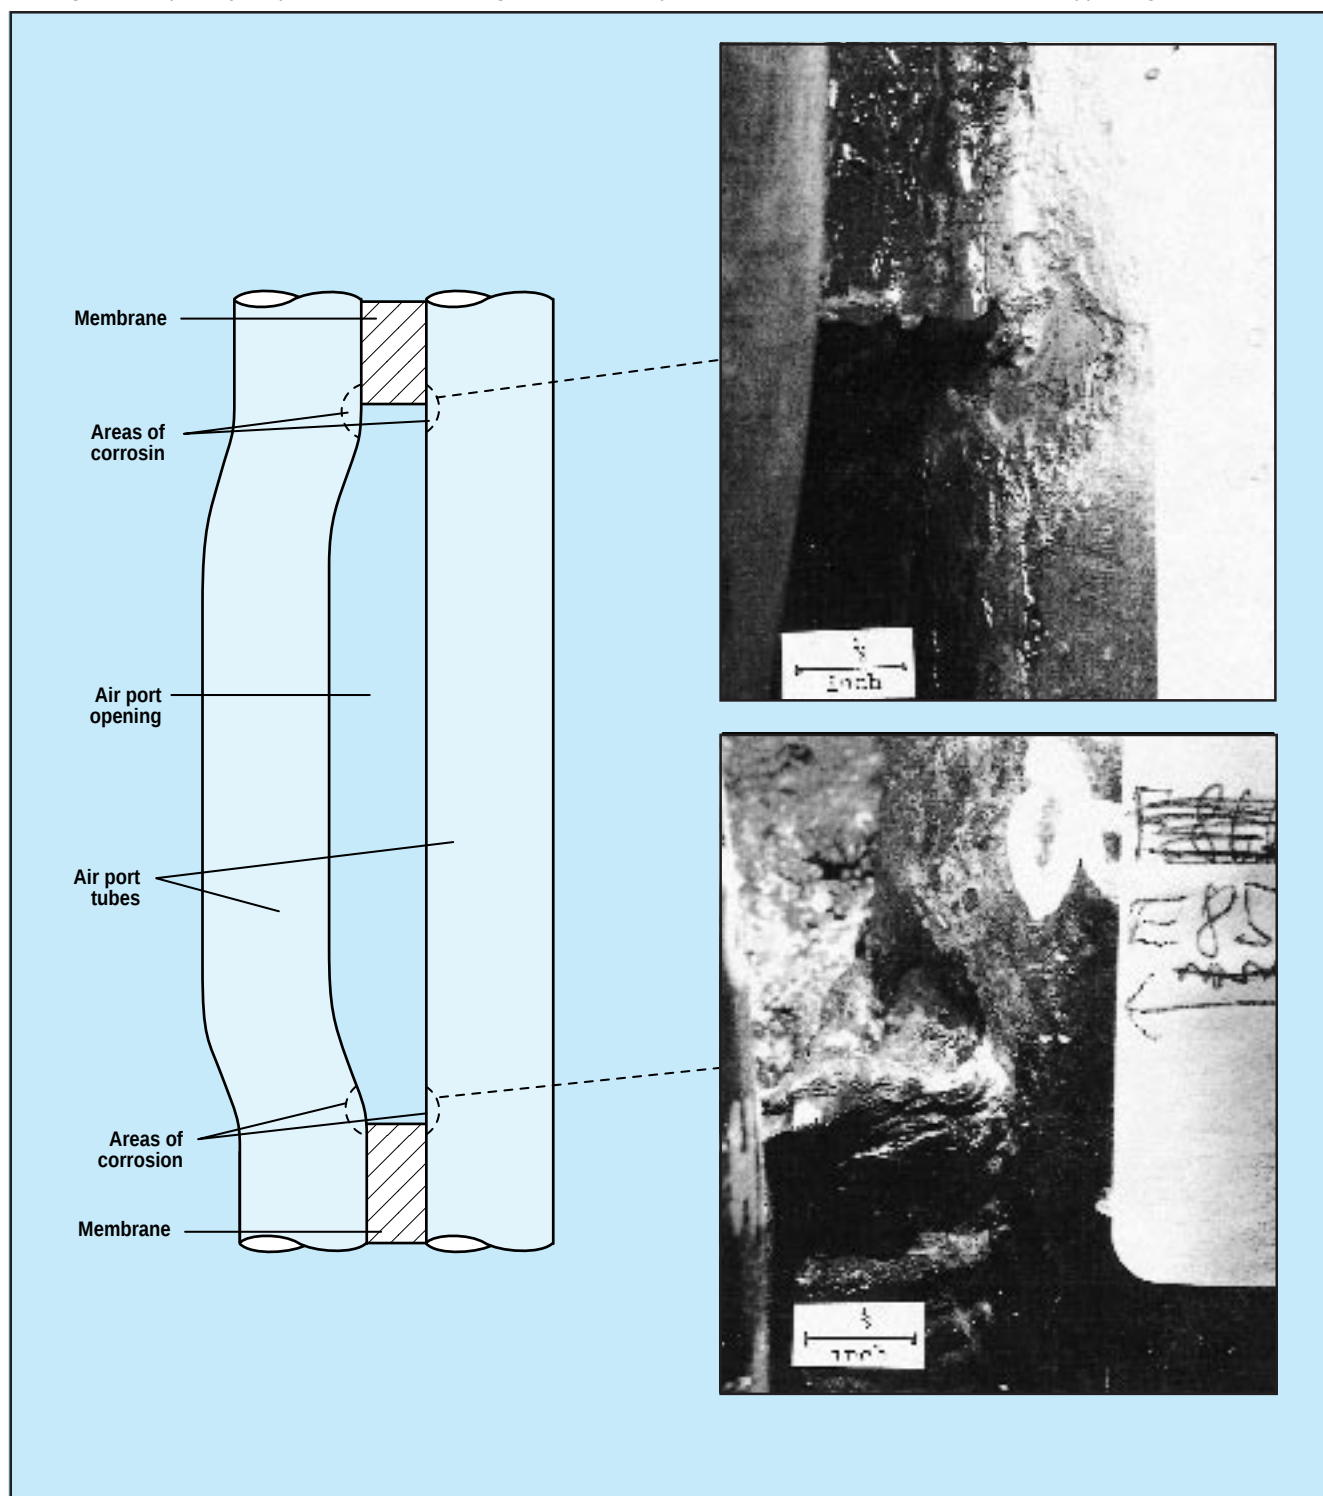
1. Diagram of a primary air port in Boiler A showing location of composite tube corrosion with corroded tubes appearing in inserts

The localized thinning of the 304L composite layer on tubes in Boiler A occurred at the top and bottom of

port openings indicated in **Fig. 1**. The thinning resulted equally toward the fireside and the casing side of the tube. Thinning of the carbon steel substrate after the outer 304L layer had corroded away was not measurable. It is necessary to qualify the observation by the fact that the corroded areas were weld overlayed before the exposed carbon steel reached one square inch. The exposure time of the carbon steel was therefore subject to a limitation. While thinning of the stainless layer occurred on tubes of many air ports, tubes at some adjacent air ports remained unaffected. On many primary air port tubes, thinning occurred at the top and at the bottom of the port opening. Some primary port tubes showed thinning only at the top or the bottom. Significant thinning in Boiler A occurred at the bottom of only the primary air ports and at the tops of the primary and secondary air ports and some inspection ports. The spout wall and one side wall had the highest numbers of affected tubes. Although the other two walls did not have as many corroded air port tubes, the severity or rate of thinning on individual tubes did not relate to location.

The corroding areas on tubes in Boiler A had one common feature. Corrosion occurred where reduced smelt flowing down the tube or membrane contacted air. This occurred at the top of primary and secondary air ports, the bottom of the primary air ports (corresponding to the smelt line), and at the bottom of one sec-

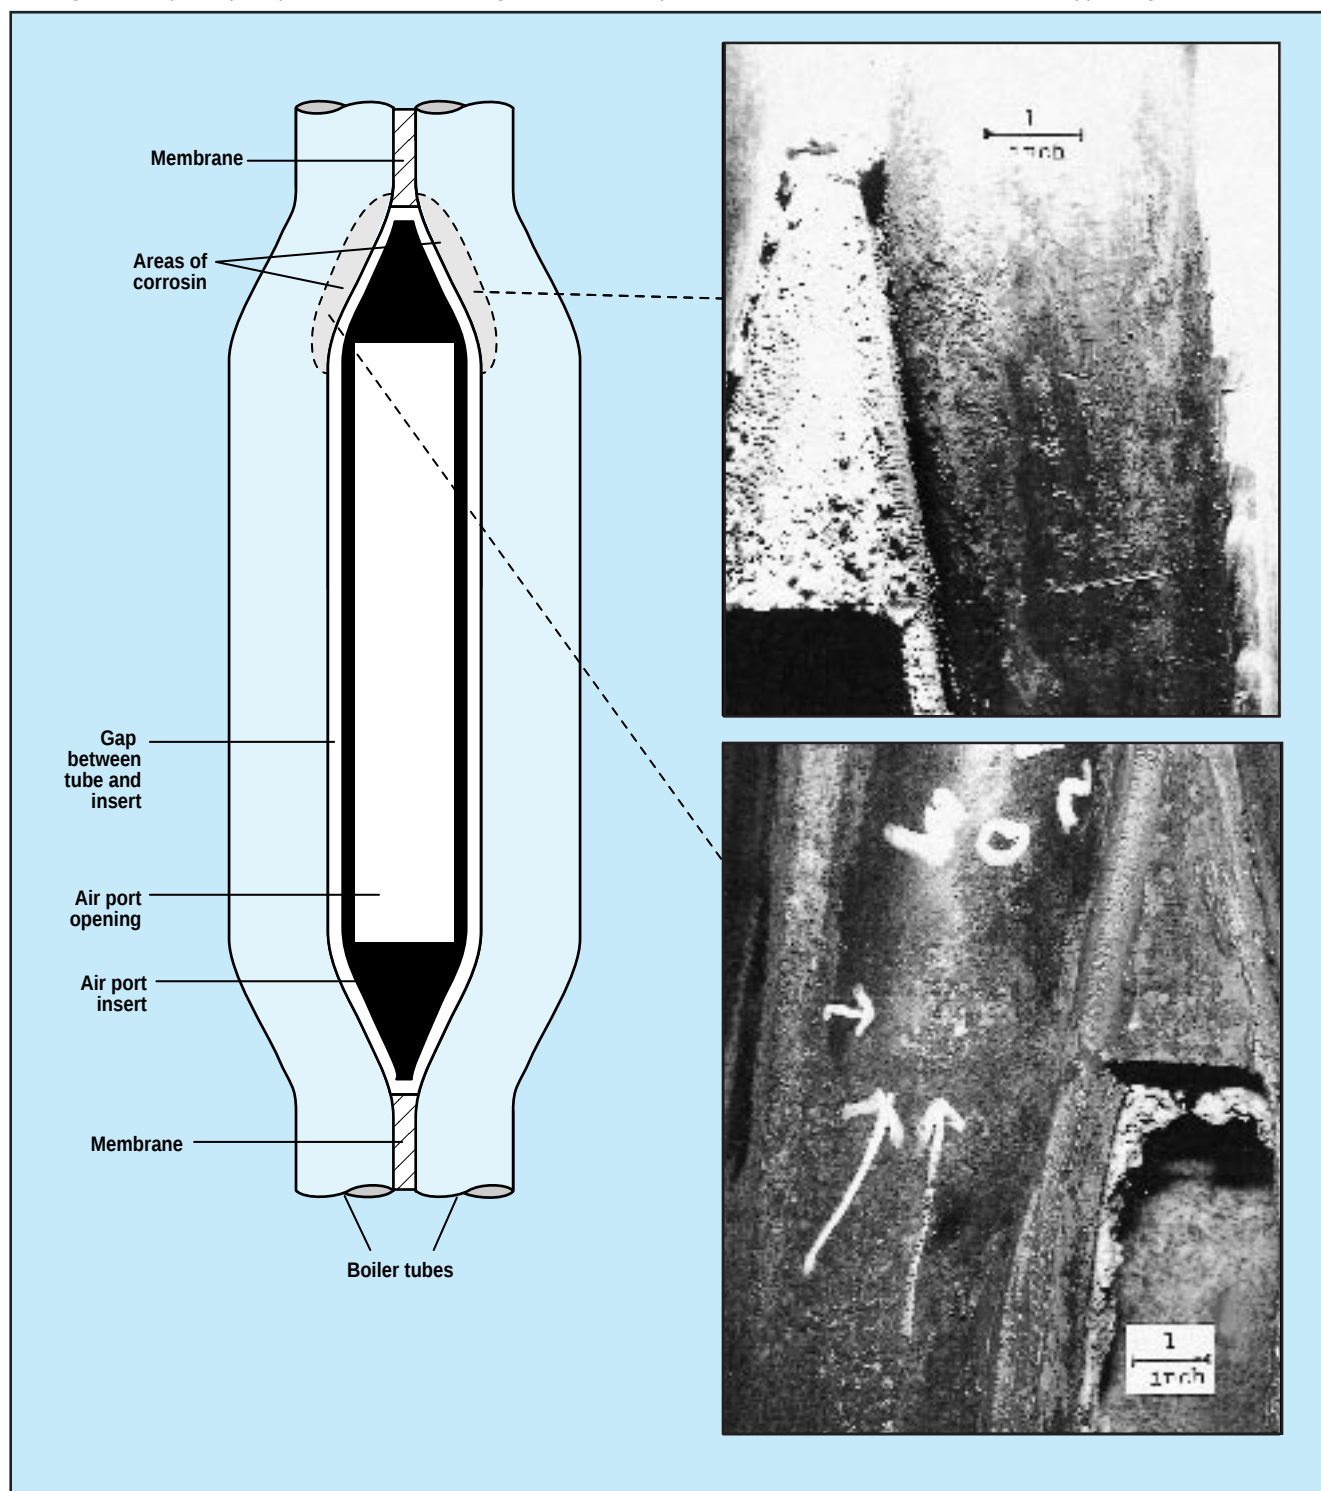
2. Diagram of a primary air port in Boiler B showing location of composite tube corrosion with corroded tubes appearing in inserts

Thinning of the stainless layer on air port tubes in Boiler B occurred only toward the fireside as **Fig. 2** shows. This boiler has air port inserts. Minor attack occurred opposite the corners of the rectangular port insert openings as the figure shows. There was no clear correlation between thinning rate and wall position in this boiler.

ondary air port with much less severity. Tertiary air ports at an elevation above the liquor guns did not experience an effect because much less smelt or liquor exists on the tubes at this elevation. Figure 2 shows discolorations and surface roughening indicative of the initial stages of this type of tube corrosion near the corners of the air port inserts in Boiler B.

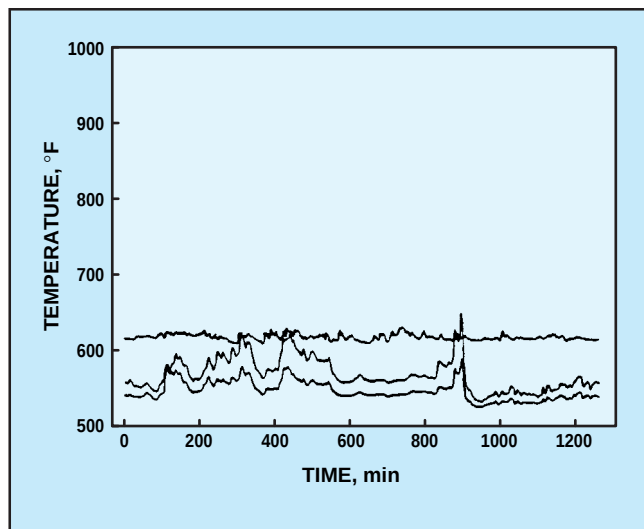
3. Representative temperature vs. time plots for thermocouples welded on a corroded composite air port tube surface in the recovery boiler showing a period of relative temperature stability

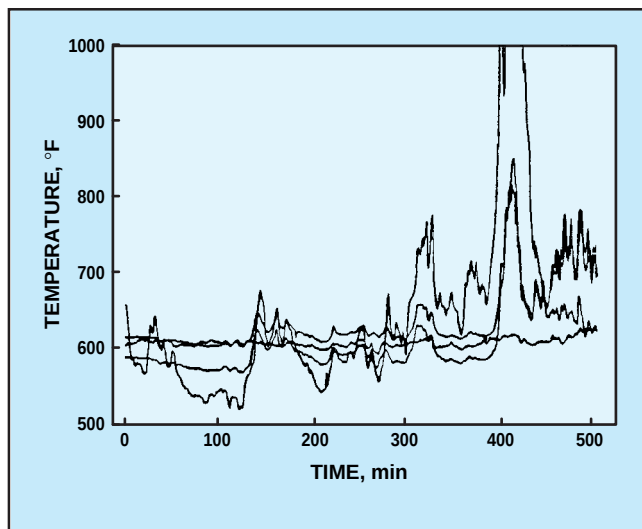
4. Representative temperature vs. time plots for thermocouples welded on a corroded composite air port tube surface in the recovery boiler showing large temperature excursions

Initial measurement of boiler tube surface temperatures on dozens of air ports in Boiler A used a specially designed contact probe. Temperatures substantially above the saturation steam temperature or approximately 600°F for 1500 psi steam were measured with intermittent excursion above 900°F. Measurements at the bottom of the primary ports indicated that molten and burning smelt was contacting the temperature probe and the tube surface. Ten 1/8 in. diameter Inconel 600 sheathed thermocouples were subsequently welded to the tube surface in four primary air ports in Boiler A. The thermocouples were welded to the upper and lower corners of the air port opening where corrosion was taking place. Nine of the thermocouples provided data for several months. **Figures 3 and 4** show that tube surface temperature generally varied between 500–700°F with excursions up to 1100°F lasting up to 60 min. Each trace represents data from one thermocouple. The excursions were presumably caused by molten and burning smelt in direct contact with both the thermocouple and the tube surface. Periodic manual rodding of the bare tube surfaces in this boiler would likely ease the melting of the insulating layer of frozen smelt. The observed temperature excursions several hundred degrees above the steam saturation temperatures allow consideration of corrosion mechanisms other than the one based on hydroxide condensation.

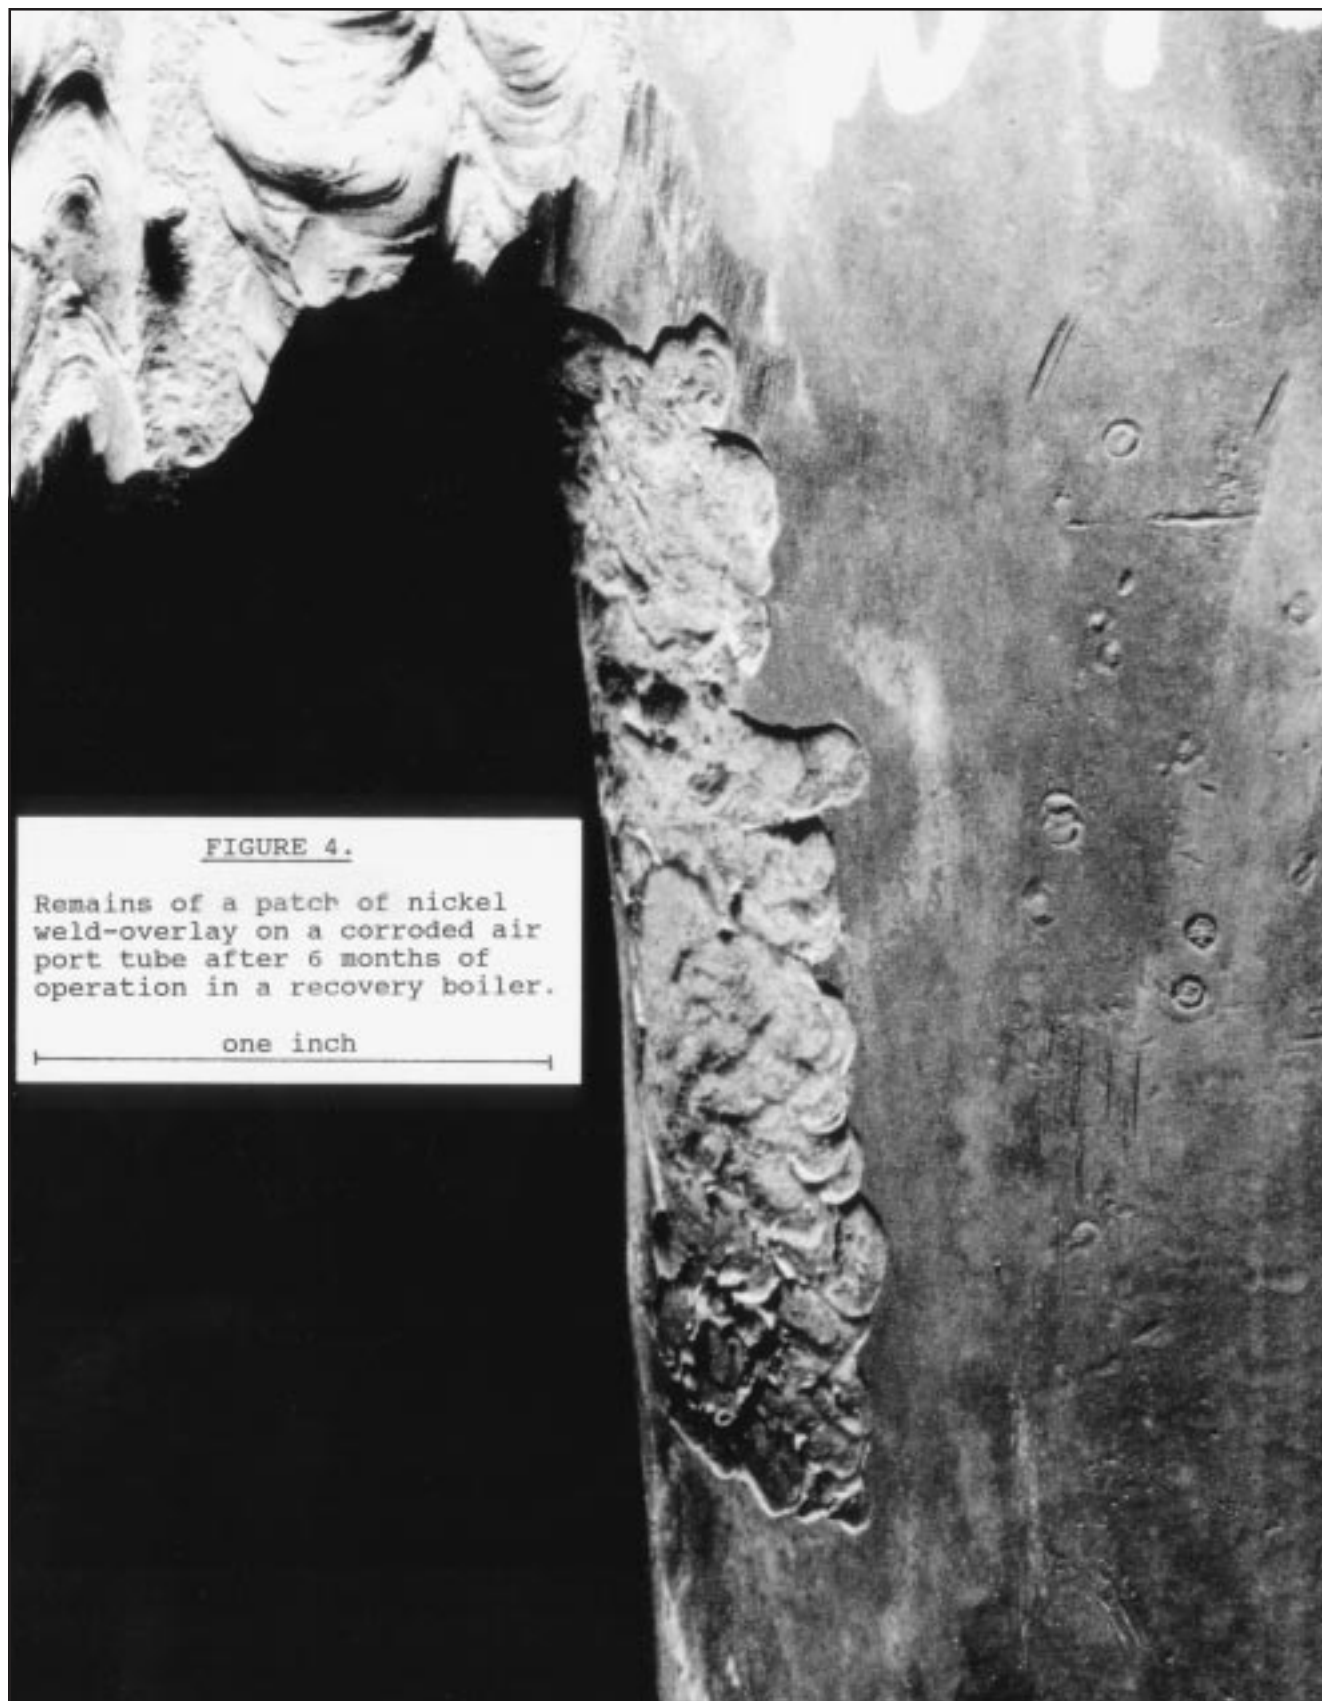
Several 309L repairs in Boiler A were weld-overlayed with patches of nickel. After less than seven months of service, the nickel patches were preferentially consumed to the fusion boundary with the 309L as **Fig. 5** shows.

5. Remains of a patch of nickel weld overlay on a corroded air port tube after six months of operation in a recovery boiler
