# In-plant corrosion testing in chlorine dioxide environments

Johan Nordström and Arne Bergquist

**ABSTRACT:** *Welded coupons of stainless steels, nickel-base alloys, and titanium were exposed in process equipment used to produce or to bleach with chlorine dioxide. Test locations included tanks for spent acid from chlorine dioxide production, bleach-plant scrubbers, bleaching tower inlets, and bleach washers. The results of ten exposures are discussed in connection with descriptions of the process environments. All tested alloys—except for titanium and stainless steel S32654—suffered corrosion in at least one test environment.*

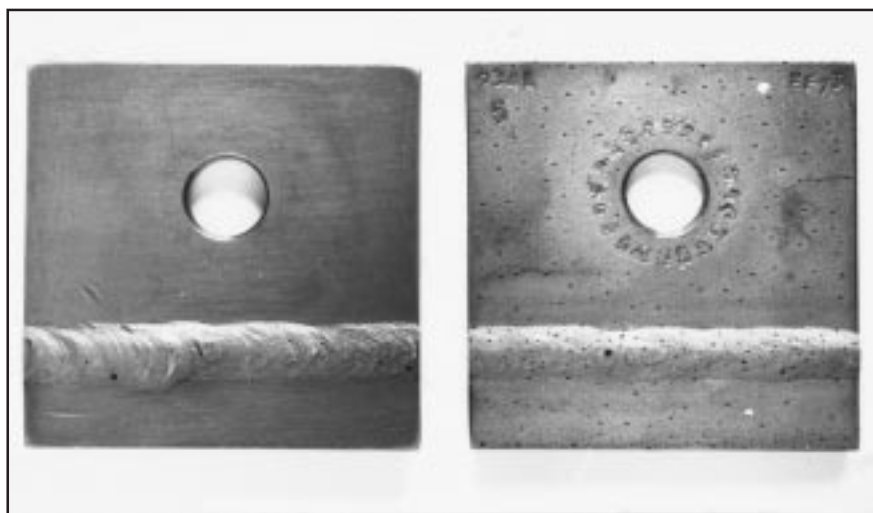
#### 2. Two samples from Rack 1—stainless steels S32750 and N08904

After 138 days of testing, only two of the stainless steels were attacked. Stainless steel N08904 suffered severe localized corrosion, and stainless steel S32750 exhibited pitting in the weld, as seen in **Fig. 2**. No sign of corrosion was found on the stainless steels S31254 and S32654 nor on the nickel-base alloys or the titanium specimen. More detailed results are presented in **Table IV**.

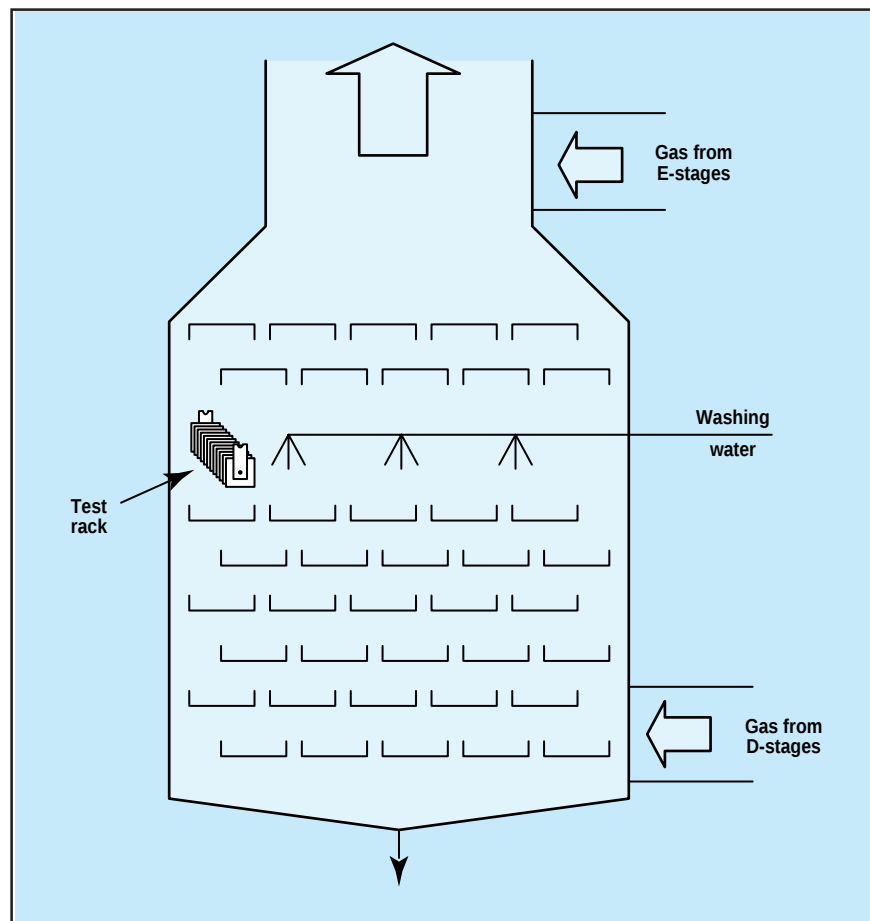
### 3. Location of Rack 5 in bleach-plant scrubber

Rack 5 was placed inside the bleach-plant scrubber at another pulp mill, as shown in **Fig. 3**. This

the droplet separators. However, some influence from the alkaline washing water (pH 10.8)—basically tap water with additions of NaOH and SO<sub>2</sub>—cannot be excluded. After 138 days, stainless steel N08904 had one perforating attack starting in the drilled hole, but there was no attack of higher alloyed grades, as seen in **Table VIII**.

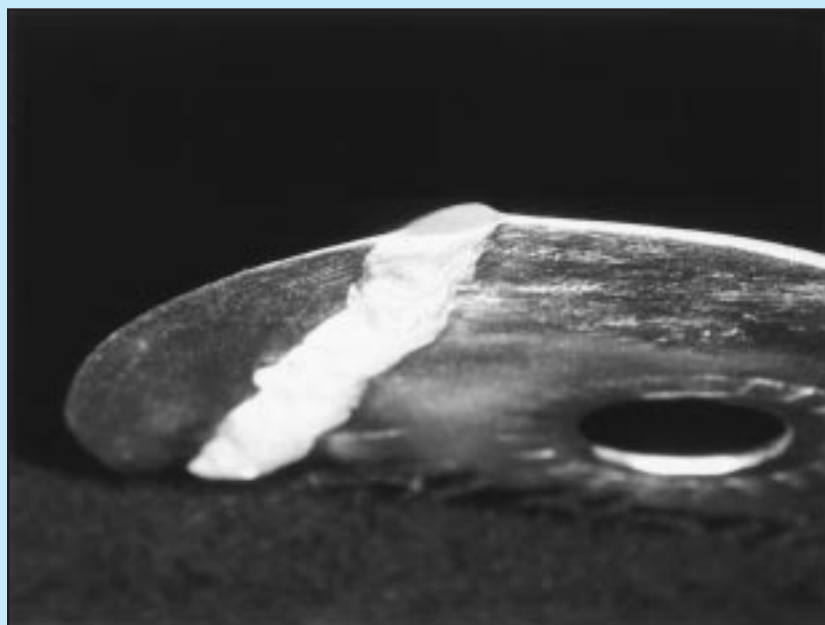
4. Alloy N06022 from Rack 6, bleach tower inlet. The edge of the circular coupon is shown in the upper foreground, and the most corroded area is to the left.

nickel-base alloys. **Figure 4** shows the N06022 coupon, the thickness of which locally had been reduced from 2.0 mm to 0.3 mm during one year. Stainless steels S32654 and S32750 and titanium were the only grades without any attack, as seen in **Table X**.

All of the nickel-base alloys in Rack 6 were severely attacked by uniform corrosion. Titanium was completely resistant, as were S32750 and S32654, while S31254 suffered uniform corrosion in a weld defect. The samples in Rack 7 also lost some weight, but the corrosion rates were negligible, and the alloys can be regarded as resistant.
