## Characterization and evaluation of microbiologically induced corrosion on water heating networks

Ernesto S. Zumelzu and Ricardo Silva

This study characterizes and evaluates MIC under simulated conditions in a medium derived from a water heating network of a forestry processing plant. It uses observations by electron microscopy to assess bacterial populations.

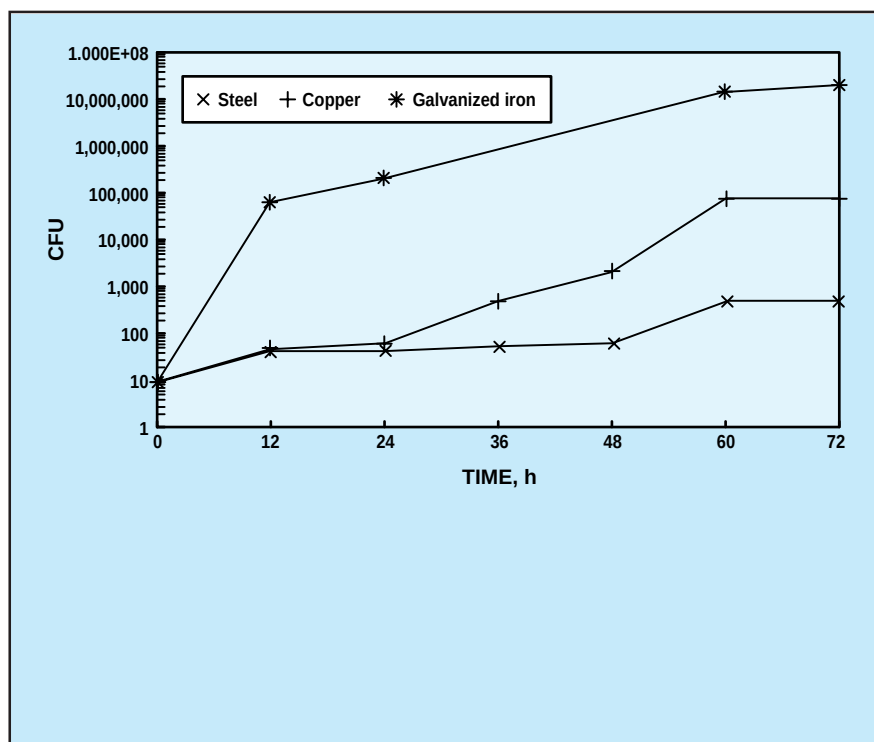
1. Bacterial growth over time on galvanized iron, copper, and steel

**Figure 1** shows the growth of the total bacterial population in water measured as a colony forming unit per mL per unit of time (CFU) for the immersed materials. The amount of biofilm and superficial tubercles observed by SEM show that the galvanized iron had a higher and faster bacteriological growth than copper and stainless steel.

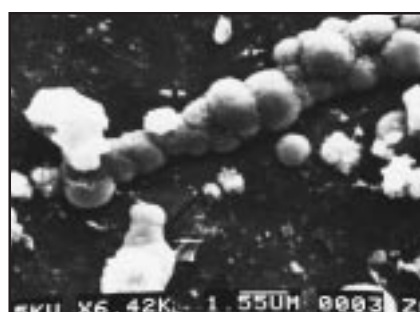
3. Morphology of bacterial forming rods in the surface, 6420X SEM

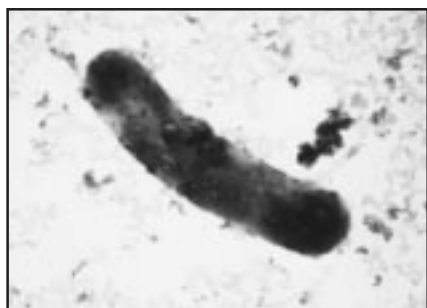
4. Shape of a single bacterium between the nodule layers, 22,000X TEM

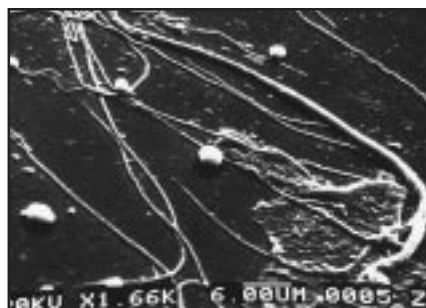
5. Filamentous bacteria over the nodule surface, 1660X SEM

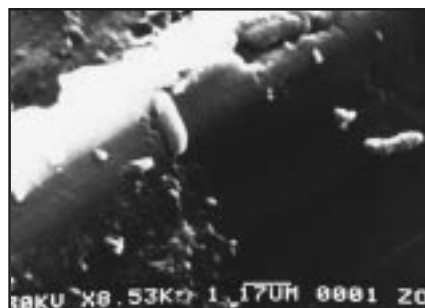
6. Curve-shaped organisms on the nodule surface, 8300X SEM

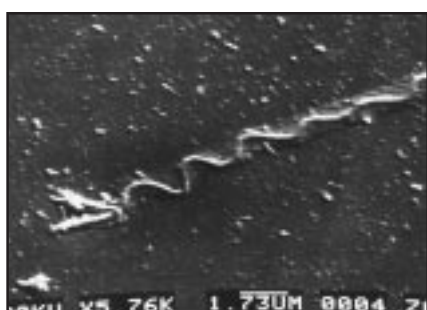
7. Morphology of a spherical-shape bacteria on the nodule surface, 5760X SEM

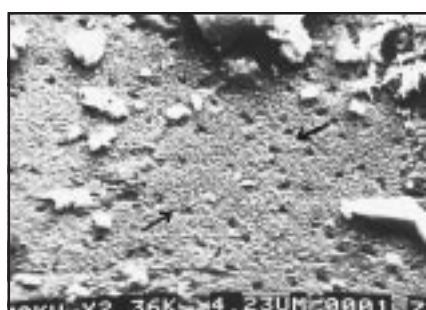
8. Tunnel formation in nodules over galvanized iron, 2360X SEM

**Figure 8** shows the formation of cracks in the surface of nodules with average diameters of 1  $\mu\text{m}$  (dark spots) covering galvanized iron and the colonized bacteria under it. **Figure 9** provides the details of a superficial tunnel in the stainless steel nodules (middle left area). This phenomenon occurs with localized metabolic processes that induce concomitant corrosion processes. The iron oxidizing bacteria can apparently detect the presence of ferrous ions formed from the corrosion of steel. They catalyze the reaction of ferrous ions with water-dissolved oxygen to form ferric oxide. The  $\text{Fe}_3\text{O}_4$  that they excrete is insoluble in water. It combines with organic matter to form a layer or tubercle over the source of ferrous ions. This tubercle is a deposit that favors cor-

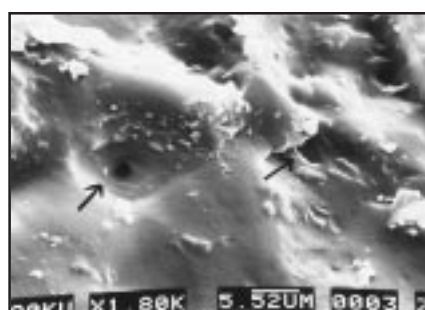
9. Tunnel detail in nodule over stainless steel, 1800X SEM

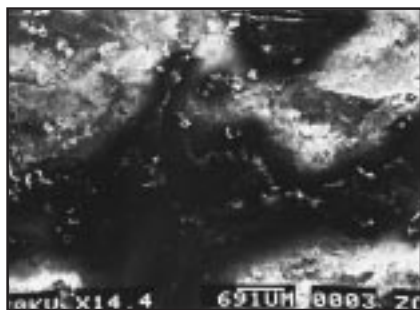
10. Surface morphology of galvanized iron, 14.4X SEM

The samples having nodules or slime formation with bacteria present underwent cleaning with ultrasound to characterize and evaluate the superficial damage of the material by SEM. **Figure 10** shows the galvanized iron surface free of tubercles. There are different states of iron oxidation and selective damage (dark zone). This occurs because the nodules and the associated microbiological activities create conditions for the ions to concentrate mainly in or under the nodules. Such conditions can promote the oxidation of ferrous iron to ferric iron. Then the need for neutralizing charges results in the accumulation of chloride ion in the nodule or crevice region.

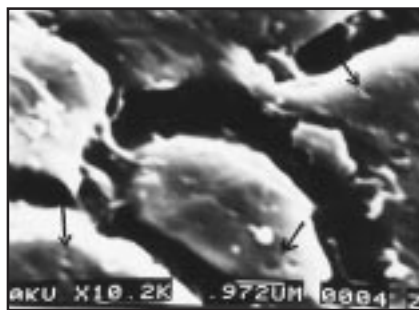
11. Details of small pits (round spot) in grains under nodules, 10,200X SEM

**Figure 11** shows the MIC effect on the surface of the stainless steel after removal of the nodule deposit to evaluate the presence of micropitting. The nodules showed small entrance points. These led to a large cavity under the surface. The austenite phase had more severe attack than the ferric one. In addition, the X-ray dispersive energy mi-

croanalysis suggested the formation of iron sulfide layers that are responsible for the formation of the tubercle.

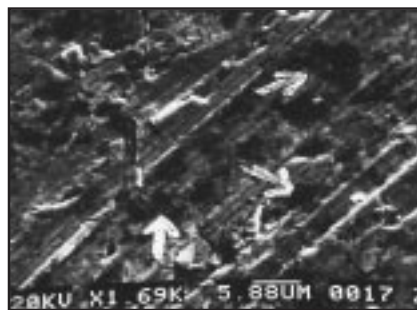
12. Surface morphology of nodule-free copper, 1690X SEM

For copper samples, **Fig. 12** shows the presence of localized attack (dark areas) to the surface morphology. This remains after the removal of the tubercle or nodule.

The most frequent attack produced by MIC in copper is type I (6). A characteristic of this attack is a shallow cavity with green precipitate. This is similar to the action of medium and high hardness water containing a high concentration of sulfate—the electrolyte in this study. The type I mechanism is pitting corrosion that always has a green or bluish green covering of corrosion products that are mostly malachite (6). A copper oxide layer acting as a membrane completely covers the area of superficial attack.
