# ROOT CAUSES OF RECOVERY BOILER LEAKS

JULES GOMMI

***A REVIEW OF RECOVERY-BOILER LEAKS OVER THE PAST DECADE  
REVEALS SOME INTERESTING TRENDS AND HIGHLIGHTS AREAS OF SPECIAL CONCERN***

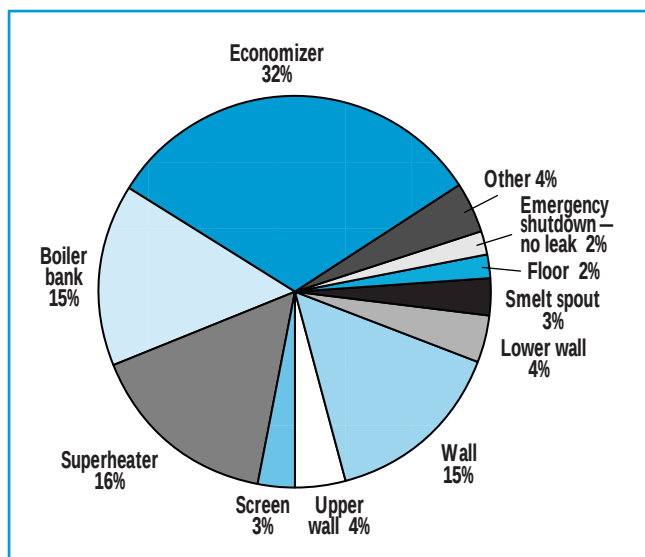
1. Location of leaks

The first look at the data shows where the incidents are located. **Figure 1** follows the recovery unit flow from the

floor to the economizer. Most incidents are associated with pressure parts. The “other” classification includes dissolving tank, burners, feed pipes, chemical line, desuperheaters, valves, etc.

The major finding here is the large number of leaks associated with economizers—one-third of all reported cases of hazard-caused shutdowns. It is likely that this is also the component most often not reported, since many consider economizer leaks to be nonhazardous. If economizer leaks are indeed underreported, then the effect of economizer leaks on boiler reliability is even greater than the data suggest. The data show no particular trend by manufacturer; the results are about evenly divided. However, 13,000 hours of unit downtime are associated with this component.

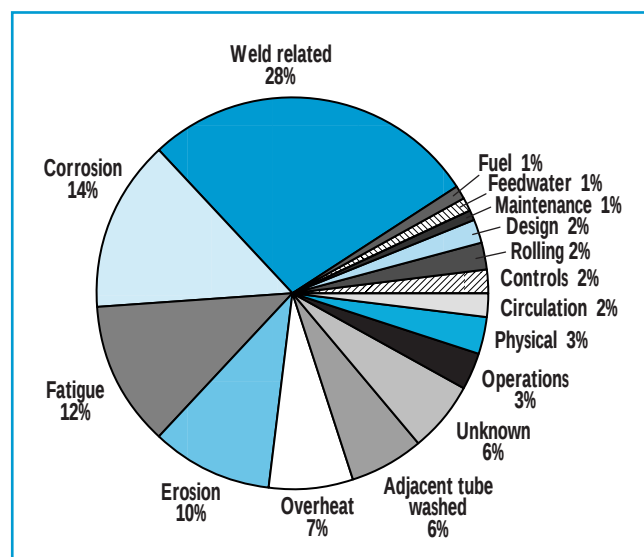
2. Root causes of recovery boiler shutdowns

**Figure 2** lists the root causes of recovery boiler shutdowns in descending order of occurrence.

**Weld-related.** By far, the largest root cause of failures is related to welds. The importance of welds will be highlighted later in this report, but the sheer size of this category calls for a more rigorous treatment of weld proce-

**Corrosion.** Most corrosion is slow acting and can be detected through proper and timely inspection. While many locations in the recovery unit are difficult to examine, a cooperative effort with the manufacturers should lead to future designs with inspectable configurations. Almost 17,000 hours of downtime are related to corrosion surprises.

**Fatigue.** The size of the fatigue category points to design deficiencies that could be addressed by the manufacturers. It is hoped that the information in the database will raise awareness of this issue and that manufacturers will take action to mitigate the effects of metal fatigue. Hours of downtime for this and subsequent root causes have not yet been determined.

**Erosion.** The erosion category includes smelt erosion, erosion from wet sootblowers, and erosion of adjacent tubes from small leaks. Note that washing of adjacent tubes accounts for 6% of the shutdowns. At least 70 such incidents have been found to date.

dures. It elicits such recommendations as mandatory training and certification of all welders who work on the boiler in any capacity; proper review of, buy-off of, and adherence to all weld procedures (including materials, techniques, and heat treatments), and proper inspection of all welds at time of execution. Over 23,000 hours of downtime are related to weld failures.

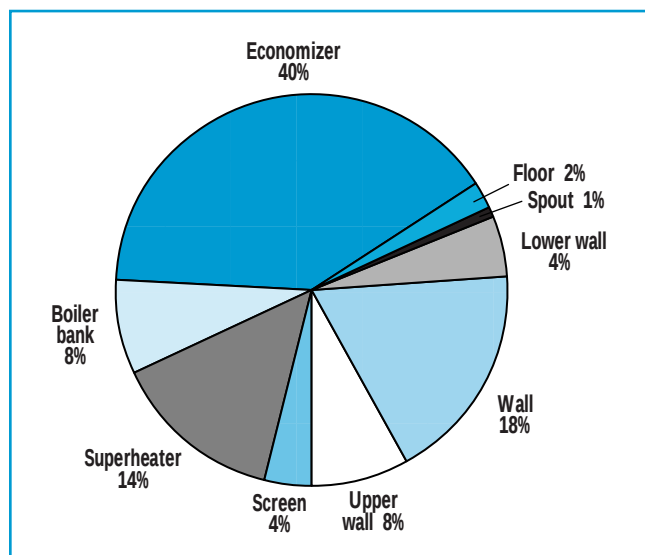
3. Location of weld-related leaks

**Weld-related leaks.** Figure 3 shows that the areas with the highest frequency of weld-related leaks are the economizer (40%), water walls (31%), and superheater (14%). This is not surprising, since these components have the highest concentration of welds. The issue of weld-related failure is examined in greater detail later in this report.

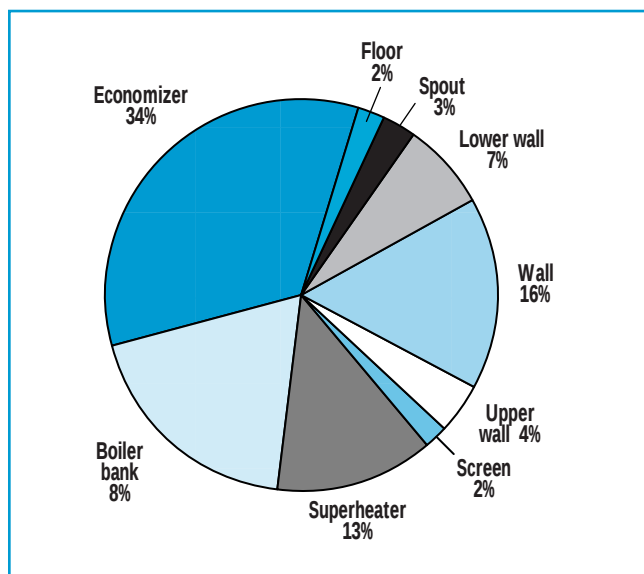
4. Location of corrosion-related leaks

**Corrosion-related leaks.** Corrosion-related leak locations in Fig. 4 confirm an expected high incidence in the walls (27%), superheater (13%), and boiler bank (19%), but a higher-than-expected incidence in the economizer (34%). The issue of corrosion-related failure is examined in greater detail later in this report.

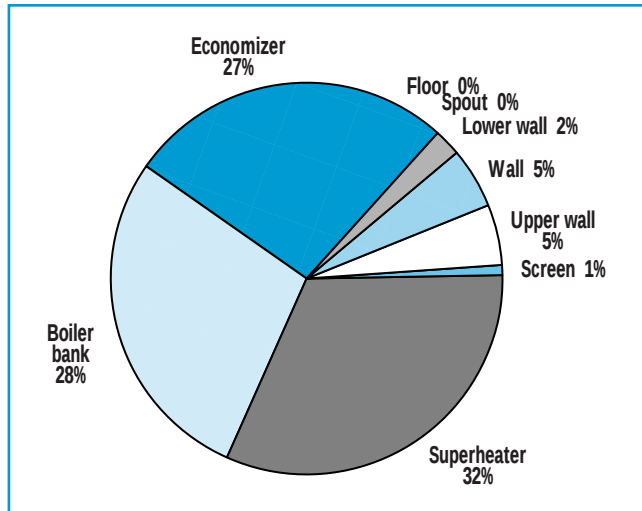
5. Location of fatigue-related leaks

**Fatigue-related leaks.** One would expect locations of fatigue-related leaks to occur most often in areas where long tubes are not fully supported against vibration forces, such as those generated by sootblowers. Figure 5 bears out this expectation.

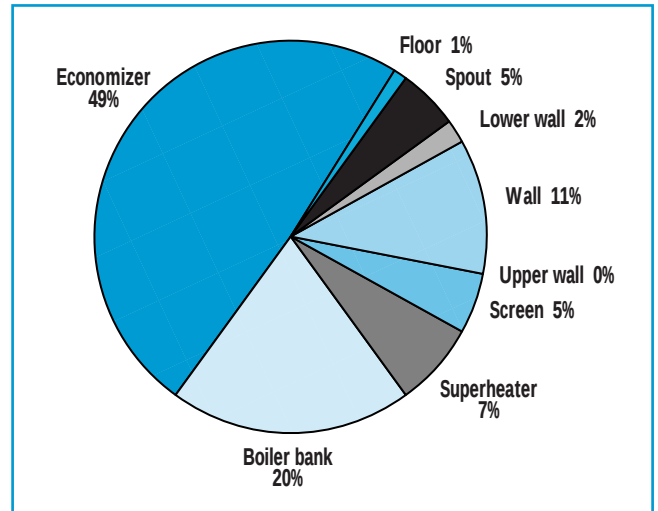
6. Location of erosion leaks

**Erosion-related leaks.** Figure 6 shows a surprising number of erosion-related leaks in the economizer.

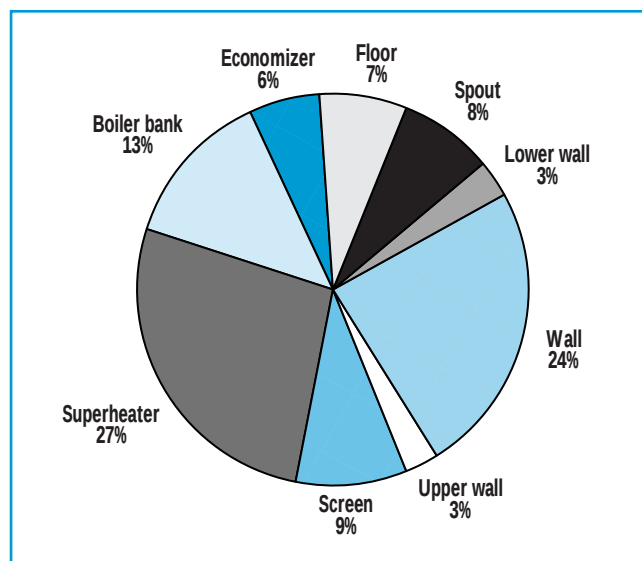
7. Location of water-side-related leaks

**Water-side-related leaks.** The water-side-related leaks combine three less-frequent categories on the premise that they are likely related. The three categories are feedwater (scale), circulation deficiencies, and overheat, both short term and long term. As noted earlier, specific cases do not always fit the trends, and there are specific cases where combining these three categories is obviously a wrong premise. Consider, for example, a situation where overheat failures of a superheater tube are due to improper selection of material rather than insufficient cooling flow ("circulation") through the tube. Figure 7 shows the location of water-side-related leaks.

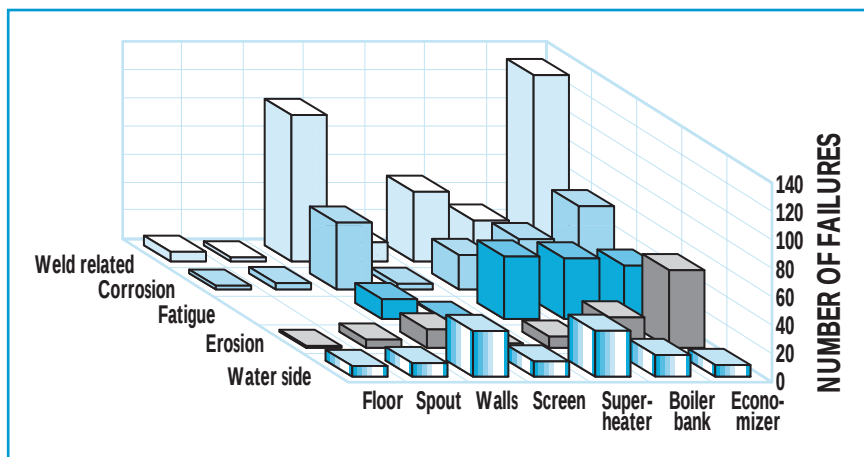
8. Location of leaks by major root causes

**Combined summary of root cause vs. location.** Figure 8 summarizes the previously discussed results (Figs. 3–7) by showing the distributions of the five major root causes in each of the seven locations within the recovery unit. This combined view shows the likely cause of failure at each location. It also provides some perspective regarding the frequency of each root cause. For example, note that the large pie slices depicting wall and superheater failures in the water-side cases of Fig. 7 are less prominent when compared with the higher bars in the other root-cause categories (weld-related, corrosion, fatigue, and erosion).

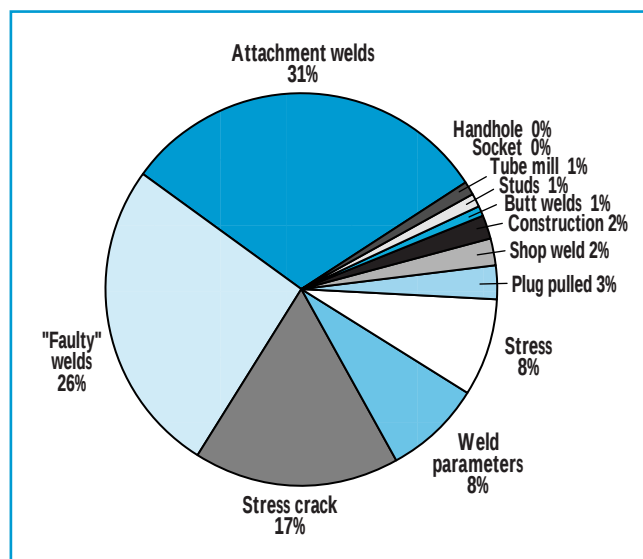
9. Classification of weld-related failures

**Discussion.** Because weld-related failures are so significant, this category was broken into subcategories depicting the types of weld failure. Figure 9 shows the frequencies of failure in the weld subcategories.

There were very few butt-weld failures. Rather, most weld failures are related to attachment welds. This is an important finding. As suggested earlier, one expects weld failures to be higher in components where there are a lot of welds, such as economizer, walls, and superheater. The finding here indicates that the shop- and field-welding procedures and inspection methods used for butt welds have definitely paid off in their rigorous application. Clearly, it has been worth the extra effort that this industry applies to ensure quality welders and butt welds.

What is of major significance is that the failures of attachment welds are undermining reliability so much. The incidence of stress and stress-cracking failures in attachment welds calls for a major review of attachment methods. The industry has addressed the failures of the 1960s and 1970s, where "tangent welds" (welds made on

The "weld parameters" category, which accounted for 8% of weld-related failures, includes lack of penetration (LOP), lack of fusion (LOF), porosity, inclusions, undercut, arc strikes, blow-through, and torch cuts.

The "faulty welds" category, which accounted for 26% of weld-related failures, has the greatest potential for improved performance in the future. If the results presented here can spur the industry to demand improvements in welder training, then proficiency at the job site will improve. Reporting of weld failures should include an explanation of the type of failure. The general "faulty" or "bad" weld category is too broad to advance our knowledge of failure or improve our welders' qualifications.

Figure 9 further confirms the weakness of field welding ("attachment," "faulty," and "weld parameter" categories) compared with "shop" and "tube mill" results.

the tangent of a tube to a crossing attachment member) were banned and replaced with the requirement to weld on membranes, use doubler plates, or use scallop bars. Some of the failures in this category likely can be traced to preexisting tangent welds. Nevertheless, based on the trends uncovered here, further work *must* be devoted to develop a reliable field stress-relieving procedure and requirement for attachment welds.

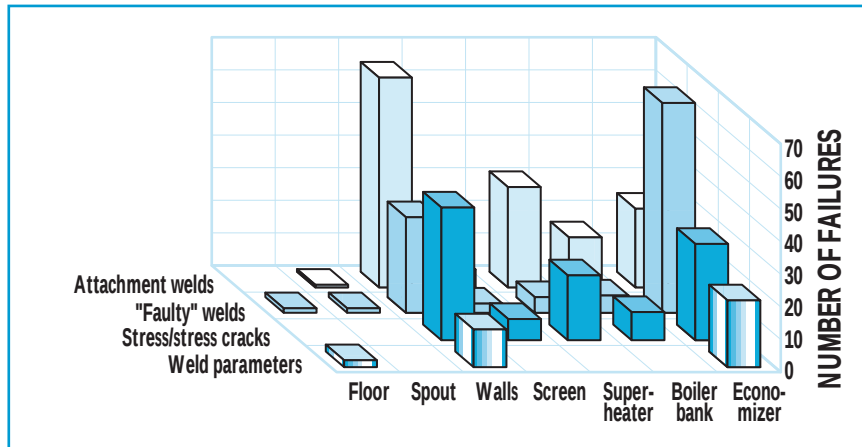
10. Location of major weld-related failures

**Location of major weld-related failures.** Figure 10 shows the distributions of the four major weld-related failures in each of the seven locations within the recovery unit. "Attachment" and "faulty" welds in the walls and economizer stand out as the primary areas of opportunity. Nevertheless, better reporting of weld failures is required to clarify this area of weakness.

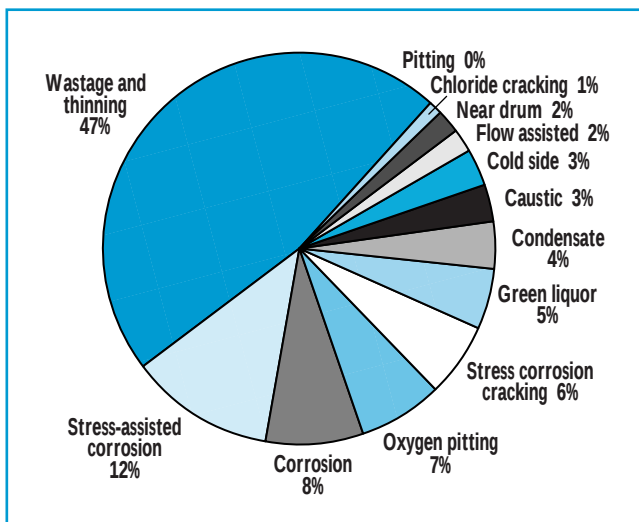
11. Classification of corrosion-related failures

**Discussion.** After weld-related failures, the next-largest root-cause classification was corrosion-related failures. This category was broken into subcategories depicting the types of corrosion failure. Figure 11 shows the frequencies of failure in the corrosion subcategories.

Corrosion is often a slow process, albeit insidious. General wastage and thinning represent half of all the root-cause mechanisms that “surprised” the operations with leak failures. Continued emphasis on corrosion containment is a valid strategy for improving safety and increasing uptime. Knowledge of the causes and locations of corrosion, as depicted by these data, can help owner-operators plan proper and timely inspections with greater confidence.

Oxygen-pitting failures are exclusively associated with feedwater oxygen and economizer inlet locations. Deaerator and oxygen scavenger problems are unforgiving and cumulative. A short-lived upset establishes an equivalent pitting intrusion. Subsequent incidents, no matter how short, each add to the pit depth, and first failures are usually accompanied by ongoing failures. With oxygen pitting accounting for 7% of corrosion-related failures, it is clear that mills must be diligent in strictly maintaining target oxygen levels. Merely measuring the level of scavenger chemicals does not offer adequate protection.

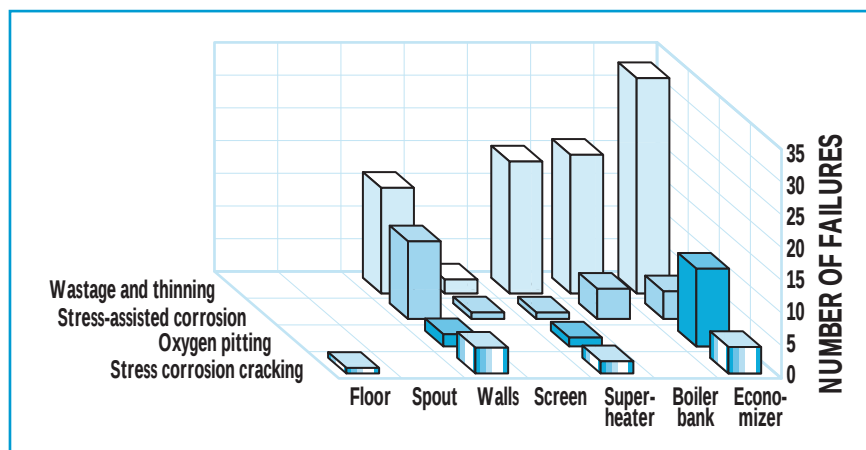
12. Location of major corrosion-related failures

Figure 12 shows the distributions of the four major corrosion-related failures in each of the seven locations within the recovery unit.

A major finding is that half of the incidents occur where water might be expected to reach the hearth (i.e., the walls and the boiler bank). The superheater and economizer account for the other half. Luckily, the floor, screen, and spout have not played a major role in corrosion failure during the past decade. This suggests that procedures to detect and correct wastage in these areas are working.
