*During the past decade, many pulp mills have experienced severe corrosion of generating bank tubes in the vicinity of the lower drum of two-drum-style kraft chemical recovery boilers. This phenomenon has been labeled "near-drum" corrosion. In 1994, a trial mill developed a plan to test various products and applications for controlling and ultimately eliminating this problem. The use of chromized tubing has so far produced encouraging results and, as a result, further development of this tubing has been initiated to specifically address the application. This paper includes the test plan and the results, and reviews the chromizing developments made specifically to combat near-drum corrosion.*

## Chromizing for near-drum corrosion protection

JAMES LABOSSIERE AND JEFF HENRY

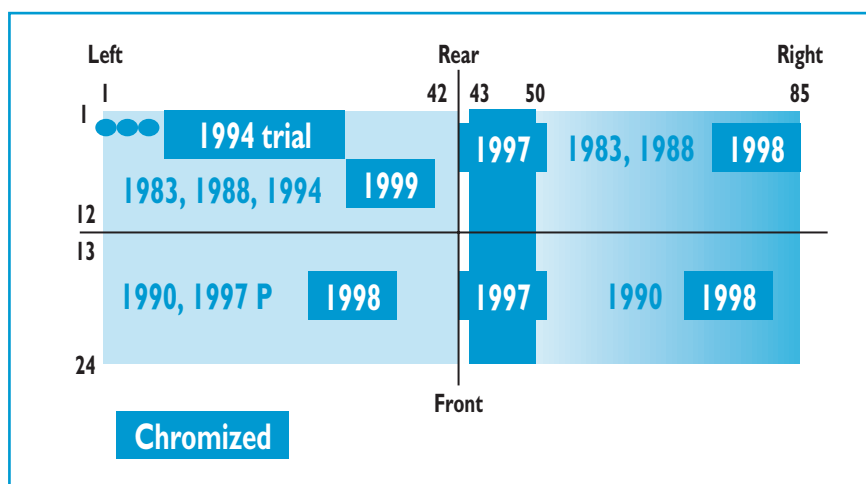
**I. Generator tube layout and retubing history location of three 1994 chromized trial tubes**

The other trial choice selected for 1994 was chromizing. Three sections of tube, each about 3.66 m (10 ft) long, were made up to match three positions in the second row at the rear of the generator. This area was chosen because it has a history of high thinning rates. One end was swaged to 50.800-mm (2-in.) OD, and the tubes were then bent to match the pattern for the intended row. The three tubes were then chromized for their entire length, including the swaged portion. During the generator retubing, matching lengths were cut off of three nonchromized tubes for row 2. The chromized portions were then field-welded onto the main section of the tubes. These trial tubes were then installed into row 2 in tube positions 2, 3, and 4, as measured from the left side of the boiler.

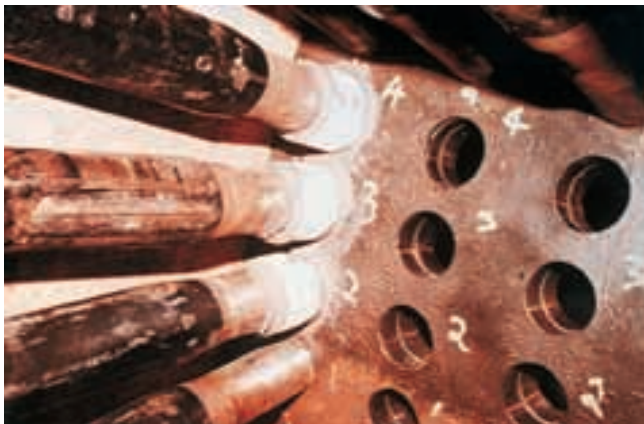
2. March 1994 installation of ceramic shields during generator tube installation

Ceramic shields, 50.8 mm (2 in.) long, were made to allow for a gap of 0.254–0.635 mm (0.010–0.025 in.) between the outside diameter of the cold tube and the inside diameter of the ceramic shield to allow for thermal expansion. Thirty-two of the shields were installed during the tube-stabbing process, and after the tube expansion, the shields were grouted into place at the drum. **Figure 2** is a photo of the 1994 installation of some of the ceramic shields.

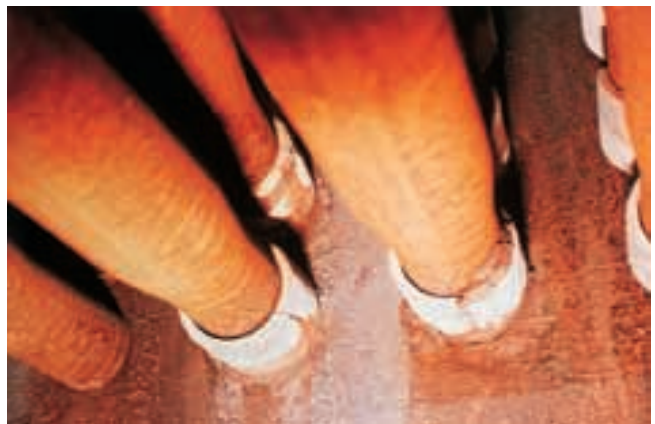
3. April 1995 ceramic shields starting to break off after only 1 year of service

**Figure 3** shows the ceramic shields after only 1 year of service and illustrates that most of the shields had already started to break

and fall off in that time. Even though most of the shields failed, they still provided a few years of significant protection. However, because most of them broke or fell off within the first few years, the method was considered a failure.

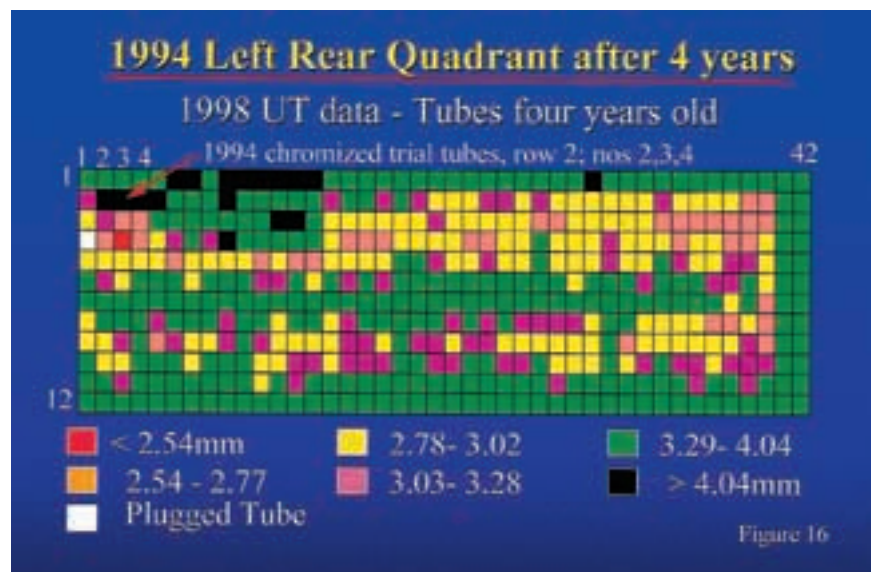
4. 1998 UT data on the left-rear quadrant (retubed in 1994) illustrate that most other tubes have thinned considerably, compared to the three trial chromized tubes in row 2, positions 2, 3, and 4.

The difference is dramatic. In 4 years, all three of the original chromized trial tubes have retained almost all of their nominal thickness, whereas the worst-case nonchromized tube has lost over 1.651 mm (0.065 in.) of wall thickness, or over 0.406 mm (0.016 in.) per year. Figure 4 shows an overview of the 1998 NDE results of the left-rear generator section, which is now only 4 years old. It is clear that many of the tubes around the chromized trial tubes are now severely thinned, including some that were part of the 1994 ceramic shield trial. It is also obvious that the left-rear quadrant, where the chromizing trial began, needs to be retubed for the fourth time. The plan is to replace this quadrant in 1999. This will finish the entire generator with chromized stubs at the mud-drum end, except for 36 of the outer structural tubes: 12 on the left-front section and all 24 on the right side. To date, of the 48 structural tubes, only the 12 left-rear ones have experienced significant thinning.
