# *Influence of cooking conditions on continuous digester corrosion in a Brazilian pulp mill*

**Application:** This paper describes two specific cases of digester corrosion and protection and relevant processes and construction materials. The information may be useful to mills that have switched to newer cooking processes, or plan to do so.

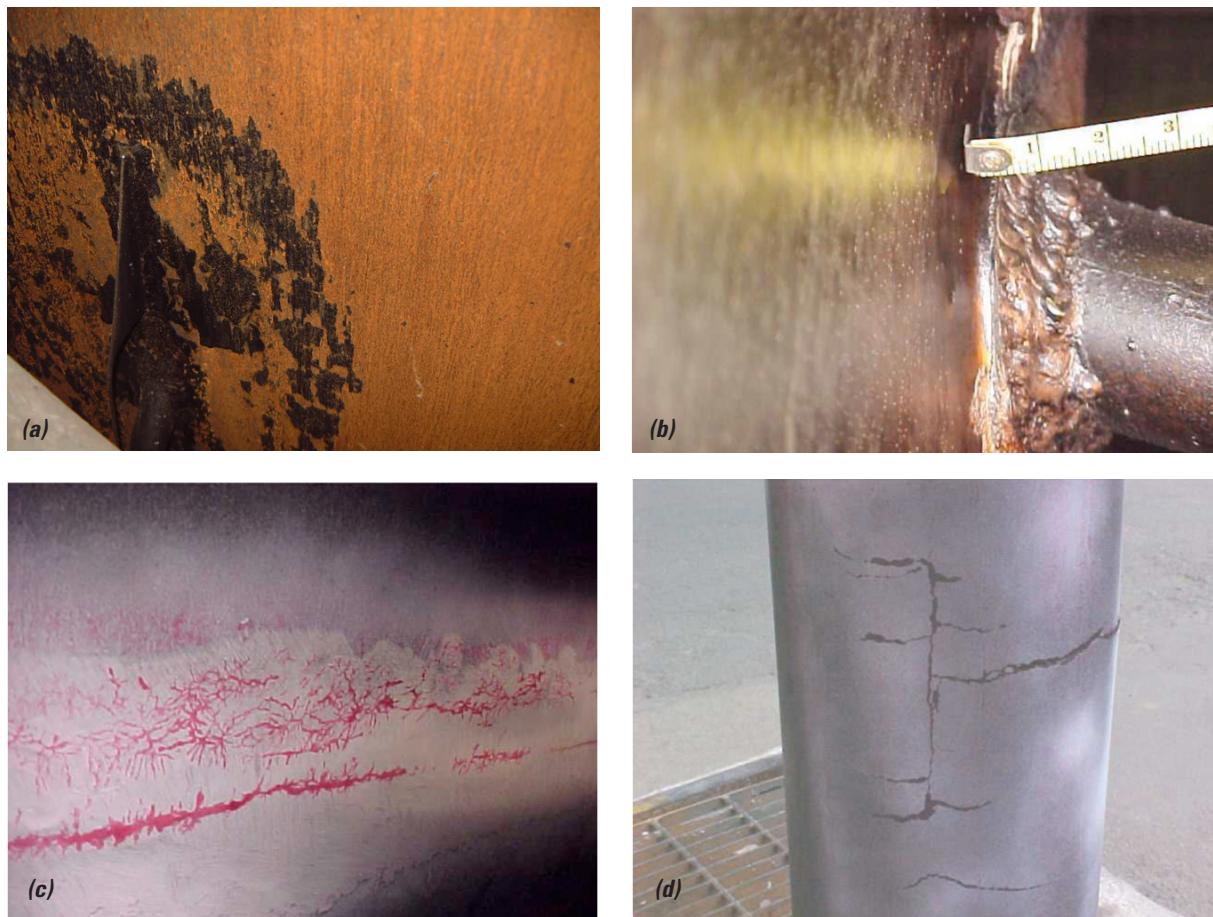
Also in May 2003, SCC was observed around the digester circumference at the beginning of the clad plates that form the top separator, right above the thinned areas, requiring repairs and crack grinding. In October 2003, the 316L central pipe failed, completely destroyed by SCC, and was replaced by a new pipe in 2205 duplex stainless steel.

**Figure 5** presents the main corrosion aspects observed in digester 1.

**5. Corrosion aspects observed in digester 1: (a) and (b) shell corrosion thinning, (c) stress corrosion cracking (SCC) on the stainless clad plates of the upper zone, (d) central pipe destroyed by SCC.**

The total losses of the thinned walls of digester 1 up to the AP installation had been 5 mm. In some locations the remaining thickness was close to the code-allowed minimum. The mill therefore needed to build up part of the lost thickness on the thinned shell courses. The mill decided to resort to the additional security afforded by 110 m<sup>2</sup> stainless steel weld overlay, in ER312 alloy with 3 mm thickness, applied during October 2004.
