# *Could biomass-fueled boilers be operated at higher steam temperatures?*

## *Part 2: Field tests of candidate superheater alloys*

JAMES R. KEISER, W.B.A. (SANDY) SHARP, AND DOUGLAS L. SINGBEIL

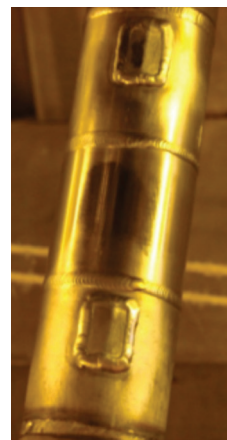
**1. Schematic of the corrosion samples (left); photo of samples tack welded with thermocouples protruding from the surface of the samples (center); and photo of samples welded together and with shim stock welded in place to hold thermocouples on the surface of the samples (right).**

Each air-cooled corrosion probe was designed to contain 30 samples each at 5.08 cm (2 in.) long fabricated from 1.5 in. schedule 40 pipe or the equivalent. The samples were fabricated so that they were interlocking and each had a slot machined in the surface to accommodate a 0.0625 in. dia. sheathed thermocouple. Temperatures were measured by twenty-four thermocouples so that four of every five samples had a thermocouple attached. These thermocouples were fed through the inner diameter (ID) of the corrosion probe. The corrosion sample design, which is shown in **Fig. 1**, provides for about 1 cm of the thermocouple to be in contact with the outer surface of the sample. This design was intended to minimize the cooling effect on the thermocouples of the air flowing through the probe, thus making the measured temperature representative of the temperature of the outer surface of the samples. To assure that each thermocouple maintained full contact with the sample surface, a piece of 0.78 mm (0.031 in.) stainless steel shim stock was welded to the sample so that the shim stock held the thermocouple tightly against the sample. Pictures of the thermocouple arrangement without and with the shim stock are also included in Fig. 1. Besides showing the

shim stock that was welded in place over each thermocouple, this figure also shows the tack welds that were used to position and align the samples before application of the circumferential welds that rigidly connect adjacent samples. To provide additional support for the probe, which extended at least 2.1 m (7 ft) from the boiler wall, a 0.5 in. dia. stainless rod ran the length of the probe inside the corrosion samples (along with the thermocouples). A stiff spring was placed between the rod and the outside base of the corrosion probe in order to allow for thermal expansion that was expected to differ between the array of welded samples and the stainless steel support rod that was cooled by the air flowing through the probe.

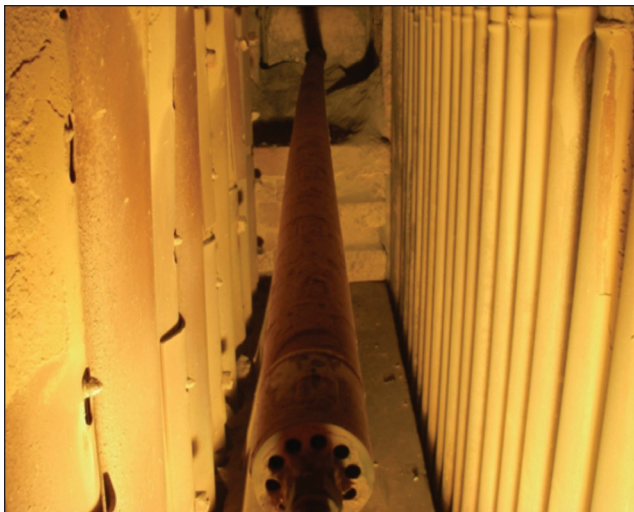
**13.** Photo of the corrosion probe in the Gadsden power boiler just prior to its removal (photo courtesy of Billy Zemo, Southern Company).

This corrosion probe was inserted in a sootblower lane between superheater tube platens and is shown in **Fig. 13** just before it was removed. Deposits on the probe were a reddish color and were fairly limited in terms of the amount accumulated. Although there were a couple of interruptions in boiler operation during the early stages of the exposure, as shown in **Fig. 14**, the temperatures were far more constant than observed in the other three boilers that were studied. The total exposure period lasted for about 123 days, but the first several days were during a startup period when temperatures were low, and there were two short periods, clearly evident in Fig. 14, where the boiler briefly cooled, in one case to near room temperature. The probe was actually exposed to normal operating conditions for about 106 days or 2540 h.
