# Interchangeable collector rings

*A new design for collector rings on synchronous motors can speed the process of changing rings and reduce downtime.*

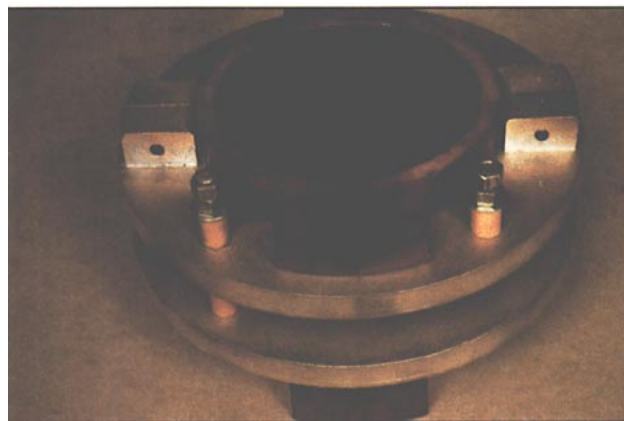
1. Prototype rings showing first design of clamping system used on Textilite hub

Deciding how the clamping tabs would look as a finished product took some time and thought. The prototype rings had two tabs on both ends of the hub, as shown in **Fig. 1**. We had some problems with this system during assembly, especially when the rings were assembled on site. It did give good holding strength.

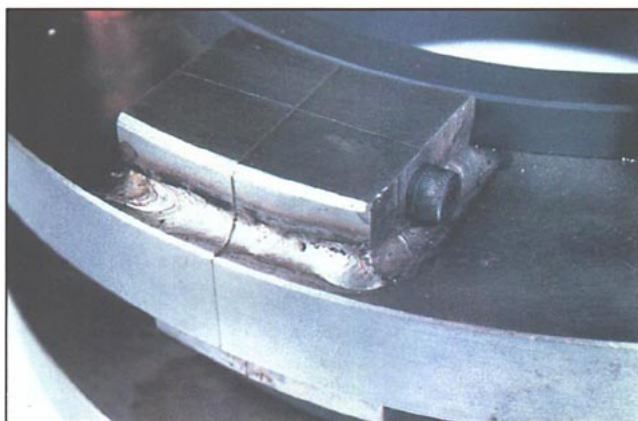
7. Stainless steel rings showing clamping tabs welded to the rings

Steel and stainless rings do not have the tabs machined into them. The tabs are separate pieces that are welded to the ring as the first step in the operation. Carbon steel or stainless steel offers the user the ability to weld the pieces together, which saves time as well as material cost. **Figure 7** shows the clamping tabs welded to the rings.
