# Influence of nondestructive test procedures on detection of stress-corrosion cracks

**ABSTRACT:** *A weld "T" joint from a scrapped carbon-steel digester level tank was used to test the efficacy of the nondestructive liquid-penetrant and magnetic-particle test methods commonly used for field detection of stress-corrosion cracks. The tests were conducted using three methods of surface preparation—wire brushing, light grinding, and sandblasting. Light grinding of the surface greatly increased the sensitivity of both the liquid-penetrant and magnetic-particle test methods. The most successful combination was light surface grinding followed by inspection with a fluorescent liquid.*

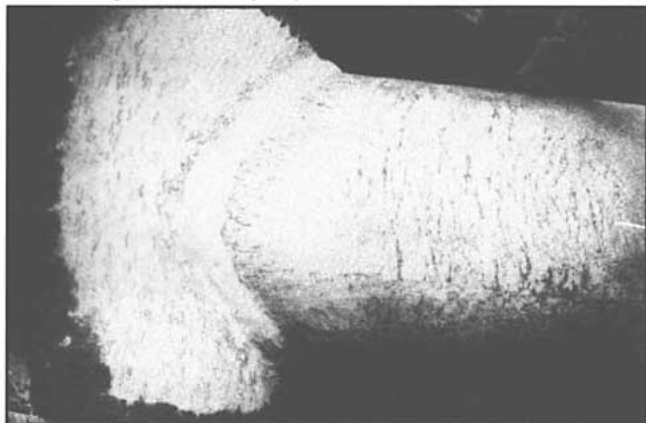
8. Lightly ground, followed by solvent-removable fluorescent LPI. The entire surface was sandblasted, tested, then lightly ground for the final, highest sensitivity inspection

**Figure 8** shows the weld "T" after completion of the test program. The entire surface was lightly ground and tested by fluorescent LPI. Cracking in parent plate at 45° to the welds is readily apparent on the left-hand side. This cracking was not detected when only sandblasting was used for sur-

face preparation. The known indications on the right-hand side (apparent in Figs. 4–7) are not visible here because the incidence angle of the black light resulted in glare.

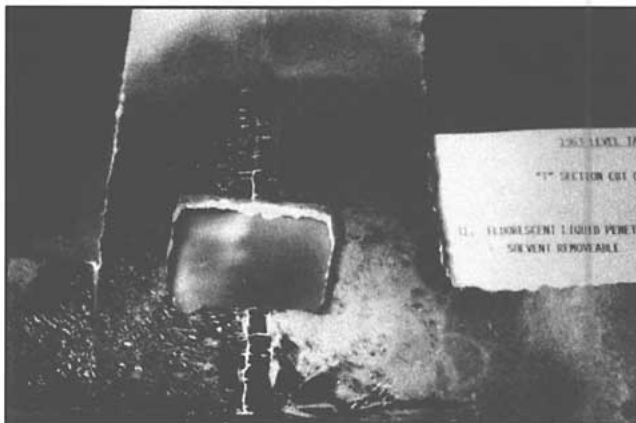
9. Chloride SCC in Type 304L stainless-steel shower support. Light grinding was required to detect cracking via visible solvent-removable LPI

tion. Areas of through-wall cracking in the thin-gauge vapor hood were readily detected. The thick-walled support pipes for internal showers were found to be indication free. This result was judged to be questionable, so light grinding was used to prepare the surface. Severe SCC was detected, as shown in **Fig. 9**. The orientation of cracking clearly reflects the residual and service stresses present at the welded joint and is in no way related to grinding. The SCC that will eventually threaten the structural integrity of the supports would have gone undetected if power wire brushing had been relied on for surface preparation.
