# Corrosion and protection of kraft digesters

ANGELA WENSLEY

*The mechanisms of corrosion and cracking in kraft digesters are reviewed, including stress corrosion cracking, general corrosion, pitting, preferential weld attack, and intergranular corrosion. Also discussed are the various corrosion protection measures, including corrosion-resisting weld overlay, thermal spray coating, and anodic protection. In situ corrosion monitoring by coupons, corrosion potential probes, and linear polarization probes is described, as well as laboratory autoclave testing in digester extraction liquors.*

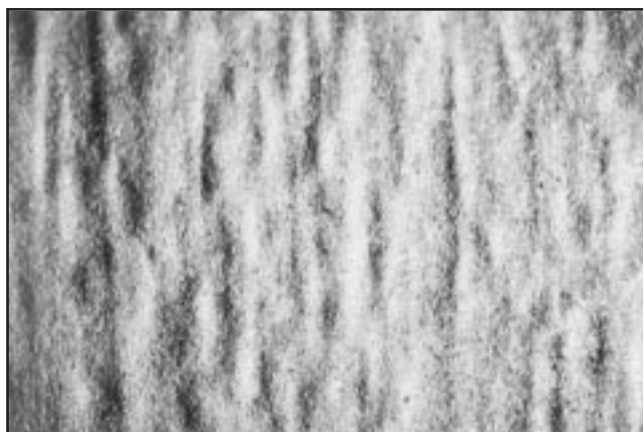
5. Nonuniform thinning in the wash zone of a continuous digester

digester wall may experience smooth, uniform reduction in thickness. Sometimes, the corroded area is found to be bright and shiny on inspection (Fig. 4). Alternatively, the wall may experience non-uniform attack. Pitting corrosion is discussed in the following section. Many vessels exhibit a "corrugated" or "rippled" surface morphology, with the vertical corrugations angled slightly in the direction of rotation of the outlet device (Fig. 5). There are also bizarre forms of corrosion morphology, such as "spikes" or uncorroded metal remaining after the surrounding metal has been corroded away (Fig. 6). Behind screens the digester

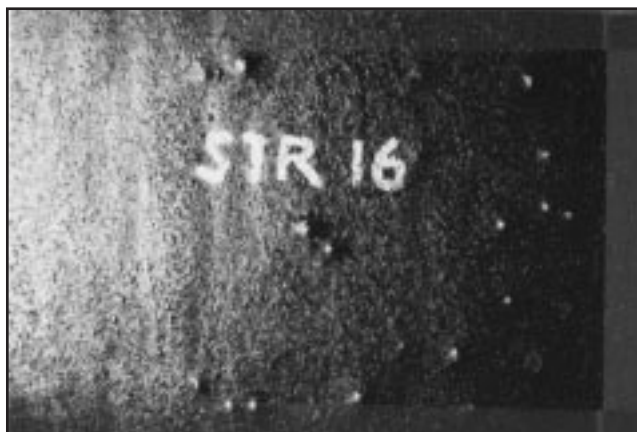
6. "Spikes" on the wall of a continuous digester, between the cooking and extraction screens

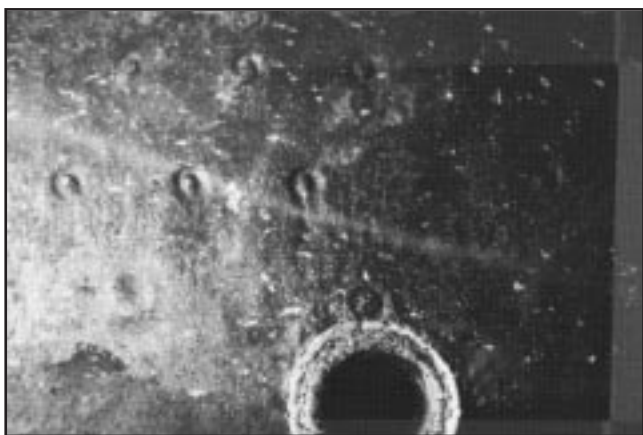
7. Erosion-corrosion behind an extraction screen

shell may corrode at an even faster rate, and exhibit features of erosion-corrosion (Fig. 7).

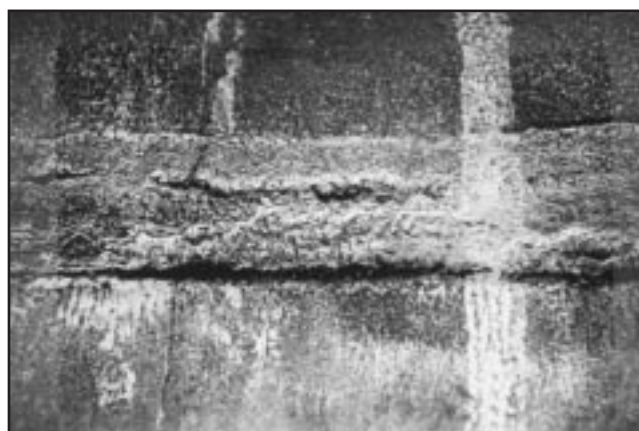
10. Preferential attack of a circumference seam weld

**PREFERENTIAL WELD CORROSION**  
Welds in continuous digesters, in particular the circumferential and vertical seam welds, often experience preferential corrosion attack compared with the surrounding carbon steel plate (Fig. 10). There are two

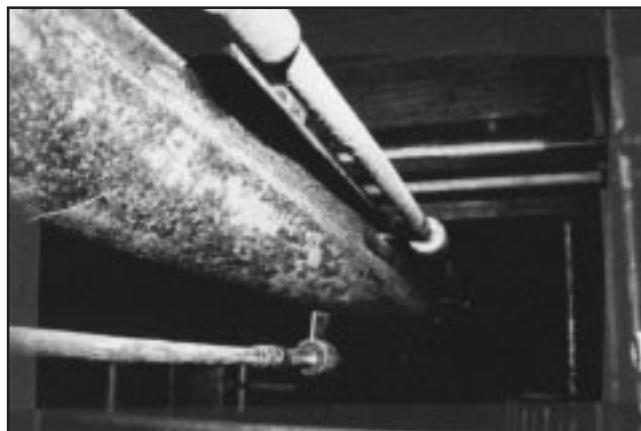
12. Anodic protection with centrally-mounted cathodes

There are two philosophies regarding anodic protection of digesters. One employs central cathodes (Fig. 12); the other, wall-mounted cathodes (Fig. 13). The range of potentials where anodic protection can provide effective protection against corrosion thinning is quite narrow, perhaps as low as 50 mV (at lower corrosion potentials the digester experiences active corrosion at a high rate; at higher potentials the digester experiences transpassive corrosion, also at a high rate). The inherent instability of the reference electrodes (stainless steel, silver, or molybdenum) used for controlling anodic protection systems may be of this magnitude in the lower zones of continuous digesters.

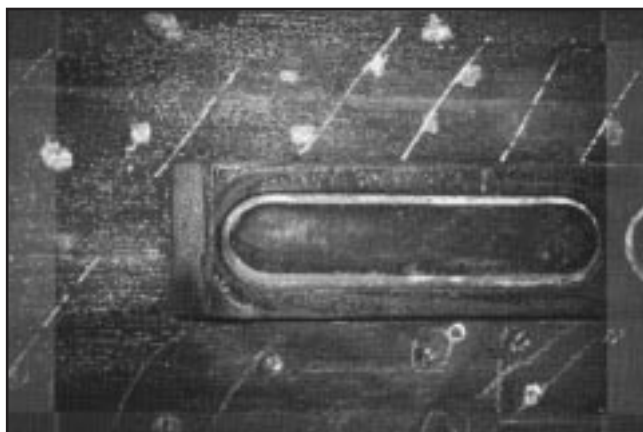
**13. Anodic protection with wall-mounted cathodes**

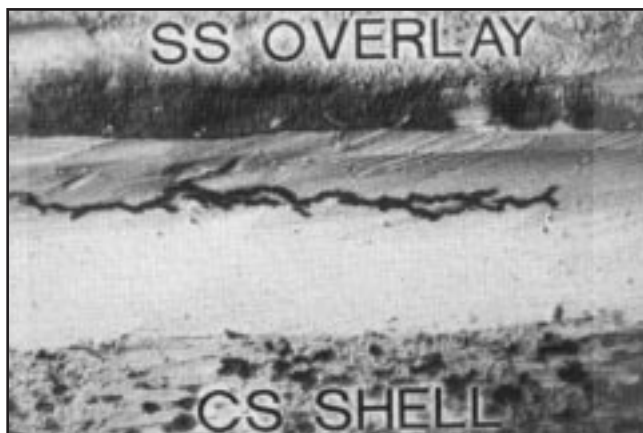
**15. SCC in the carbon steel at the edge of the stainless steel weld overlay band in the impregnation zone of a continuous digester**

In continuous digesters, stainless weld overlay bands were applied over seam welds to protect them against SCC. In many digesters, this resulted in serious SCC in the carbon steel at the overlay band edges (Fig. 15). Nickel-base weld overlay bands appear to be particularly prone to edge SCC. Overlay banding is no longer recommended for welds in the impregnation zone; bands lower in the digester should be inspected carefully for cracking. On the other hand, application of stainless weld overlay to protect large surface areas in the lower part of the vessel from corrosion thinning has been very successful.

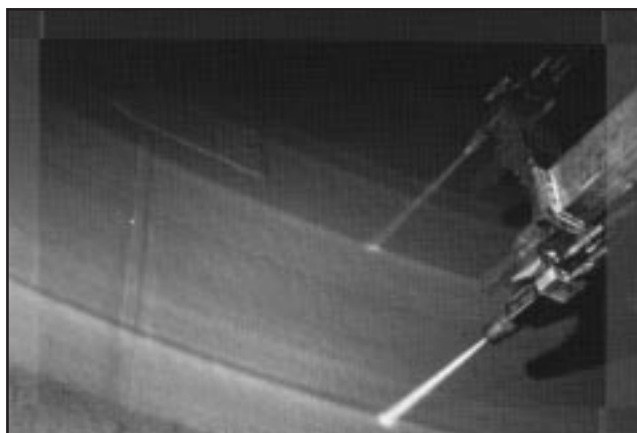
**16. HVOF thermal spray being applied by a robot arm in the wash zone of a continuous digester**
