# Yankee dryer development through stress analysis

JOHN A. KRIEDEMAN

*Stress analysis has guided the development of the Yankee dryer since its infancy in the mid 1800s. This paper traces the development of the Yankee dryer from a primitive drying cylinder to a modern pressure vessel of extraordinary productivity. The review of Yankee history also tracks the evolution of stress-analysis concepts and techniques from rudimentary equations to computer-based finite-element analysis. Stress analysis is shown to be an indispensable tool for understanding and resolving operating problems and, most importantly, for providing a methodology for running this critical piece of equipment safely.*

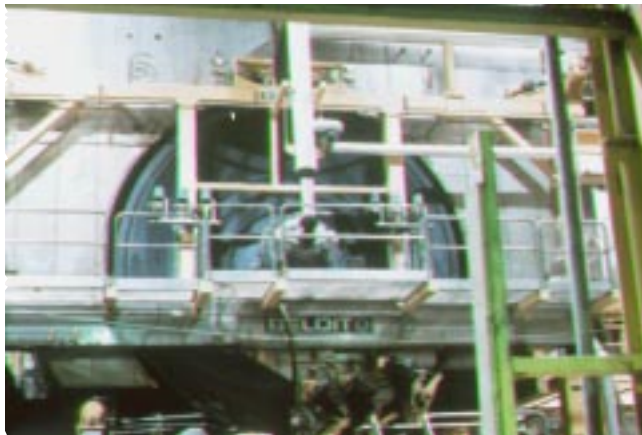
1. Yankee dryer

**T**HE YANKEE DRYER IS THE corner-stone of the crepe tissue process. In less than a single turn of this large cast-iron pressure vessel, the tissue web is pressed, dried, and creped. Today, the surface speeds for tissue-making can exceed 2000 m/min. **Figure 1** is a photograph of a modern Yankee dryer.
