# Evaluation of bleach plant piping materials

A. H. Tuthill and A. Garner

*Tests on fabricated pipes in the bleach plant show that further work is needed to establish an inside root pass procedure which avoids the formation of unmixed zones. Possible options include automatic gas tungsten arc welding, a greater root gap, or consumable inserts.*

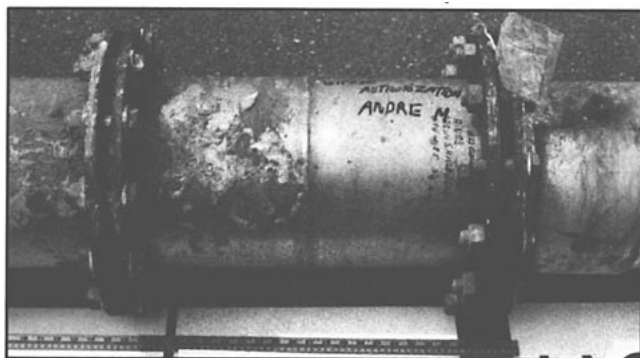
2. A section of the pipe spool before disassembly

indicated in Fig. 1. It was installed and put into service on April 17, 1987, and removed on June 5, 1988. Visual inspection from the ends indicated that the surfaces were clean and free of pulp, except in the vicinity of localized corrosion sites near the welds of some—but not all—sections. Mill practice was to flush and drain lines on shutdown. No other cleaning was done on the test assembly.
