# HELP FOR CONCRETE FLOORS IN A WET ENVIRONMENT

*A NEW PROTECTIVE TOPPING, WITH A HIGH COMPRESSIVE STRENGTH, PROVES BENEFICIAL IN REPAIRING PAPER MILL FLOORS THAT CANNOT BE THOROUGHLY DRIED.*

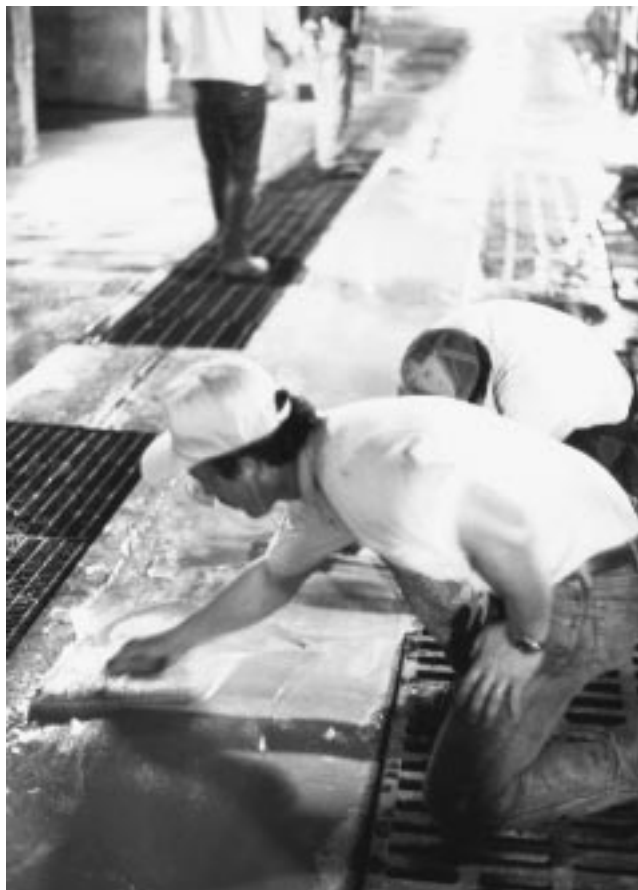
**1. A resin-rich flooring is poured onto a previously prepared section of floor between two floor drains and then smoothed with trowels. This area has been cleaned to remove loose concrete and to create a surface profile for better adhesion of the flooring. Although surrounded by wet floors and high humidity, the new floor topping adheres well to this still-damp section.**

Berea, OH, worked in sections, removing standing water, repairing cracks in the floor, and erecting plastic tents to divert moisture dripping from above. Using more than 300 ft<sup>3</sup> of epoxy grout, the contractor built up the floor and created a slope from the walls to the drains, which run the length of the basement between the paper machines. A resin-rich Overkrete industrial flooring was poured onto the floor and troweled to a thickness of 250 mils (0.25 in.). Aggregate was then broadcast over the still-wet material. After the flooring material cured, excess aggregate was swept away, leaving a uniform, nonporous, slip-resistant finish.

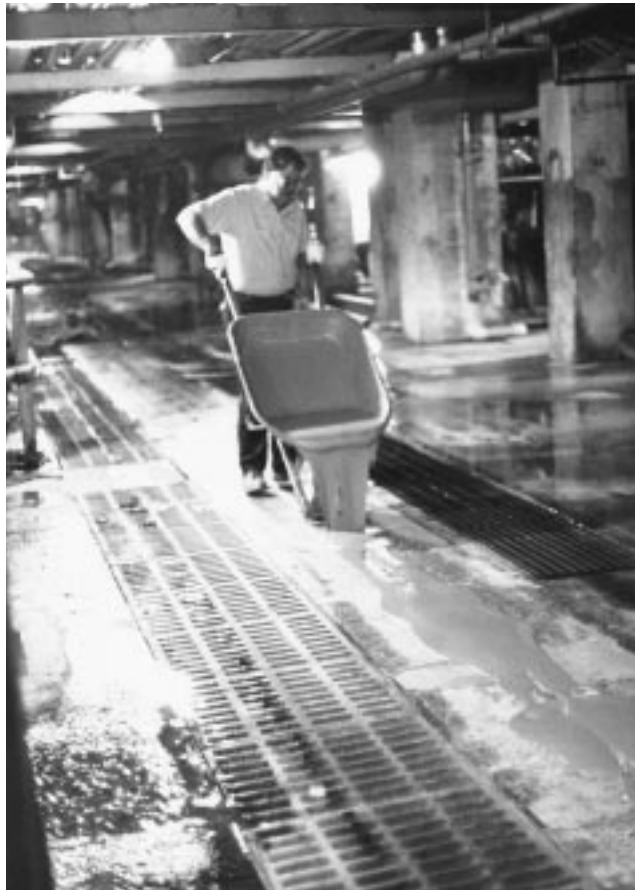
**2. The floor topping is smoothed with a trowel to a depth of 250 mils (0.25 in.). With a compressive strength of about 12,000 psi when cured, this surface can withstand extremely heavy loads. It also resists wear, abrasion, and moisture.**

With a compressive strength of about 12,000 psi, this surface can withstand extremely heavy loads without cracking or breaking. It also exhibits good resistance to wear, abrasion, and moisture.
